February 27, 2018

08345 Version 3

## 2012 RL, 2014–17 RLX: Judder from the Torque Converter Lock-Up Clutch (Snapshot Upload Required)

Supersedes 16-065, 2012 RL, 2014–17 RLX: Judder from the Torque Converter Lock-Up Clutch, dated March 24, 2017, to revise the information highlighted in **yellow**

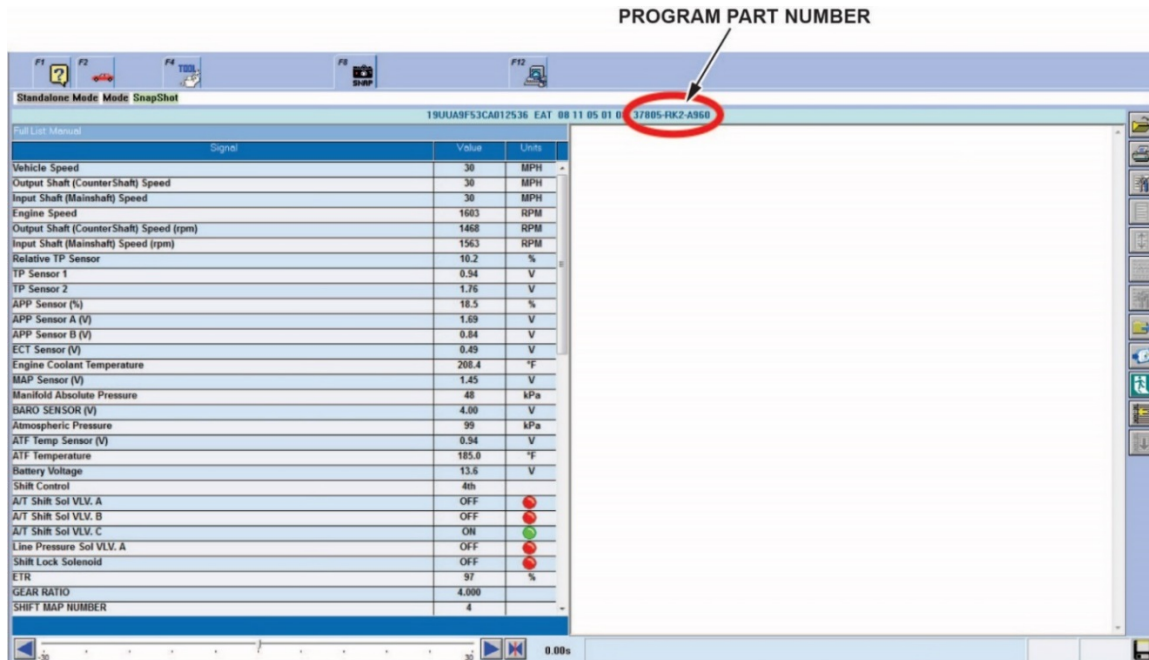
1. Connect the i-HDS, and go to the **AT Data List**. Check to see if the software has been updated by comparing the program P/N against the table below.

- If the program P/N is listed below (or later), the software has been updated. Go to service bulletin 16-066, 2012 RL, 2014–17 RLX: *Judder from the Torque Converter Lock-Up Clutch After Software Update*.
