| Title (customer effect) | Mack Chassis - Diagnostic Trouble Code ( DTC ) P2459 Lighting The Malfunction Indicator Lamp ( MIL ); Possible Frequent Regeneration Requests - OBD15 And Newer Chassis |
| Cause | OBD15 and newer chassis may log DTC P2459 - Diesel Particulate Filter Regeneration Frequency (Bank 1). P2459 may log with or without frequent regeneration requests. Guided Diagnostic steps may complete with No Fault Found. |

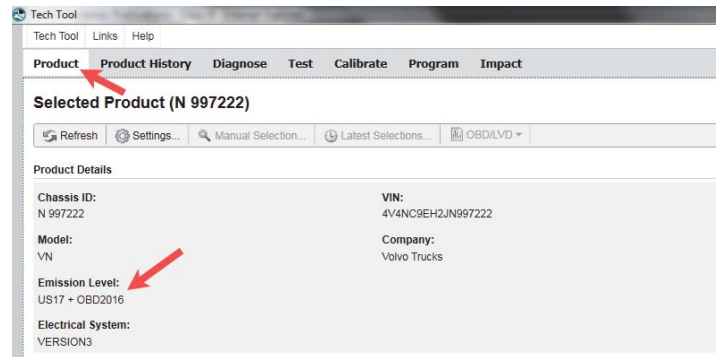
### Verify the chassis emissions level

- Details can be found in the Product Details box on the Product tab in PTT as seen below:
