# Entune Audio Head Unit Software Update (Pioneer)

## Applicability

| YEAR(S) | MODEL(S) | ADDITIONAL INFORMATION |
|---|---|---|
| 2018 | Camry, Camry HV | |

## Introduction

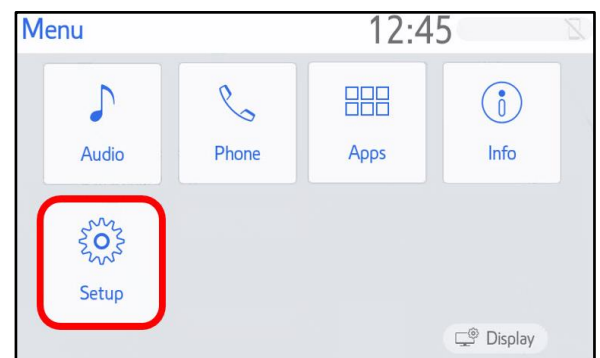
**Figure 1.**

1. Start the engine.
2. Press the Menu button on the radio faceplate, then select Setup.

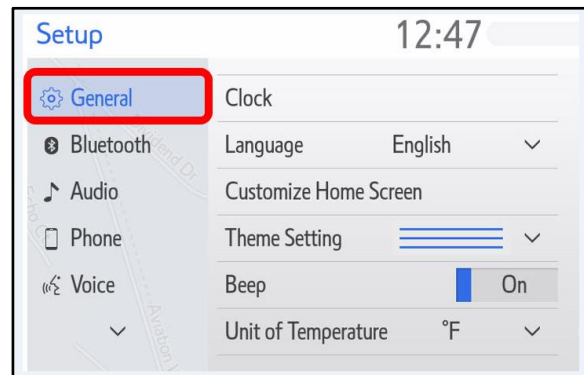
Figure 2.

3. Select General on the Setup screen.

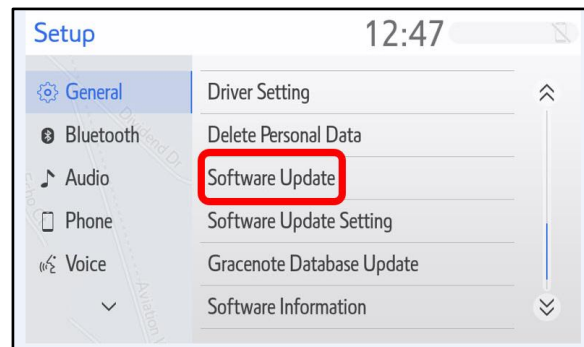
Figure 3.

4. Scroll down and select Software Update.

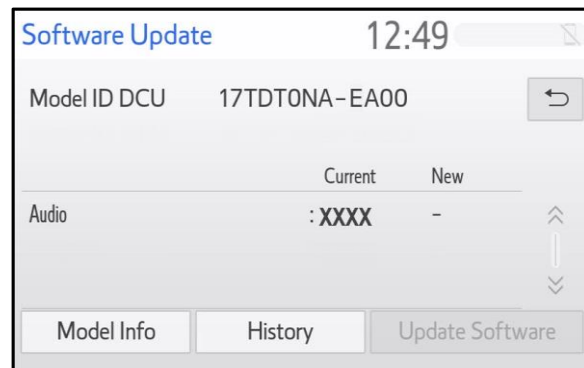
Figure 4.

5. Verify that the software version is the same or earlier than indicated in the Introduction.

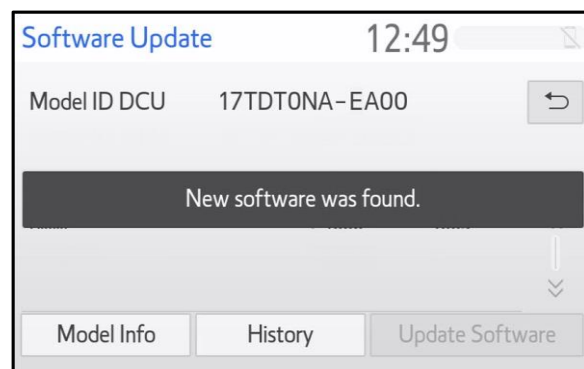
Figure 5.

7. Insert the prepared USB flash drive into the vehicle's USB port.

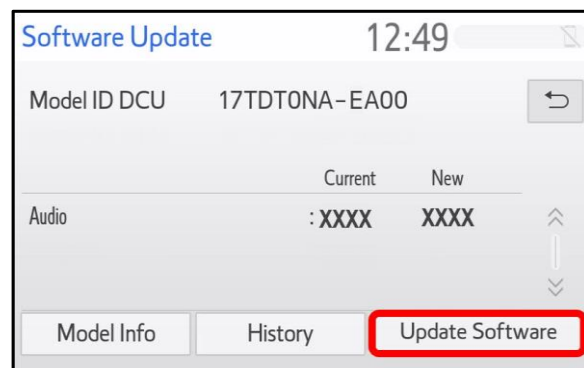
Figure 6.

9. Select the *Update Software* button in the lower right-hand corner.

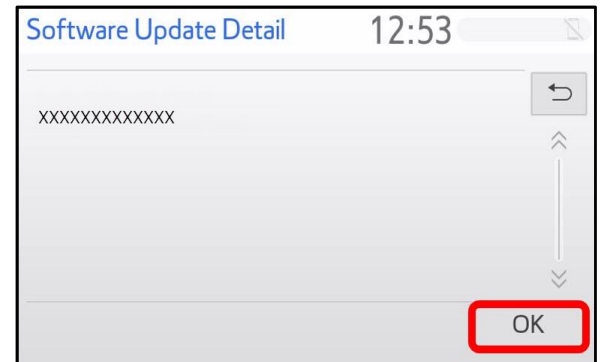
Figure 7.

10. Select OK on the Software Update Detail screen.

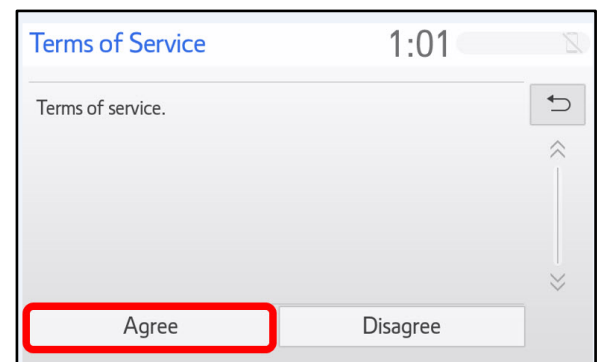
Figure 8.

11. Select Agree on the Terms of Service screen.

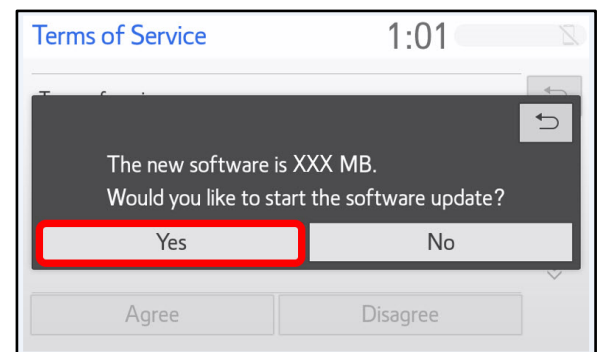
Figure 9.

12. Select Yes on the "Would you like to start the software update?" pop-up.

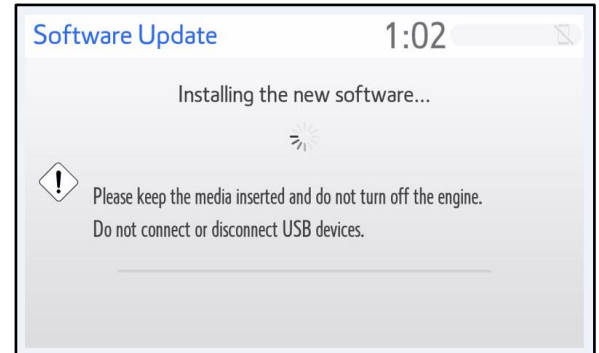
**Figure 10.**

13. Once the head unit begins installation, the update will take approximately 10 minutes.

- Do NOT turn off the engine or ACC before the software is ready for updating.
- Do NOT remove the USB flash drive until instructed in step 16.

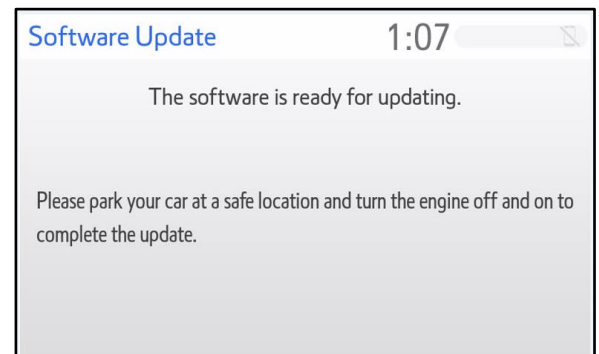
**Figure 11.**

14. When the “The software is ready for updating.” screen appears, turn OFF the ignition.

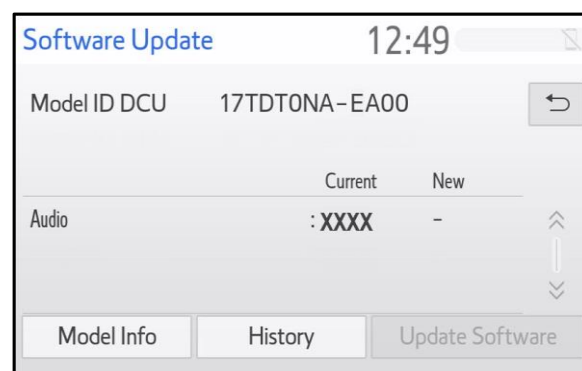
**Figure 12.**

17. Perform steps 1 – 4 to verify the software version matches the current software version information table below.
