Entune Audio Head Unit Software Update (Fujitsu Ten)

YEAR(S)	MODEL(S)	ADDITIONAL INFORMATION
2016 - 2017	Camry, Camry HV, Corolla, Prius C, RAV4, RAV4 HV

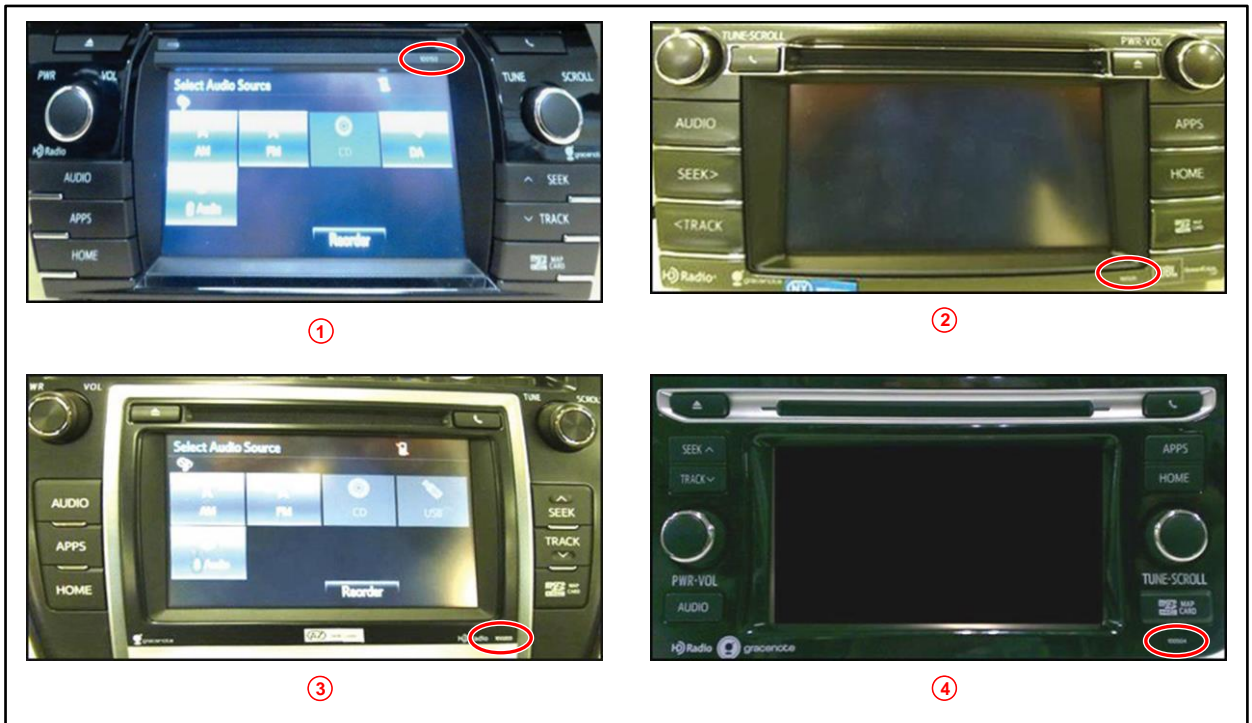
Figure 1.

1. Confirm the audio system type by checking the panel ID printed above the top-right or bottom-right of the display.

1	Corolla
2	RAV4

3	Camry, Camry HV
4	Prius C

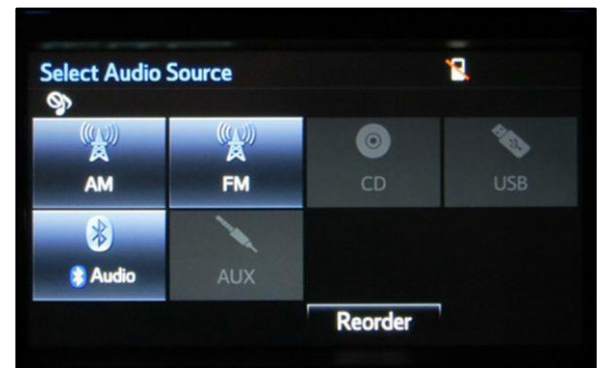
Figure 2.

2. Perform steps 7 – 11 and verify the latest software needs to be installed.
Is the software up to date?
 - **YES** — This bulletin does NOT apply. Continue diagnosis using the applicable Repair Manual.
 - **NO** — Continue to step 3.
3. Insert the USB flash drive into the vehicle USB port.
4. Start the engine.
5. When the Select Audio Source screen displays, continue to the next step.

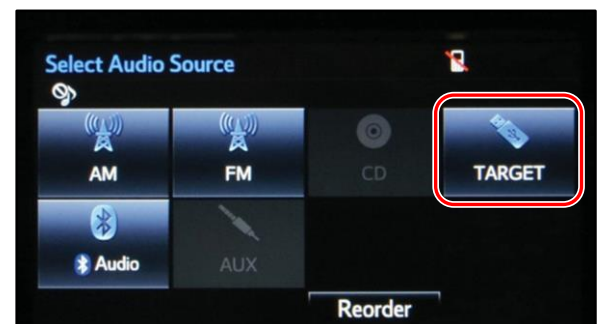
Figure 3.

6. When the USB source icon highlights and displays the USB name with the icon, continue to the next step.

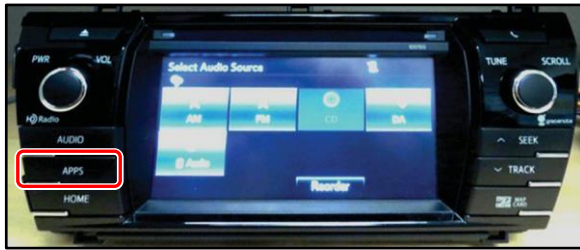
Figure 5. Camry, Corolla, RAV4

(1) Press the Apps button on the left or right of the panel.

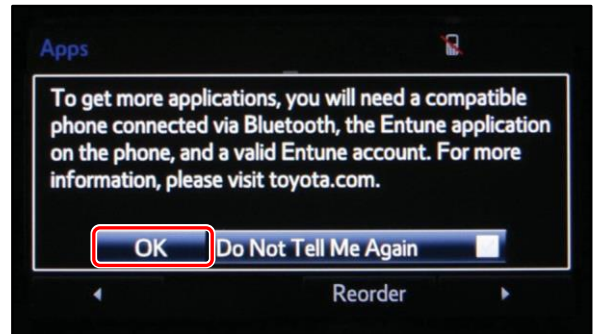
Figure 7.

If the Entune pop-up displays, select OK.

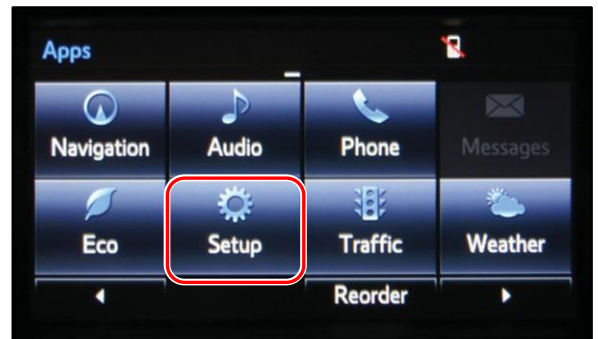
Figure 8.

(2) Select Setup on the Apps screen.

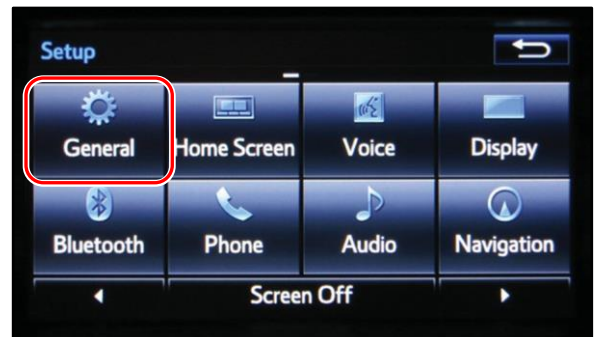
Figure 9.

8. Select General on the Setup screen

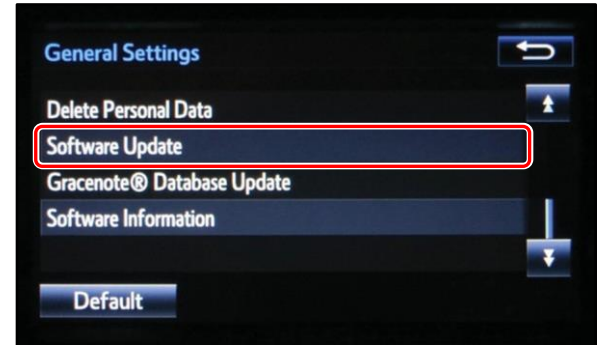
Figure 10.

9. Select Software Update from the list on the General Settings screen.

Scroll down the list until Software Update displays.

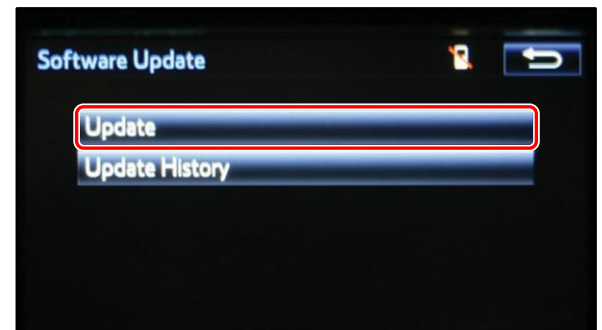
Figure 11.

10. Select Update on the Software Update screen.

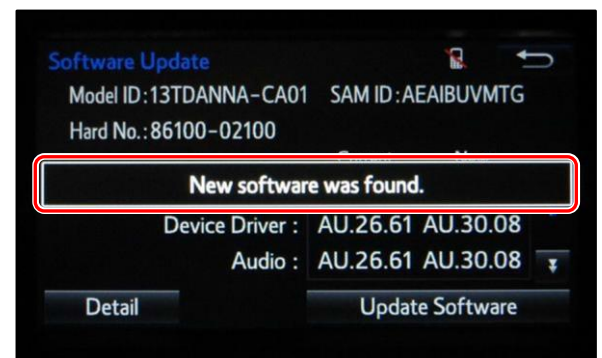
Figure 12.

If software is detected properly, a "New Software was found." pop-up will display.

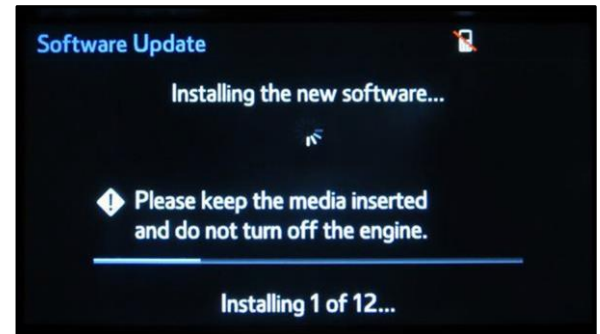
Figure 17.

14. This unit will begin installation.

Do NOT turn off ACC before the software is ready for updating.

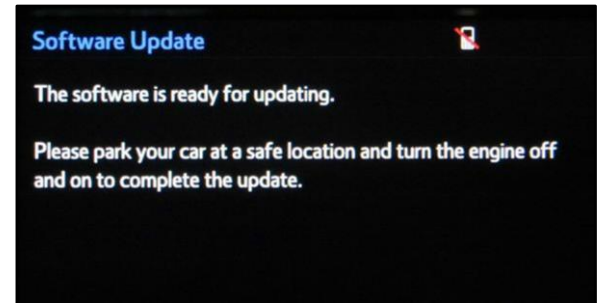
Figure 18.

15. When “The software is ready for updating.” pop-up displays, cycle the ignition OFF, wait 30 seconds, then cycle the ignition ON again.

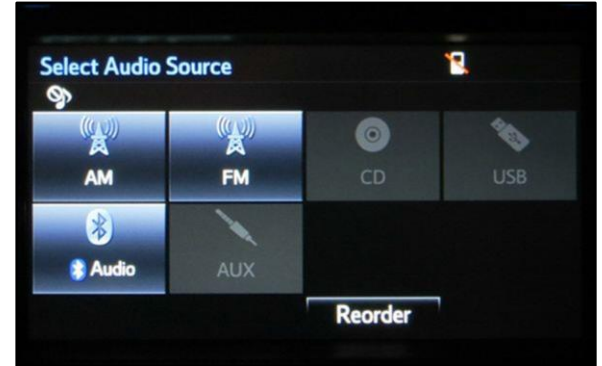
Figure 21.

- When the the Select Audio Source screen displays, continue to the next step.
