SERVICE BULLETIN

Classification: EC17-028b	Reference: NTB17-104b	Date: February 26, 2018
------------------------------	--------------------------	----------------------------

2015 – 2017 SENTRA; ENGINE TURNS OFF OR HESITATES WHEN ACCELERATING FROM A STOP DURING HOT AMBIENT TEMPERATURES (100° F OR MORE)

APPLIED VEHICLES: 2015 - 2017 Sentra (B17)

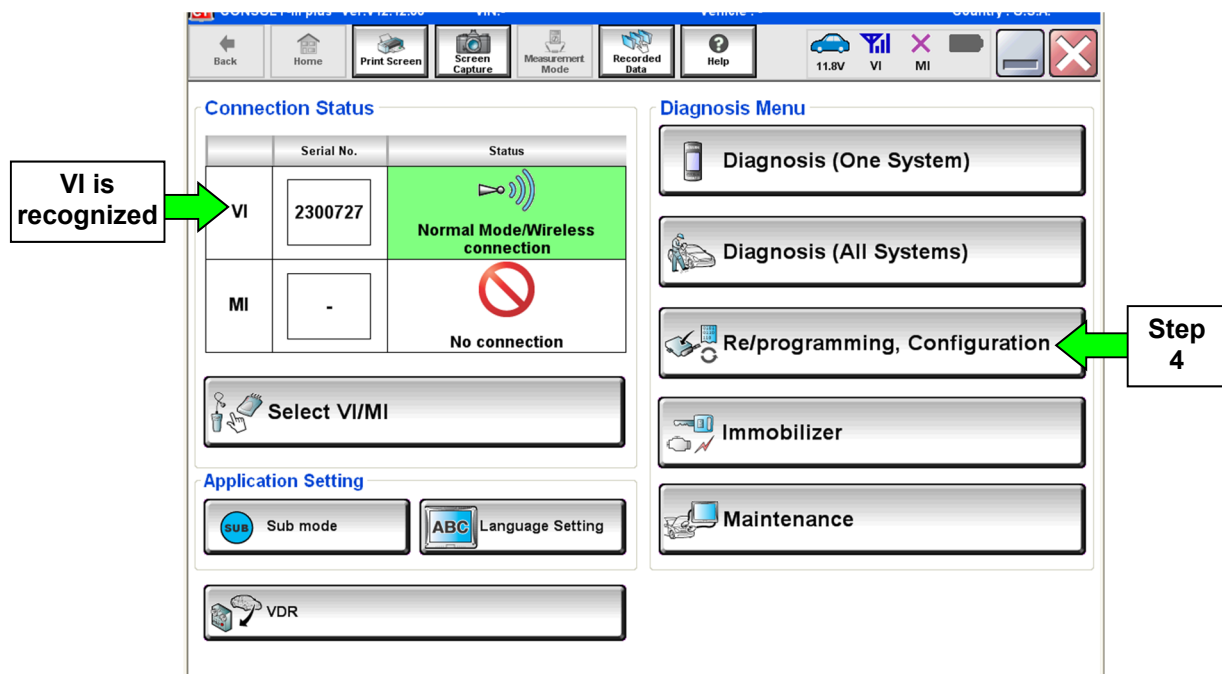
Figure 1

1. Connect the CONSULT PC to the vehicle to begin the reprogramming procedure.
- 2 Start C-III plus.
3. Wait for the plus VI to be recognized.
 - The serial number will display when the plus VI is recognized.
4. Select **Re/programming, Configuration**.

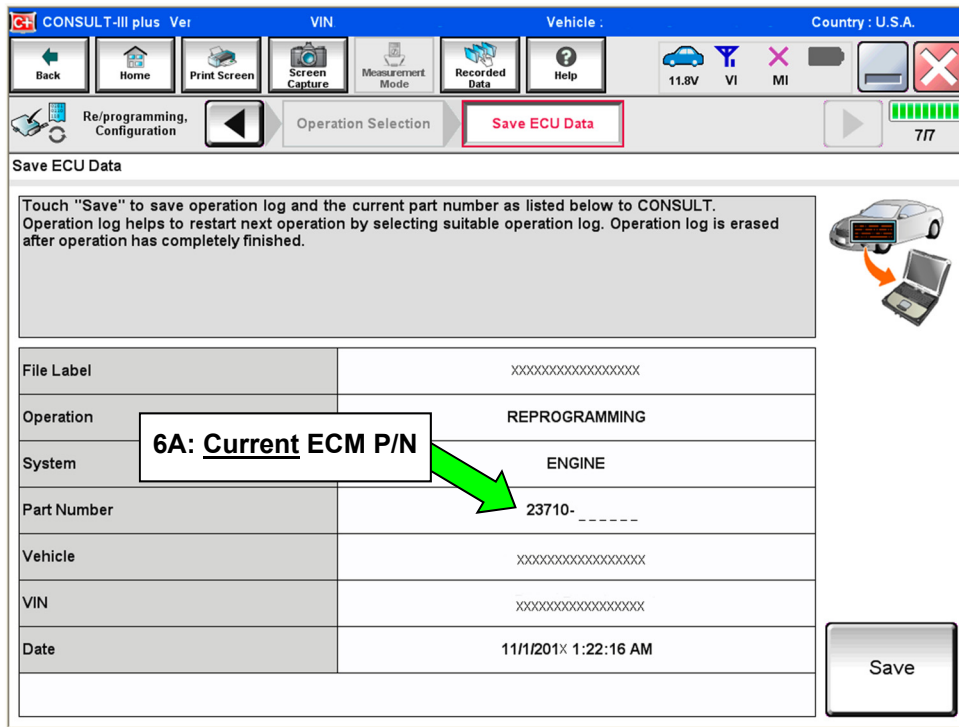
6. When you get to the screen shown in Figure 2, confirm this bulletin applies as follows.

A. Find the ECM **Part Number** and write it on the repair order.

NOTE: This is the current ECM Part Number (P/N).

5. Follow the on-screen instructions and navigate the C-III plus to the screen shown in Figure 2 on the next page.

B. Compare the P/N you wrote down to the numbers in the **Current ECM Part Number** column in **Table A** below.

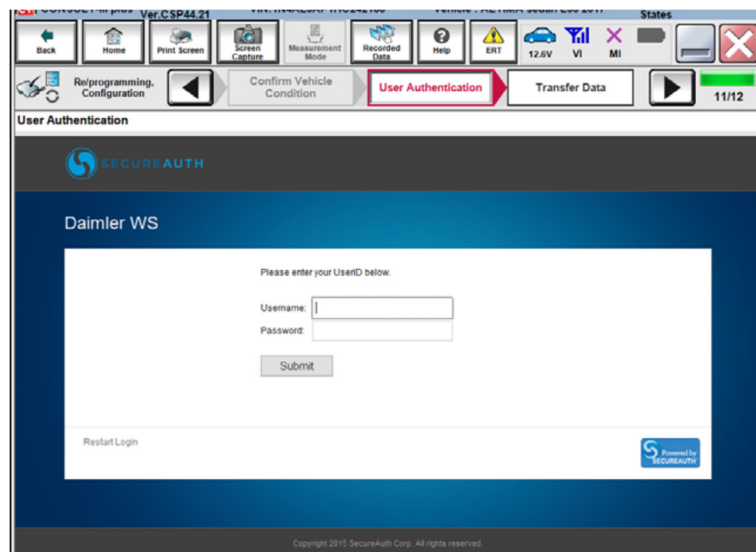
Figure 4

- Before reprogramming will start, you will be required to enter your User Name and Password.
 - The CONSULT PC must be connected to the Internet (Wi-Fi or cable).
 - If you do not know your User Name and Password, contact your Service Manager.

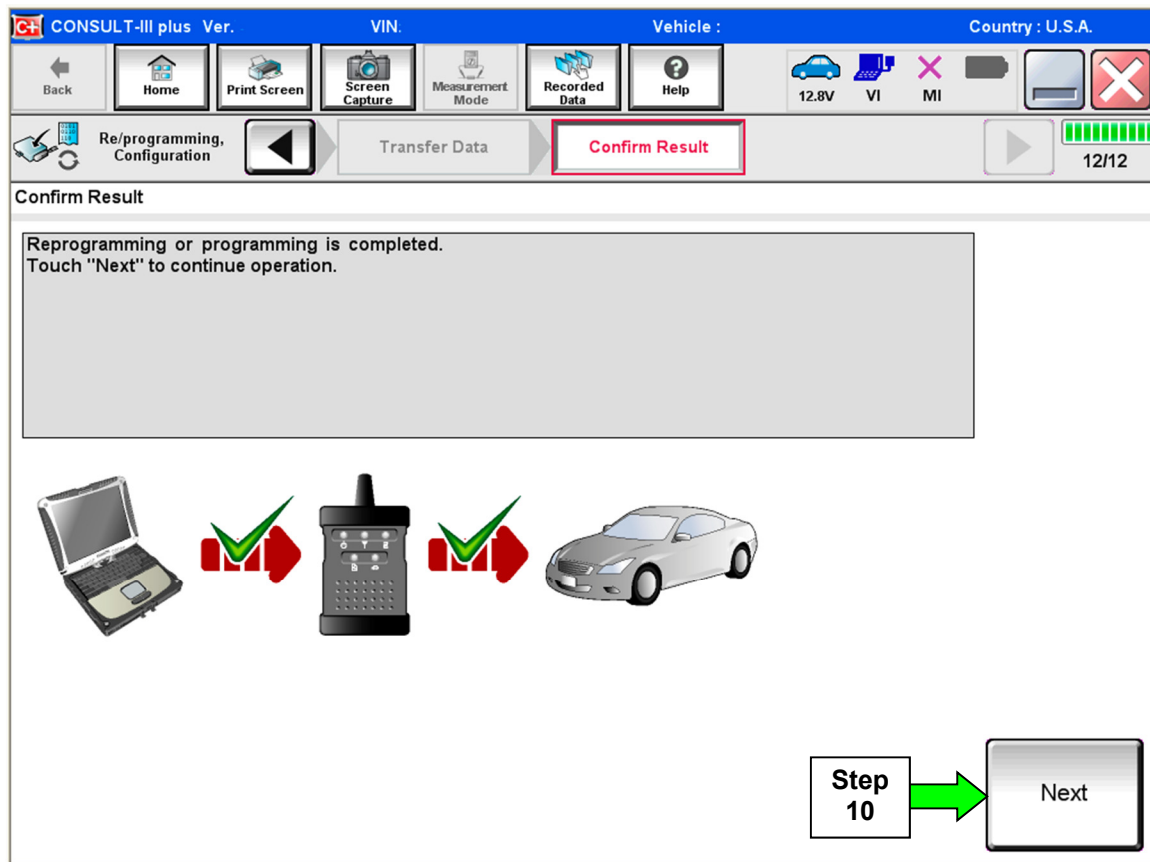
8. When the screen in Figure 5 displays, reprogramming is complete.

NOTE: If the screen in Figure 5 does not display (indicating that reprogramming did not complete), refer to the information on page 7.

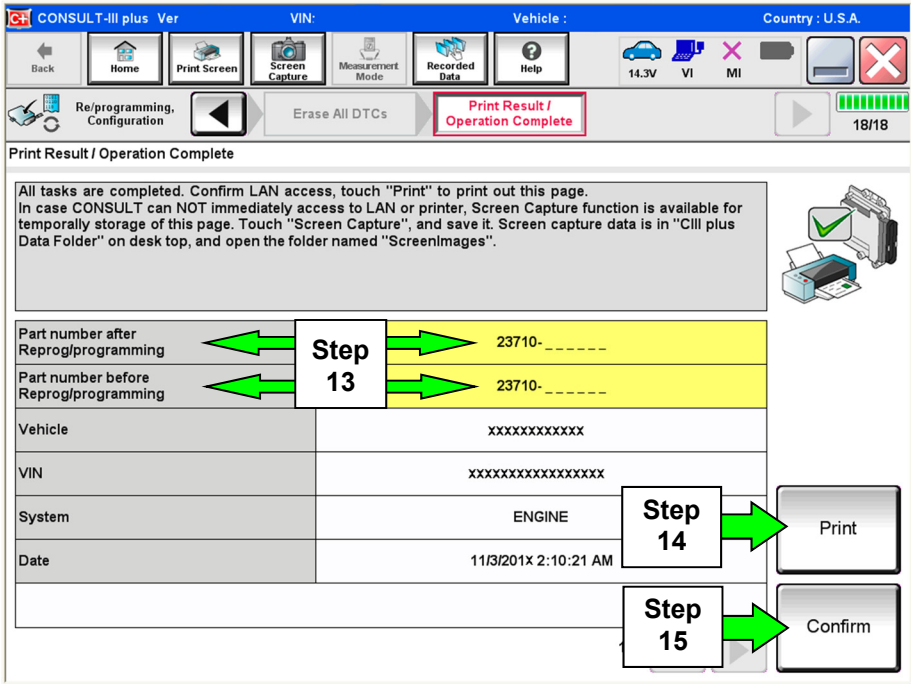
- 12. When the entire reprogramming process is complete, the screen in Figure 8 will display.
- 13. Verify the before and after part numbers are different.
- 14. Print a copy of this screen (Figure 8) and attach it to the repair order for warranty documentation.
- 15. Select **Confirm**.
