SERVICE BULLETIN

2016-2018 TITAN XD; VEHICLE WILL NOT MOVE AND/OR A/T OIL TEMP LIGHT FLASHING

APPLIED VEHICLES: 2016-2018 Titan XD (A61)
APPLIED ENGINE: Cummins 5.0L V8 Diesel
APPLIED TRANSMISSION: 6AT – RE6R01A

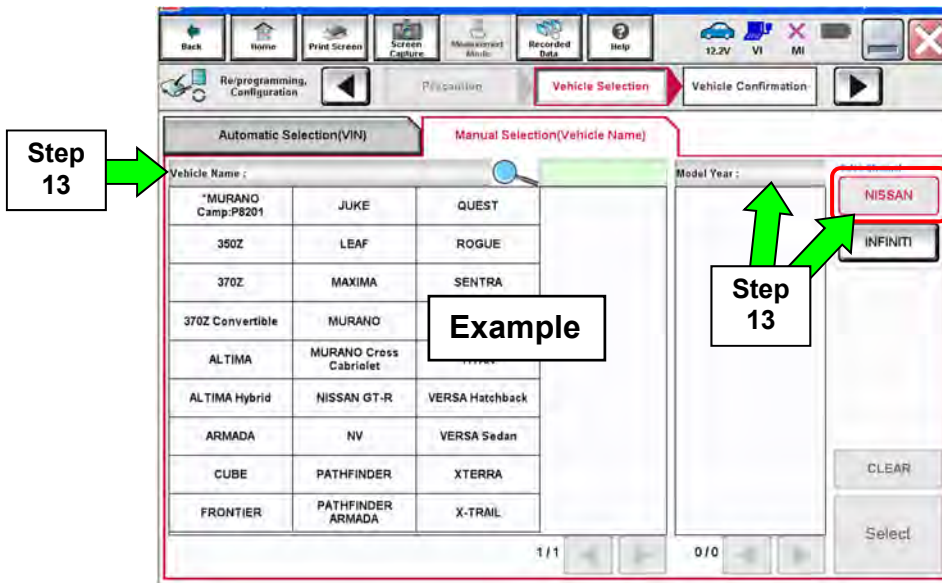
13. Select **Nissan**, **Vehicle Name**, and then the correct **Model Year**.

- If the screen in Figure 3 does not display, skip to step 14.

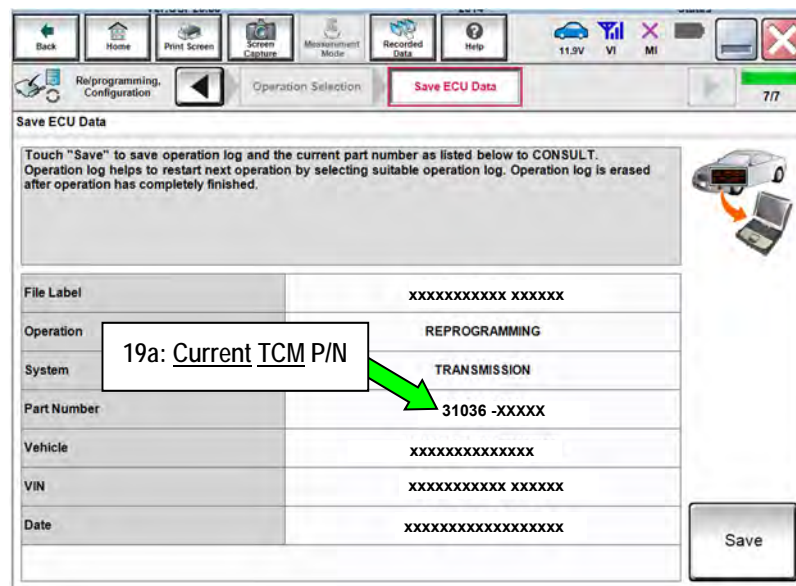
Figure 8

19. When you get to the screen shown in Figure 8, confirm TCM reprogramming applies as follows.

- Find the TCM Part Number and write it on the repair order.

NOTE: This is the current TCM Part Number (P/N).

- Compare the P/N you wrote down to the numbers in the **Current TCM Part Number** column in **Table A** on the next page.
 - If there is a match, follow the instructions in **Table A**.
 - If there is not a match, TCM reprogramming does not apply.

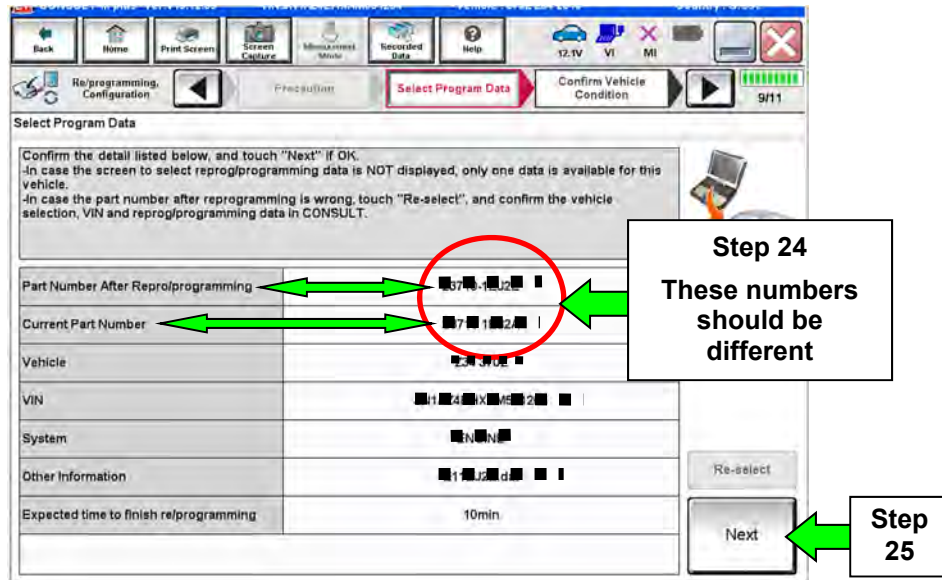
Figure 11

24. Read the **Current Part Number** and **Part Number After Reprogramming**. They should be different.

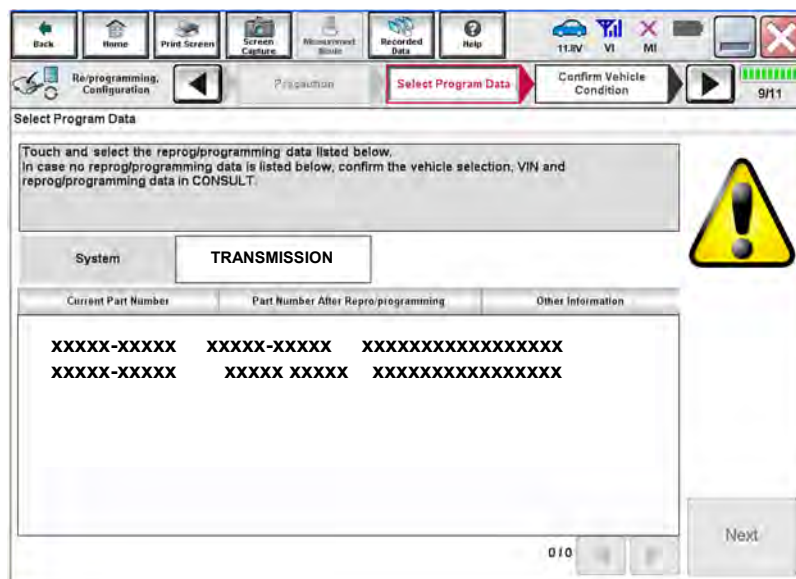
- In some cases, more than one new P/N for reprogramming is available.
 - If more than one new P/N is available, the screen in Figure 12 displays.
 - Select and use the reprogramming option that **does not** have the message "Caution! Use ONLY with NTBXX-XXX".
- If you get this screen and it is blank (no reprogramming listed), it means there is no reprogramming available for this vehicle. Close C-III plus and refer back to ASIST for further diagnosis.

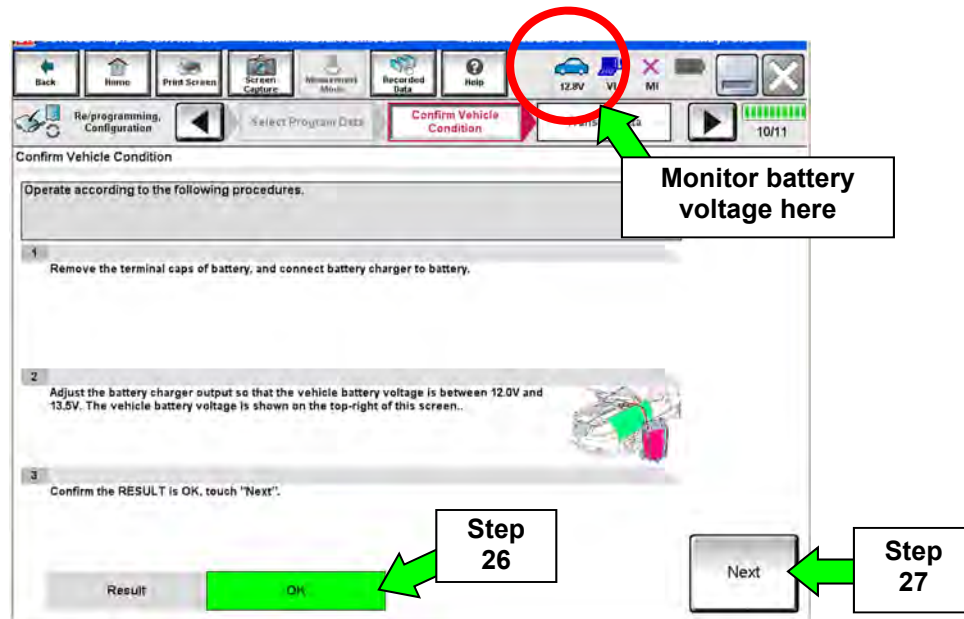
Figure 13

26. Make sure **OK** is highlighted **green** (battery voltage must be between **12.0** and **15.5 Volts**).

IMPORTANT: Battery voltage must stay between **12.0** and **15.5 Volts** during reprogramming or ECM reprogramming may be interrupted and ECM may be damaged.

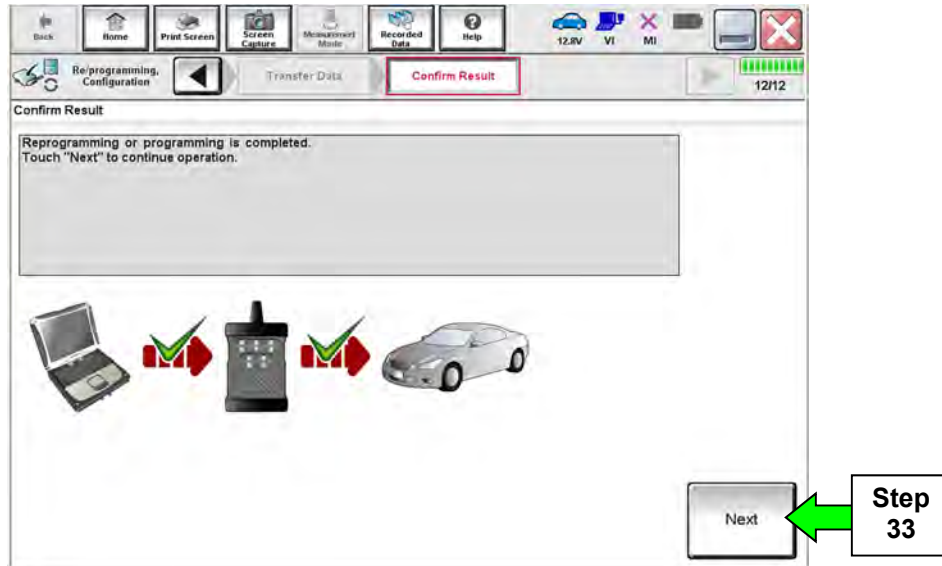
31. When the screen in Figure 18 displays, reprogramming is complete.

NOTE: If the screen in Figure 18 does not display (indicating that reprogramming did not complete), refer to **TCM Recovery** on the next page.

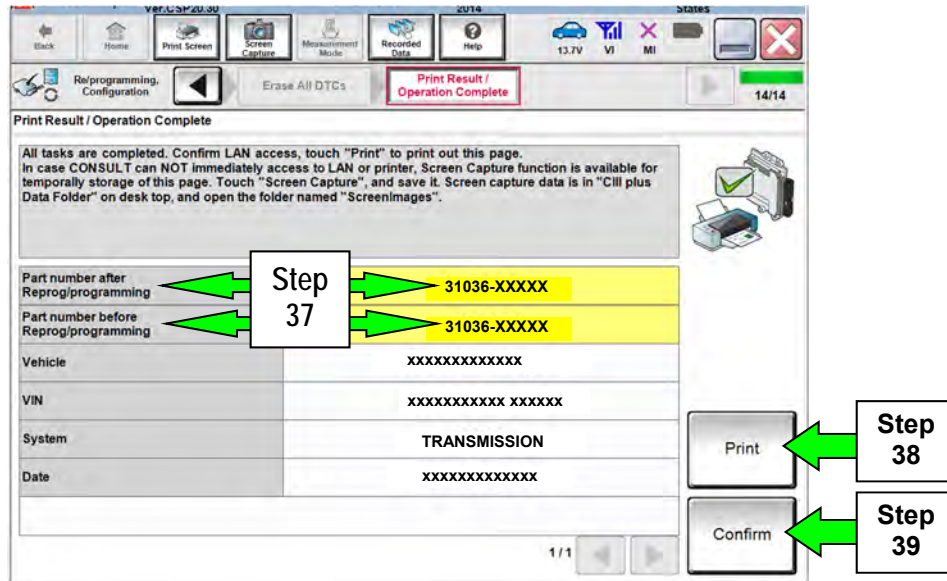
35. Follow the on-screen instructions to **Erase DTCs**.
36. When the entire reprogramming process is complete, the screen in Figure 22 will display.
37. Verify the before and after part numbers are different.
38. Print a copy of this screen (Figure 22) and attach it to the repair order for warranty documentation.
39. Select **Confirm**.

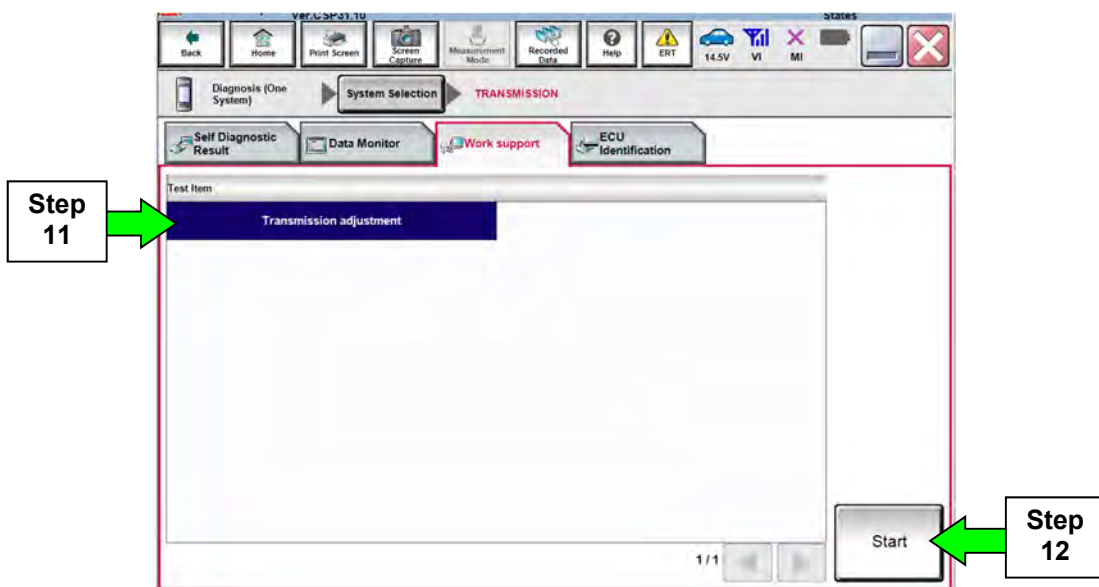
Figure 24

10. Navigate C-III plus to **Transmission > Work support** (see Figure 24).

11. Select **Transmission adjustment**.

12. Select **Start**.

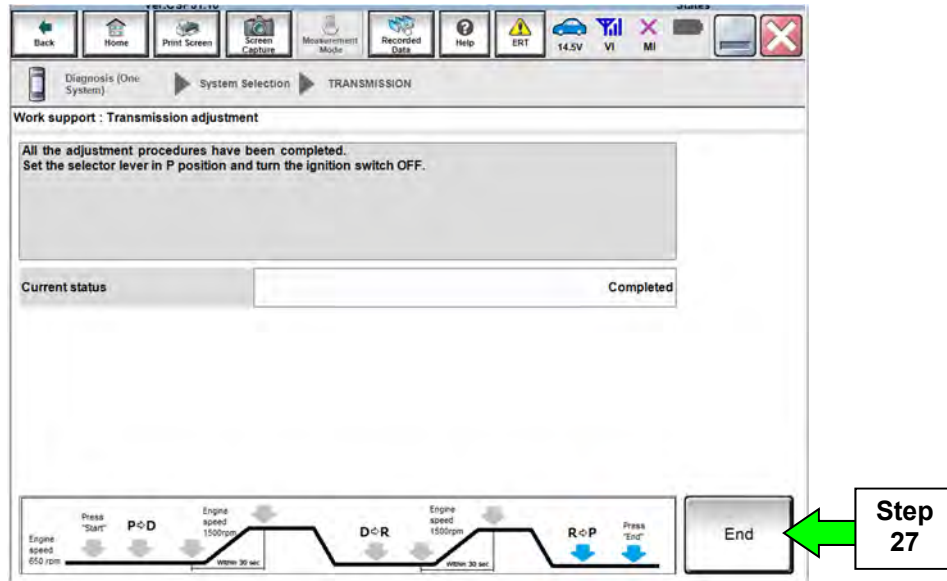
25. When the Transmission Adjustment has completed (see Figure 30), shift the transmission to Park.

- When complete the screen in Figure 30 (next page) will display.
