Field Instructions for Upgrading VMIQ in Chrysler Pacifica with Intermittent, Non-responsive Sliding Door

Document Number: TS-WI-0257

VMIQ FIRMWARE UPGRADE FOR CHRYSLER PACIFICA

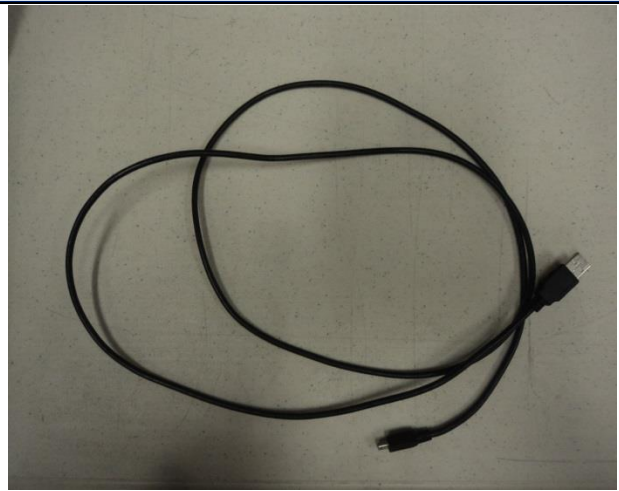
Mini USB cable

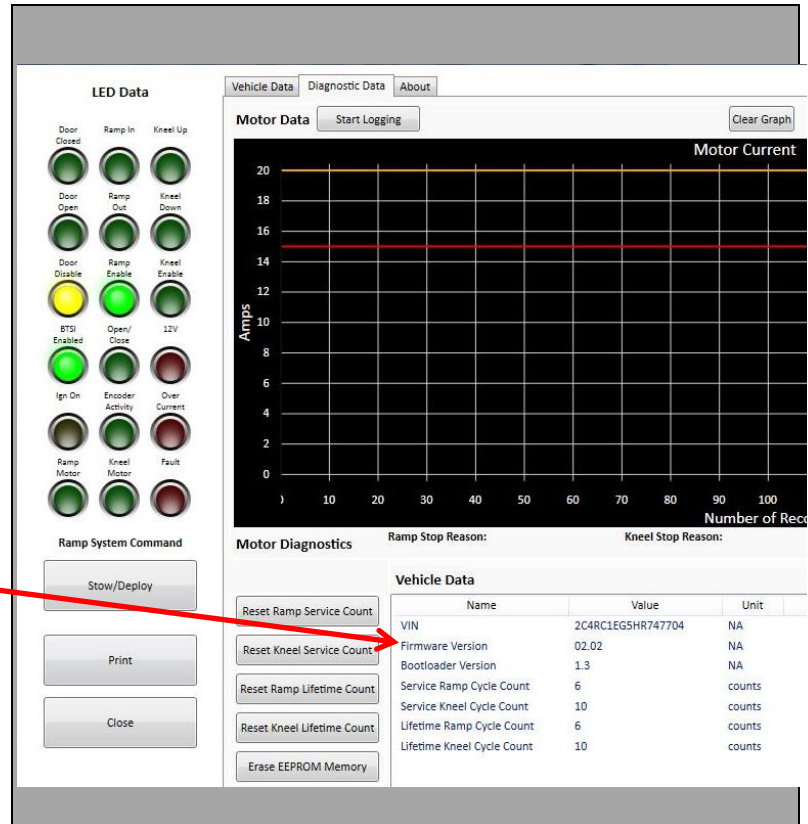
- To connect to the van and confirm the firmware version click on "Connect to VMIQ in Vehicle."

Click on the Diagnostic Data tab to confirm that the firmware you have loaded is correct.

Chrysler Pacifica should be version 2.0.3.

The screenshot shows a diagnostic software interface with several sections:

- LED Data:** A grid of 18 circular indicators for various system components like Door Closed, Ramp In, Knee Up, etc. A red arrow points from the text 'Chrysler Pacifica should be version 2.0.3.' to the 'Firmware Version' entry in the Vehicle Data table.
- Motor Data:** Includes a 'Start Logging' button and a 'Clear Graph' button. Below is a 'Motor Current' graph with 'Amps' on the y-axis (0-20) and 'Number of Records' on the x-axis (0-100).
- Motor Diagnostics:** Contains buttons for 'Reset Ramp Service Count', 'Reset Knee Service Count', 'Reset Ramp Lifetime Count', 'Reset Knee Lifetime Count', and 'Erase EEPROM Memory'.
- Vehicle Data:** A table with columns for Name, Value, and Unit.
