Service Campaign

CC-18-00-01

MODEL: Karma Revero

TITLE: Baseline BL1035 Firmware Release

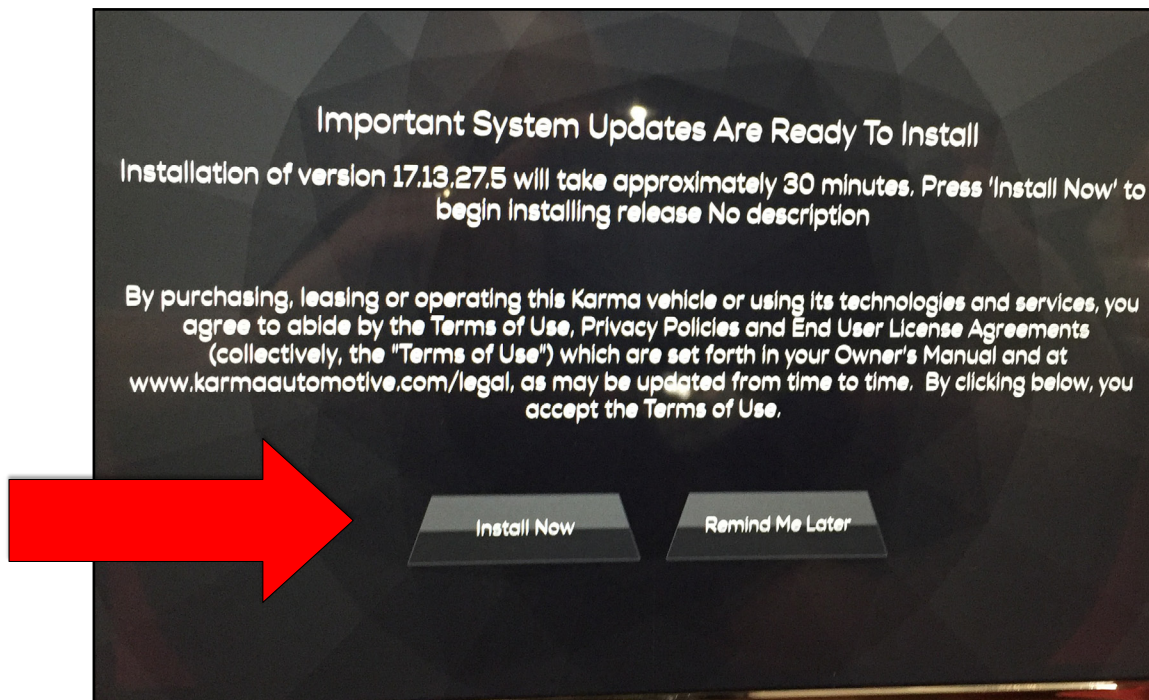
fig. 1

2. Keep the door latched (closed position) the update will not show up on TPI until power button is powered off with door still latched. This is when you can verify the TPI for update available messaging screen. If the download completed, the vehicle will prompt to accept the update (fig. 1) Accept this and allow the vehicle to update. Note that changing the door latch state will interrupt the accessory delay and shut down the TPI. If the TPI shuts down at power off, the update available screen will not display.

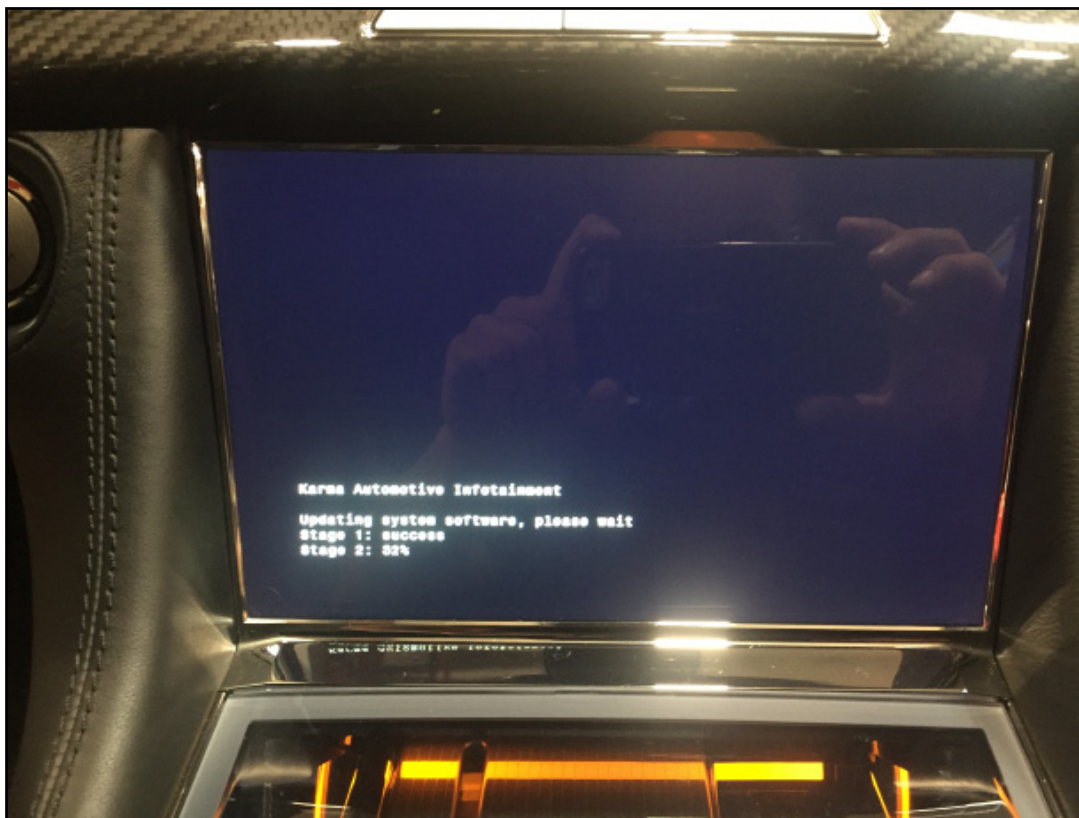
fig. 2

Below are the screens of the TPI read out as the CIU is updating (fig.2) When this is completed updating, the screen may go blank or black or cycle on and off, normal function will resume upon cycling the mode button.

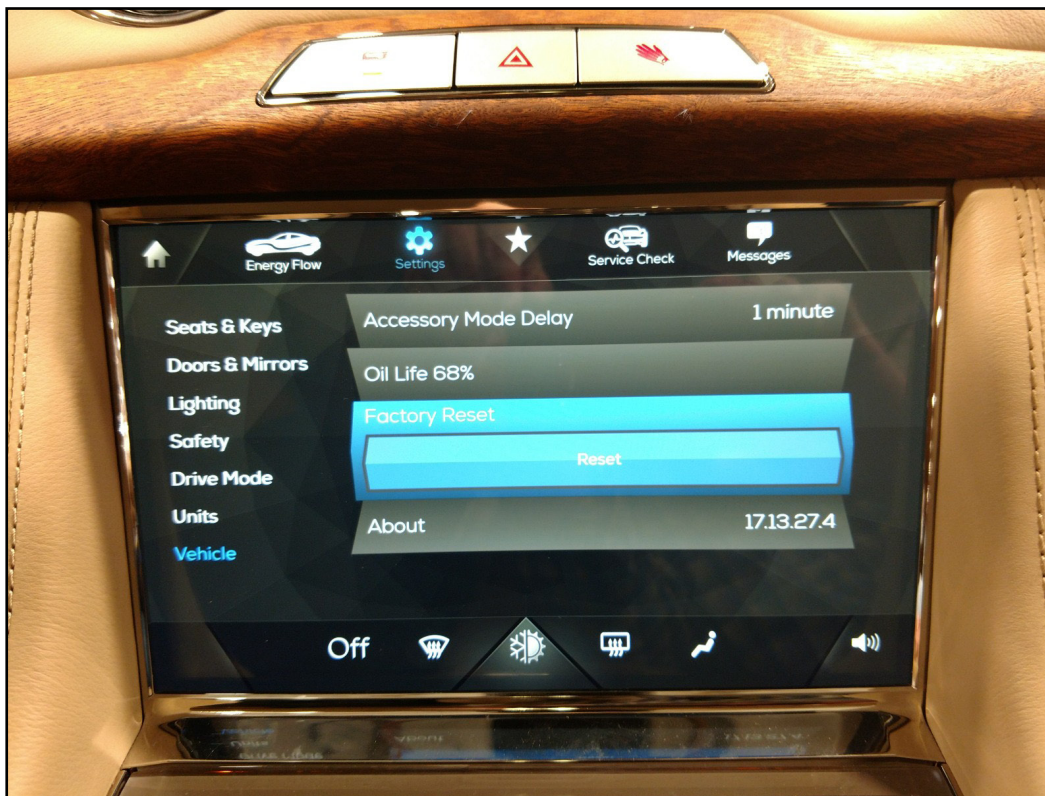
fig. 3

3. Verify the CIU software ID in the TPI after the vehicle has been placed in ready mode.
go to Setting > About, the version should be displayed above the Terms and Conditions bar (fig. 3)

The CIU Software ID should be as displayed: 17.13.27.4.

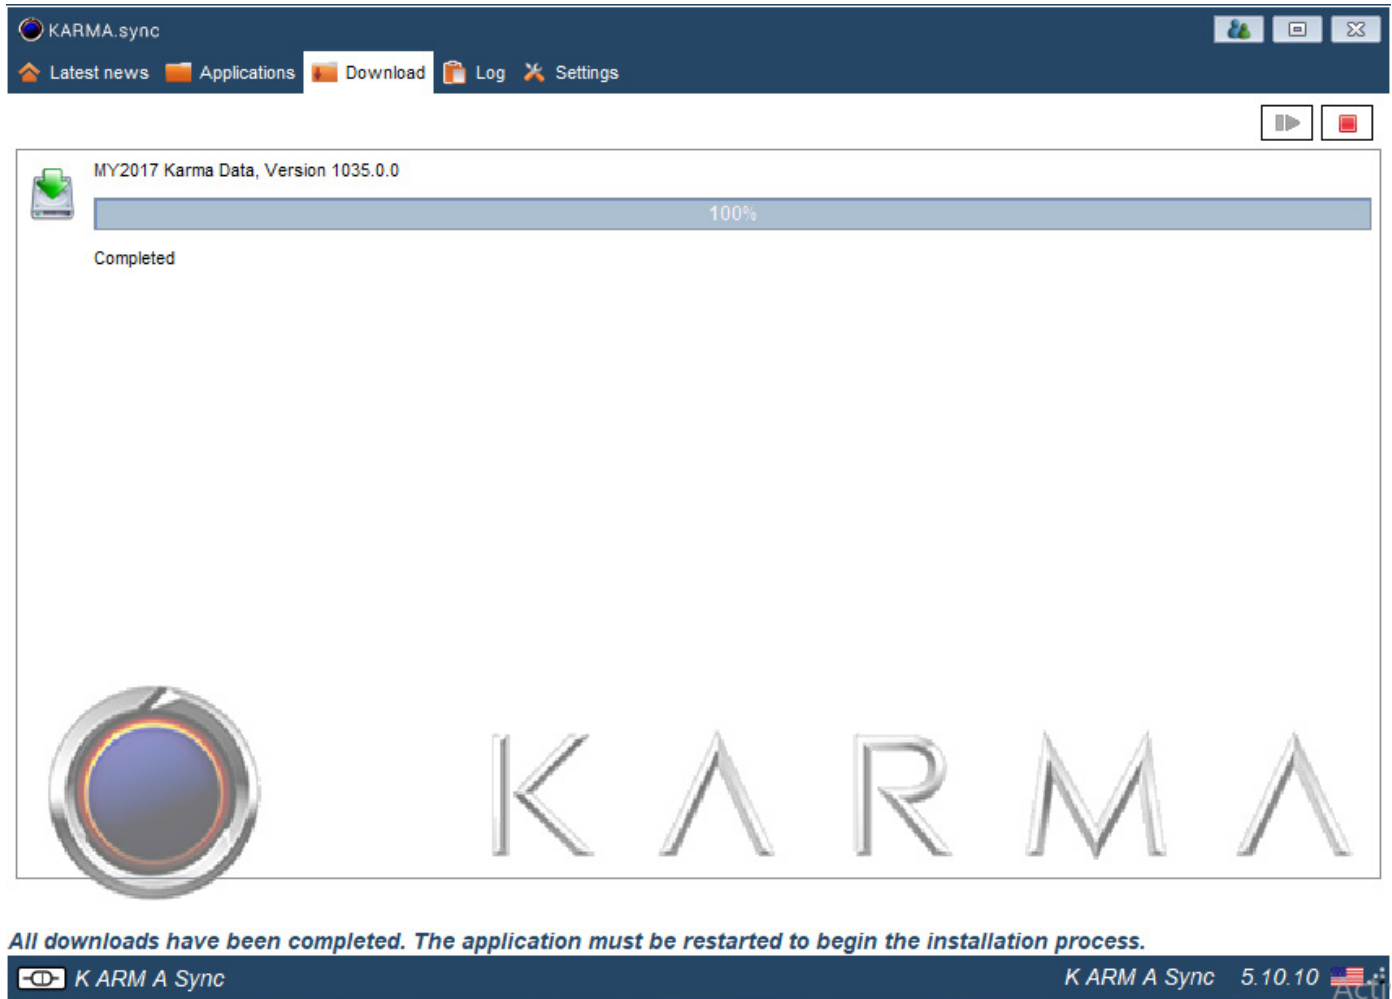
fig.5

The package will then download (fig.5).

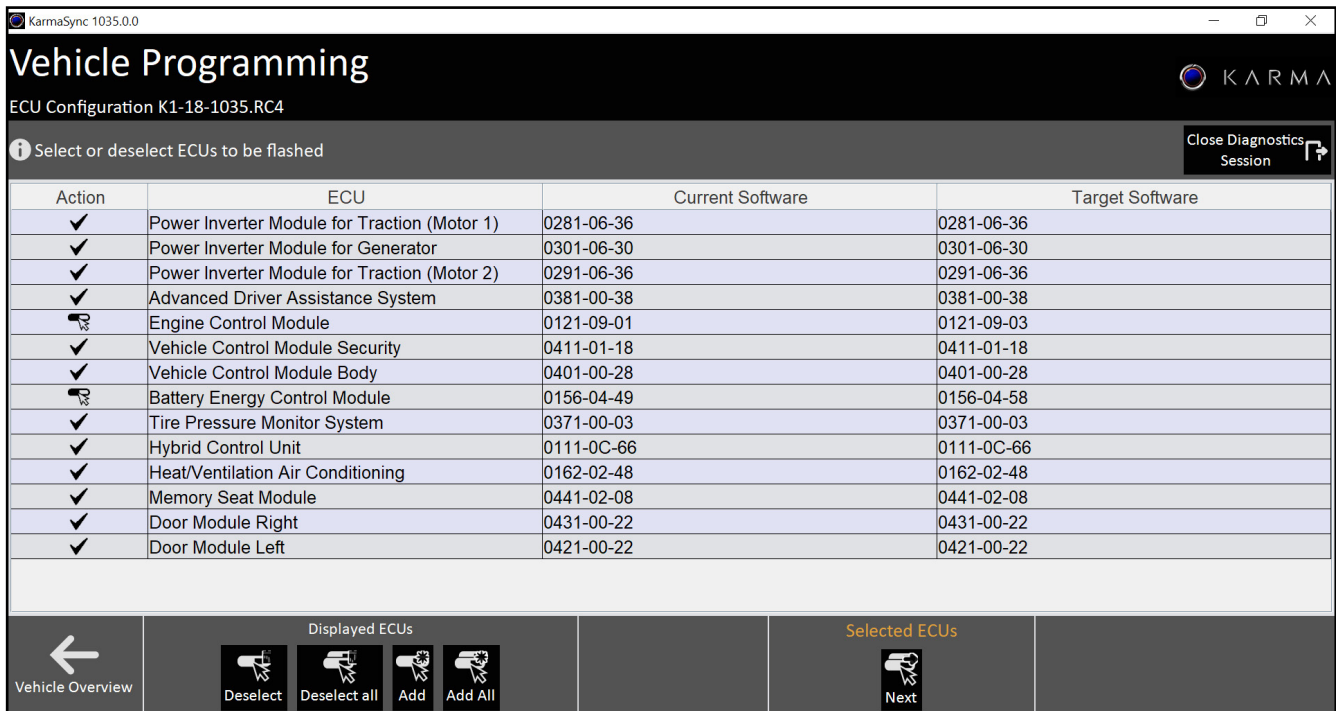
fig.13a

21. The flash information will be populated, as before (fig.13a)
- If a pop up opens stating the “OBCM failed to communicate;” disregard this message

The little “pill” icon means these require updates. Proceed to click “next” and follow the prompts.

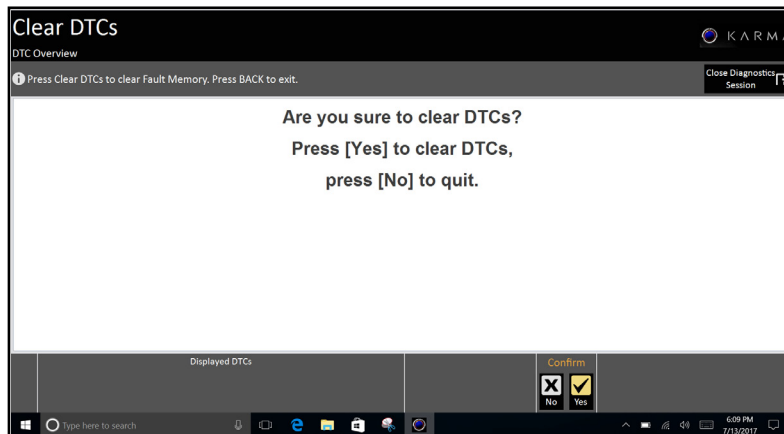
24. The update is complete with Karma Sync. Any codes need to be cleared in READY state. Ignore the pop-up of cycling state to ACCESSORY in Karma SYNC. Proceed to clear any DTC's present in the system. (fig.16a, 16b, 16c)
