March 09, 2018

08472 Version 3

2012–15 MDX: Judder from the Torque Converter Lock-Up Clutch (Snapshot Upload Required)

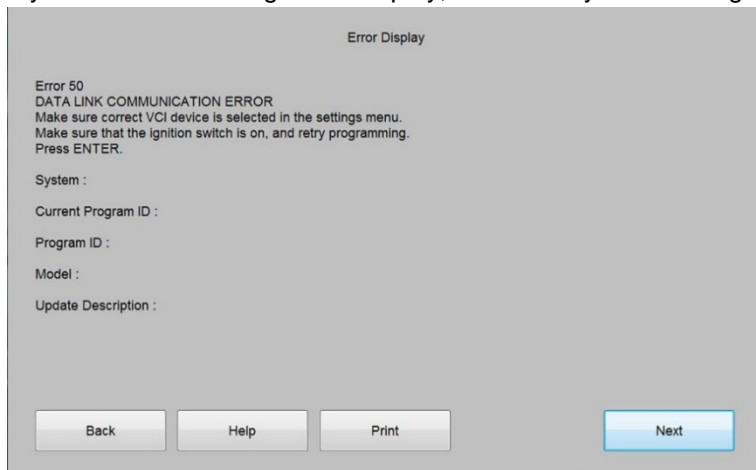
- You can't update the vehicle using the MVCI as a standalone tool.
- **Do not** use the MongoosePro VCI tool.
- Make sure the 12 volt battery is fully charged before starting an update.
- Connect a fully charged jumper battery to the vehicle and leave it connected during the entire procedure to maintain steady voltage.
- Never turn the ignition to OFF or ACCESSORY during the update. If there is a problem with the update, leave the ignition turned to ON.
- To prevent PCM damage, do not operate anything electrical (headlights, audio system, brakes, A/C, power windows, door locks, etc.) during the update.
- If you see the following Error Display, check that you are using the correct tool (MVCI or DST-i) with the i-HDS.

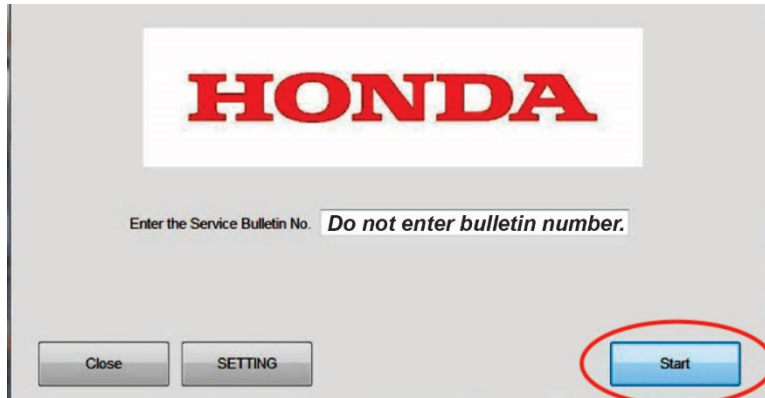
4. Select **Start**, then follow the screen prompts.

- **Don't enter a bulletin number.**
- If you receive a message that the vehicle has been already updated or that no update is available, check the transmission data list. The header should indicate one of the following numbers (or later).
