March 09, 2018

08470 Version 2

2012–13 ZDX: Judder from the Torque Converter Lock-Up Clutch (Snapshot Upload Required)

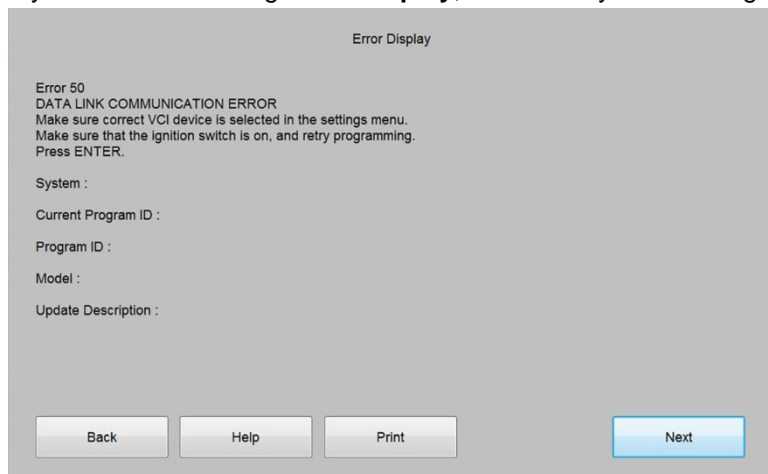
- You cannot update the vehicle using the MVCI as a standalone tool.
- **Do not** use the MongoosePro VCI tool.
- Make sure the 12-volt battery is fully charged before starting an update.
- Connect a fully charged jumper battery to the vehicle, and leave it connected during the entire procedure to maintain steady voltage.
- Never turn the ignition to OFF or ACCESSORY during the update. If there is a problem with the update, leave the ignition turned to ON.
- To prevent PCM damage, do not operate anything electrical (headlights, audio system, brakes, A/C, power windows, door locks, etc.) during the update.
- If you see the following **Error Display**, check that you are using the correct tool (MVCI or DST-i) with the i-HDS.

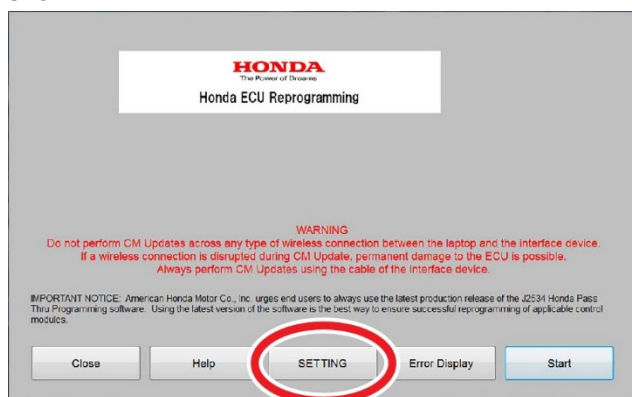
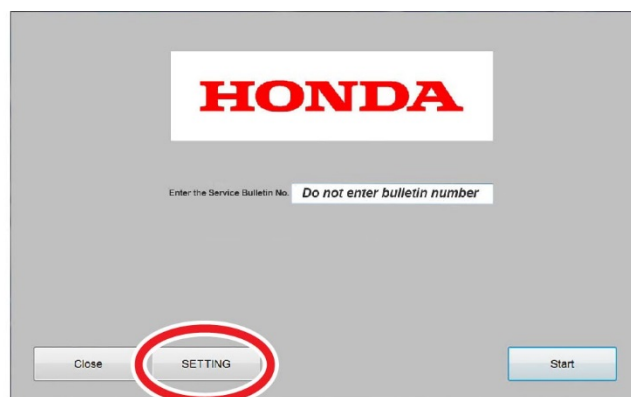
To change this, click on either of the **SETTING** selection buttons at the bottom of the J2534 initial screens as shown.

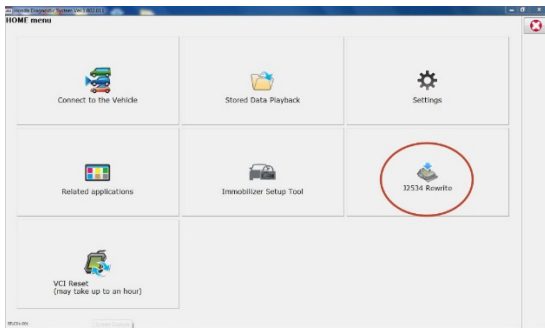
2. Select **J2534 Rewrite**.

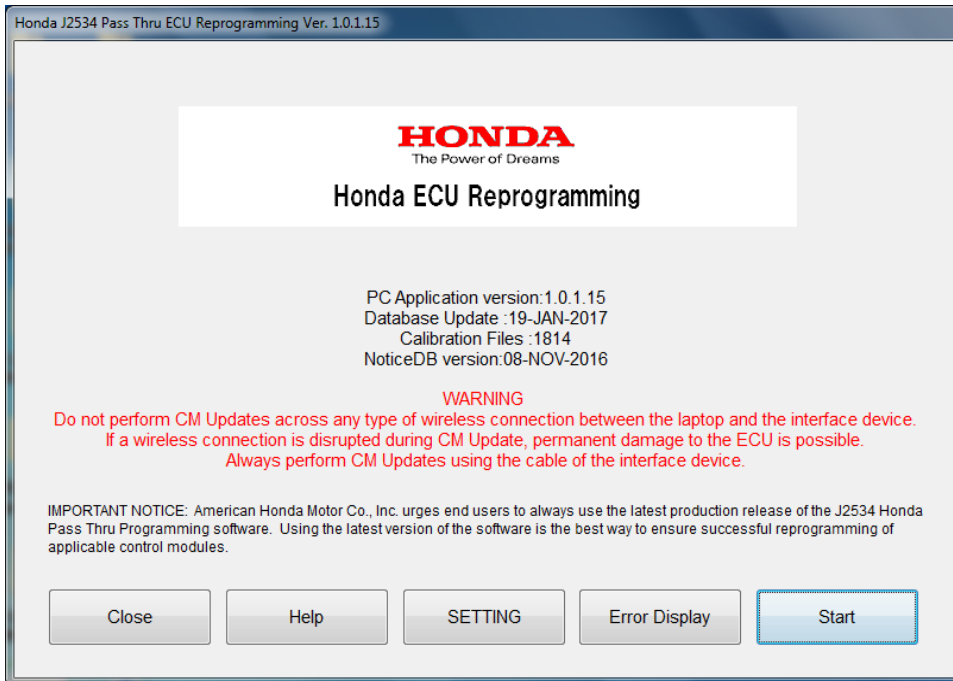
3. Confirm the software is the same **or later** as listed in SOFTWARE INFORMATION.

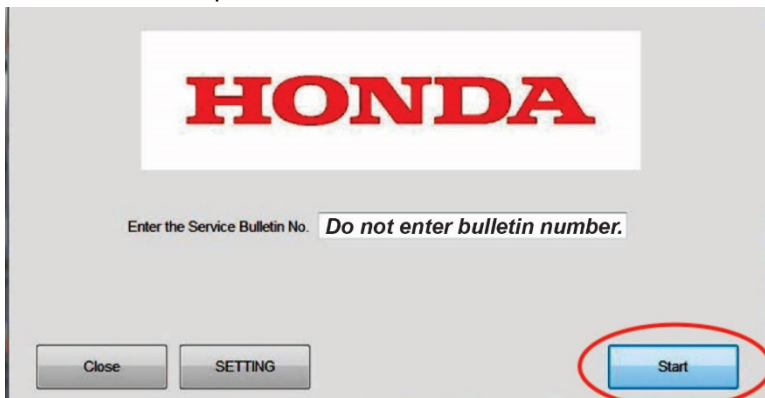
- **Do not enter a bulletin number.**
- If you receive a message that the vehicle has been already updated or that no update is available, check the transmission data list. The header should indicate one of the following numbers (or later):

37806-RP6-3080	37806-RP6-3090	37806-RP6-4060
----------------	----------------	----------------
- If the program part numbers do not match those listed above, the i-HDS software needs to be reinstalled. Contact the Special Tools Hotline at **800-346-6327** for assistance.
