March 09, 2018

08468 Version 2

## 2013-17 RDX: Judder from the Torque Converter Lock-Up Clutch (Snapshot Upload Required)

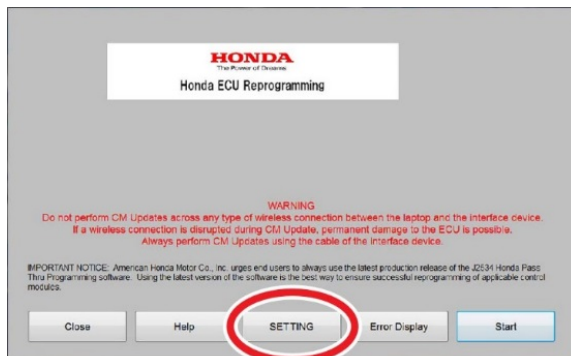
To change this, click on either of the **SETTING** selection buttons at the bottom of the J2534 initial screens as shown.
