GROUP ELE	MODEL 2015MY Multiple Models
NUMBER 128 (Rev 2, 3/7/2018)	DATE March 2017

TECHNICAL SERVICE BULLETIN

SUBJECT: **AUDIO SOFTWARE UPGRADE**

This bulletin provides the procedure to upgrade the audio software on some 2015MY Soul (PS), Sportage (SL), Optima (TF, QF), Forte (YD), and Sorento (XMa) vehicles to incorporate Bluetooth and Voice Recognition improvements. Follow the procedure outlined in this bulletin to perform a software update if the following concern(s) have been duplicated and are present when tested with a second (2nd) non-customer phone:

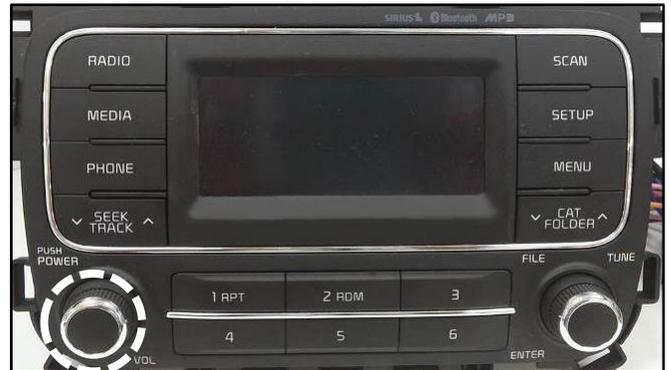
1. Start the vehicle or connect the Midtronics GR8-1299 charger.
2. Record the customer’s radio presets before performing the upgrade.
3. Turn the head unit OFF.

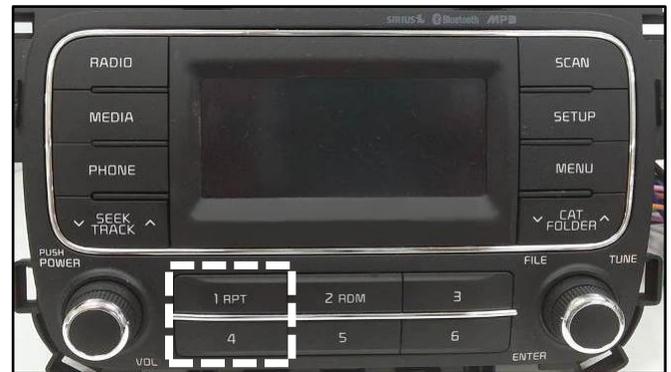
4. Press and hold preset button “1” and then preset button “4” and continue to hold both for five (5) seconds.

*** NOTICE**
 If the software version screen is displayed when pressing and holding the preset buttons “1” and “4” only, restart the procedure from step 1.

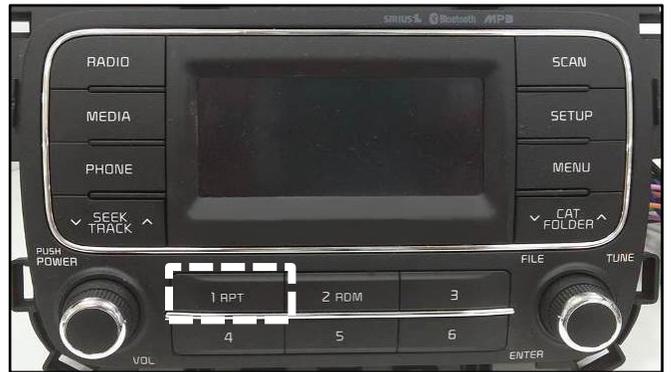
5. Immediately after releasing preset buttons “1” and “4”, press preset button “1” four (4) times in a row quickly within half a second each.

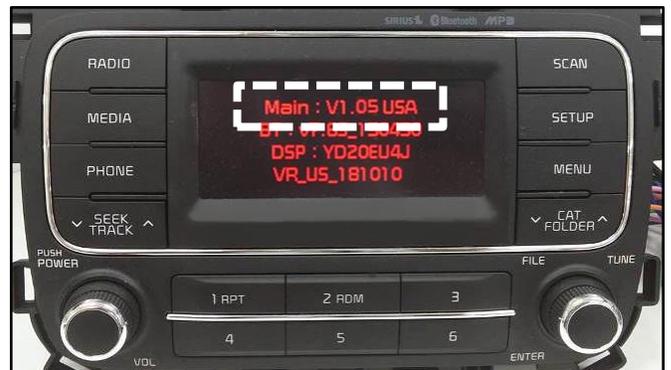
6. Check the software version and verify that it matches the versions below:

Model	Current Version
Soul (PS)	V1.02, V1.03
Sportage (SL)	V1.03, V1.04
Optima (TF, QF)	V1.03, V1.04
Forte (YD)	V1.05, V1.06
Sorento (XMa)	V1.04, V1.05

Verify that the software upgrade is successful by checking the software version by following software inspection procedure steps 3 to 6 on page 2 of this bulletin. If update is not successful, restart the procedure from step 3.

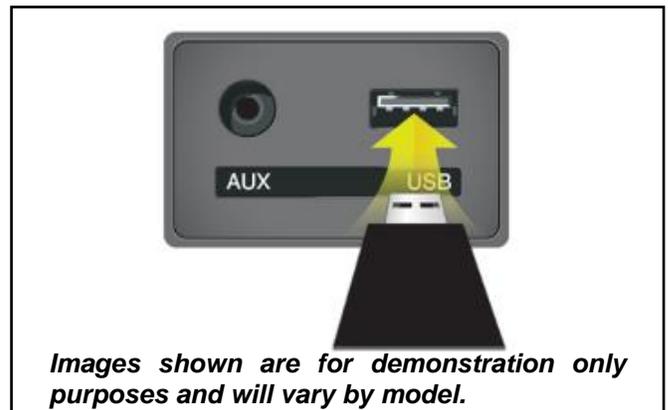
8. With the SW version screen displayed, obtain the USB stick labeled **15MY SA (AUDIO/UVO)** (white) from your Service Manager and insert it in the vehicle's USB port.

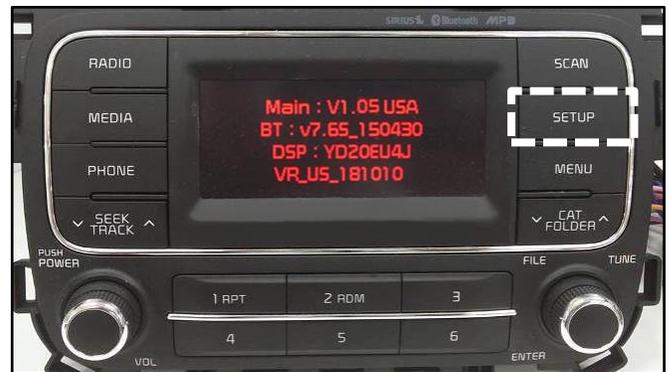
9. Press the **SETUP** button.

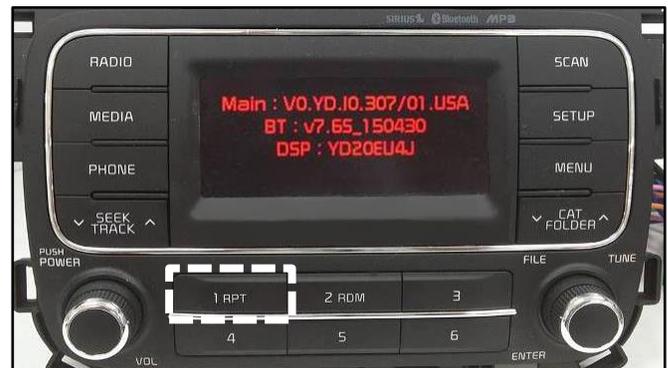
10. Press preset button "1" to display the firmware upgrade menu.

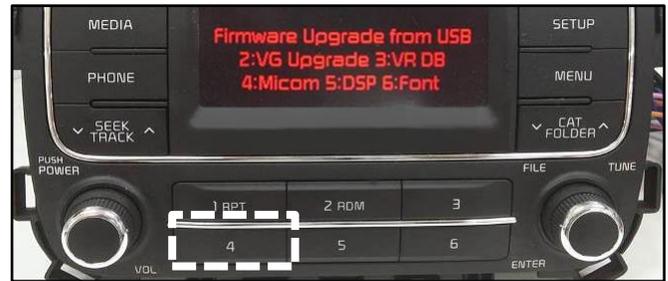
11. Once the Firmware upgrade menu is displayed, press preset button “4” to update **MICOM**.

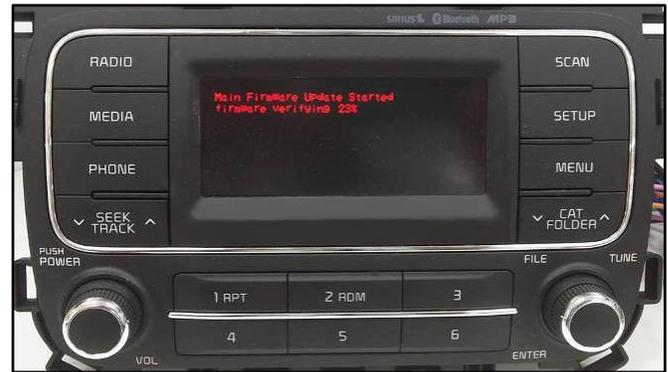
12. In some cases, the firmware upgrade (1/2) will begin and system will display the progress on the screen. Once the upgrade is complete, the head unit will automatically reset and then turn off. Monitor this part of the upgrade to ensure the second upgrade begins (see step 13 below).

The firmware update will take approximately three (3) minutes to complete. Do NOT remove the USB or turn the radio or vehicle OFF while the update is in progress.

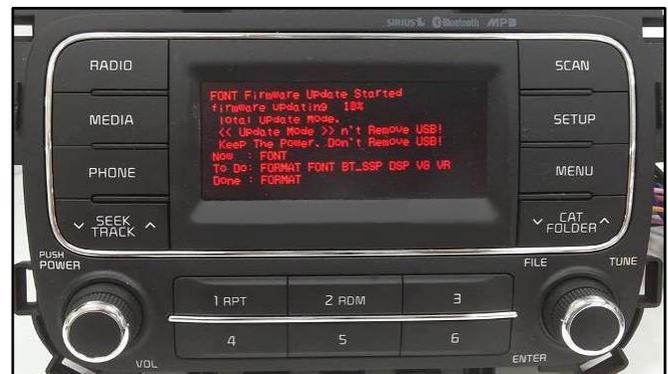
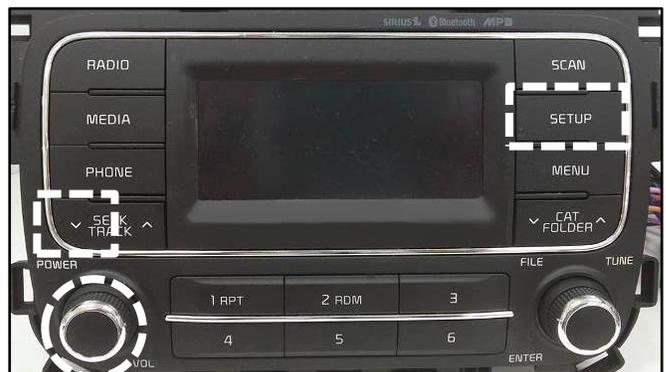
13. In some cases, the upgrade (2/2) will automatically begin and system will display the progress on the screen. Once the upgrade is complete, the head unit will automatically reset and then turn off.

On other vehicles, the upgrade (2/2) will not automatically begin. Turn off the head unit, press and hold **SEEK DOWN V** and then press **SETUP** and continue to hold both for two (2) seconds or more and then release.

The upgrade will proceed to “Format → Font → BT → DSP → VG → VR”.

The update will take approximately twenty (20) minutes to complete. Other services can be performed while the system upgrade is in progress. Do NOT remove the USB or turn the radio or vehicle OFF while the update is in progress.

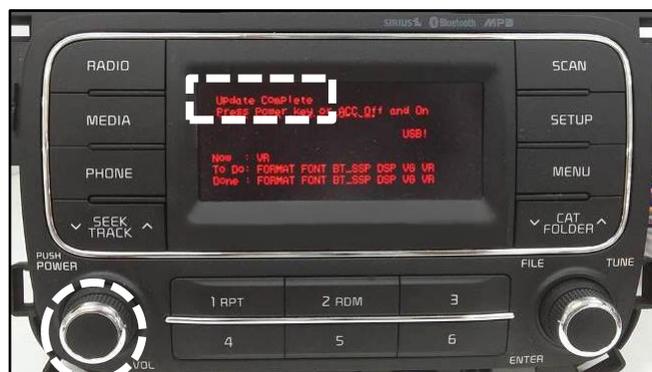
Once the update is complete, the screen as shown will be displayed (Update Complete). Press the power button to restart the unit.

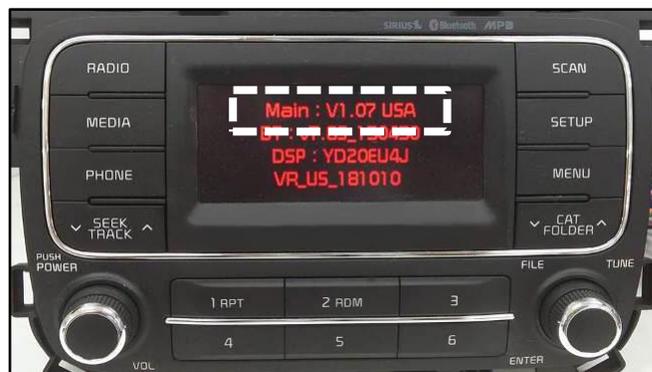
Model	New Version
Soul (PS)	V1.05
Sportage (SL)	V1.08
Optima (TF, QF)	V1.07
Forte (YD)	V1.09
Sorento (XMa)	V1.07
