GROUP ELE	MODEL 2015MY Multiple Models
	NUMBER 129 (Rev 2, 3/7/2018)	DATE March 2017
TECHNICAL SERVICE BULLETIN		
SUBJECT: UVO SOFTWARE UPGRADE

This bulletin provides the procedure to upgrade the UVO software on some 2015MY Soul (PS), Sportage (SL), Optima (TF, QF), Forte (YD), and Sorento (XMa) vehicles to incorporate Bluetooth and Voice Recognition improvements. Follow the procedure outlined in this bulletin to perform a software update if the following concern has been duplicated and is present when tested with a second (2nd) non-customer phone: “Incoming ring volume is too loud” with certain smartphones (non-iPhone). Additionally, the software update may improve Bluetooth connectivity.

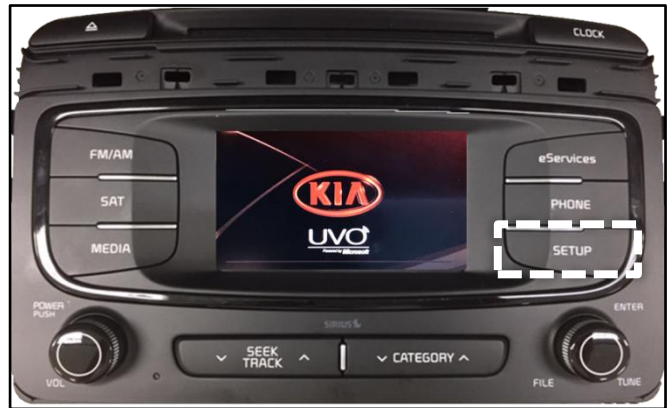
1. Start the vehicle or connect the Midtronics GR8-1299 charger.
2. Record the customer’s radio presets before performing the upgrade.
3. With the head unit ON, press **SETUP**.

*** NOTICE**
 Button layouts may differ by model.

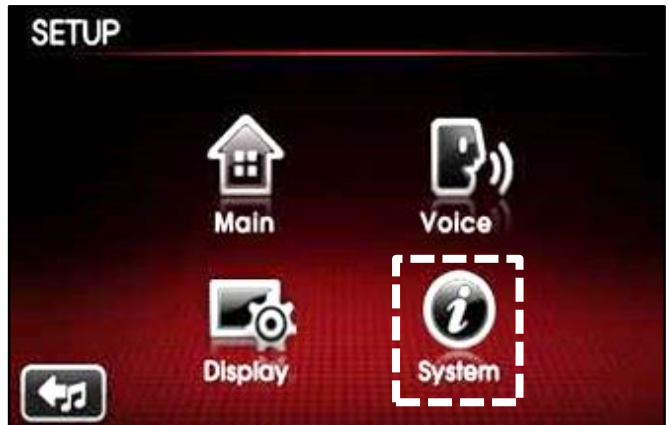
4. Touch “System”.

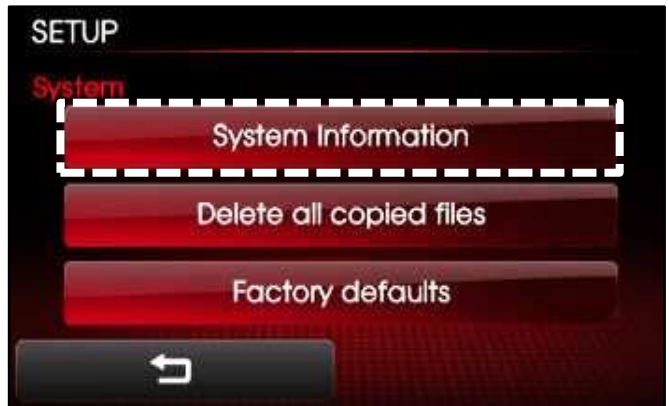
5. Touch “System Information”.

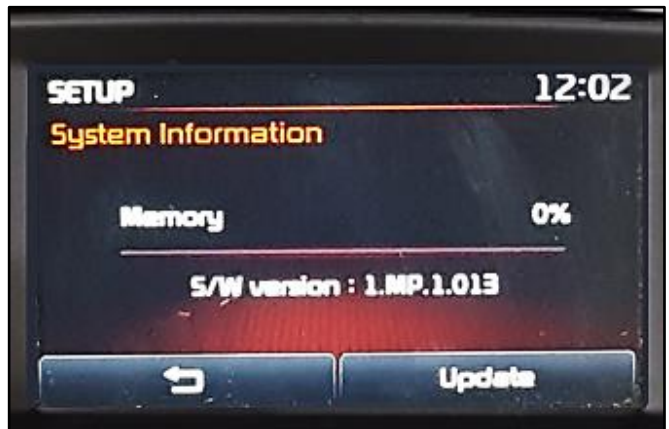
6. Check the software version and verify that it matches the versions below:

Model	Current Version
Soul (PS)	1.MP.1.007, 008, 009, 010, 011, 012, or 013.
Sportage (SL)	
Optima (TF, QF)	
Forte (YD)	
Sorento (XMa)

15. Verify that the software upgrade is successful by checking the software version by following software inspection procedure steps 3 to 6 on page 2 of this bulletin. If update is not successful, restart the procedure from step 3.

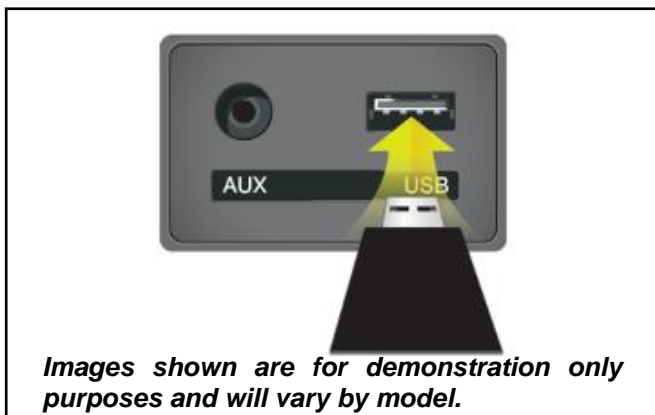
8. With the S/W version screen displayed, obtain the USB stick labeled **15MY SA (AUDIO/UVO)** (white) from your Service Manager and insert it in the vehicle's USB port.

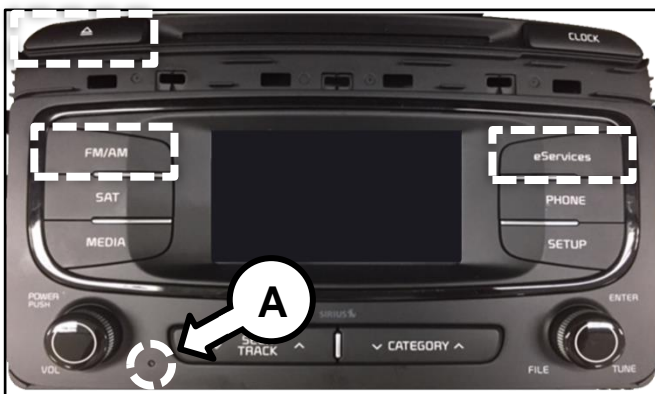
9. For Sportage (SL), Optima (TF, QF), Forte (YD), and Sorento (XMa), press and hold the **CD EJECT** button, **FM/AM** button, and **eServices** button. While holding the three (3) buttons, use a ballpoint pen or a similar tool and press the **RESET** button (A).

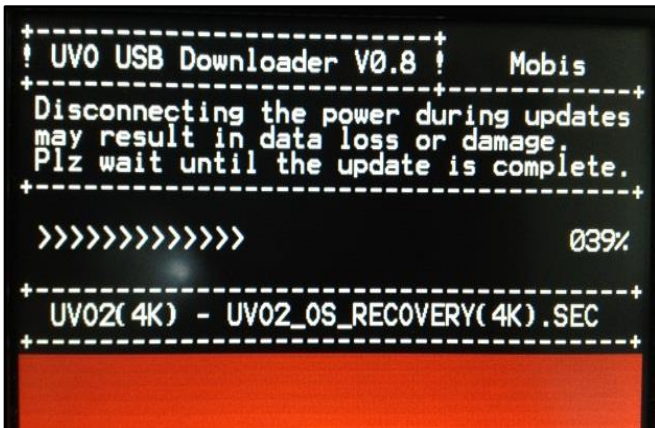
For Soul (PS) vehicles, press and hold the **FM/AM** button and **eServices** button. While holding the two (2) buttons, use a ballpoint pen or a similar tool and press the **RESET** button (A).

10. The head unit will automatically reset and begin the program download.

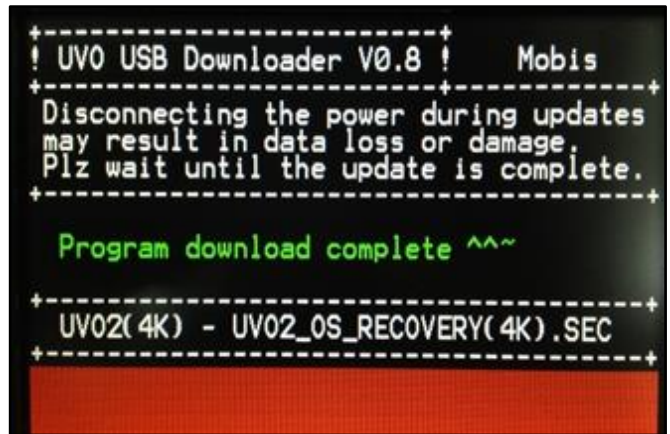
- Once the download is complete, the screen as shown to the right should be displayed.

If the screen displays “Program download failed!!”, restart the procedure from step 3.

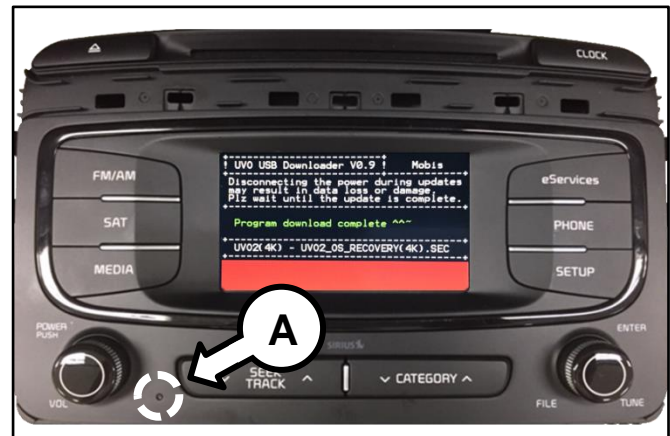
- Press the **RESET** button (A) using a ballpoint pen or a similar tool.

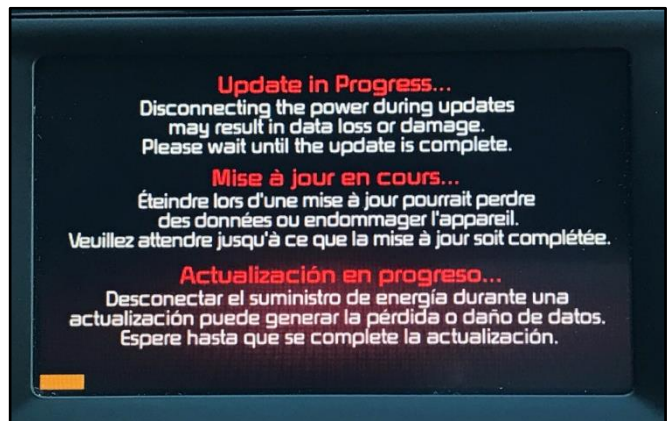
- The software upgrade should begin and the screen as shown to the right should be displayed.

The head unit may restart several times. The update will take approximately three (3) to five (5) minutes to complete. Do NOT remove the USB or turn the radio or vehicle OFF while the update is in progress.

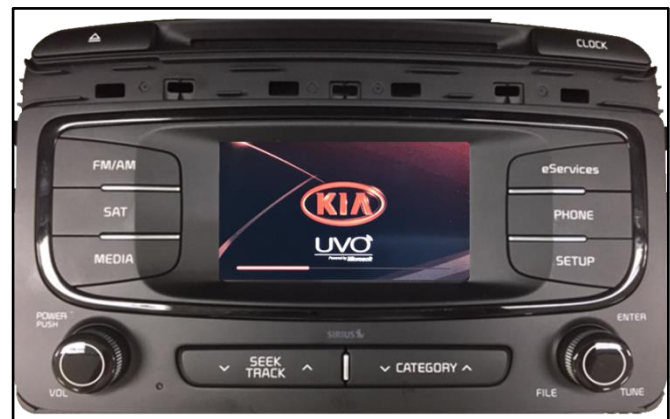
- The head unit will automatically restart once the upgrade is complete.

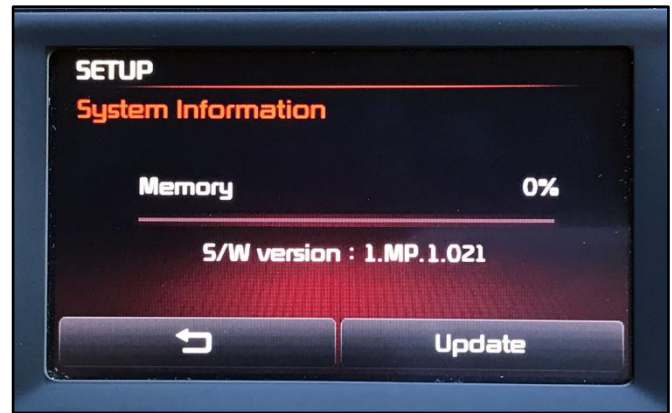
Model	New Version
Soul (PS)	1.MP.1.021
Sportage (SL)	
Optima (TF, QF)	
Forte (YD)	
Sorento (XMa)
