# SERVICE BULLETIN

Classification: EL18-006	Reference: NTB18-023	Date: March 9, 2018
-----------------------------	-------------------------	------------------------

## NISSAN; MICROPHONE DOES NOT WORK

**APPLIED SYSTEM**      Vehicles equipped with Telematics

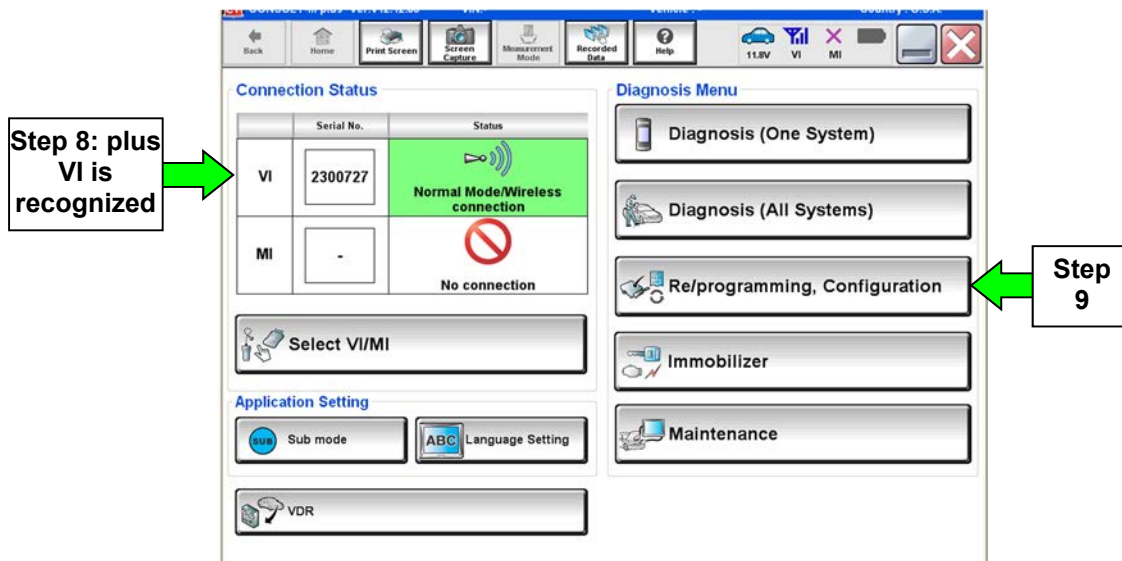
Figure 1

5. Turn the ignition ON with the engine OFF or “not ready”.
6. Turn the hazard lights ON.
7. Start C-III plus.
8. Wait for the plus VI to be recognized.
  - The serial number will display when the plus VI is recognized.
9. Select **Re/programming, Configuration**.

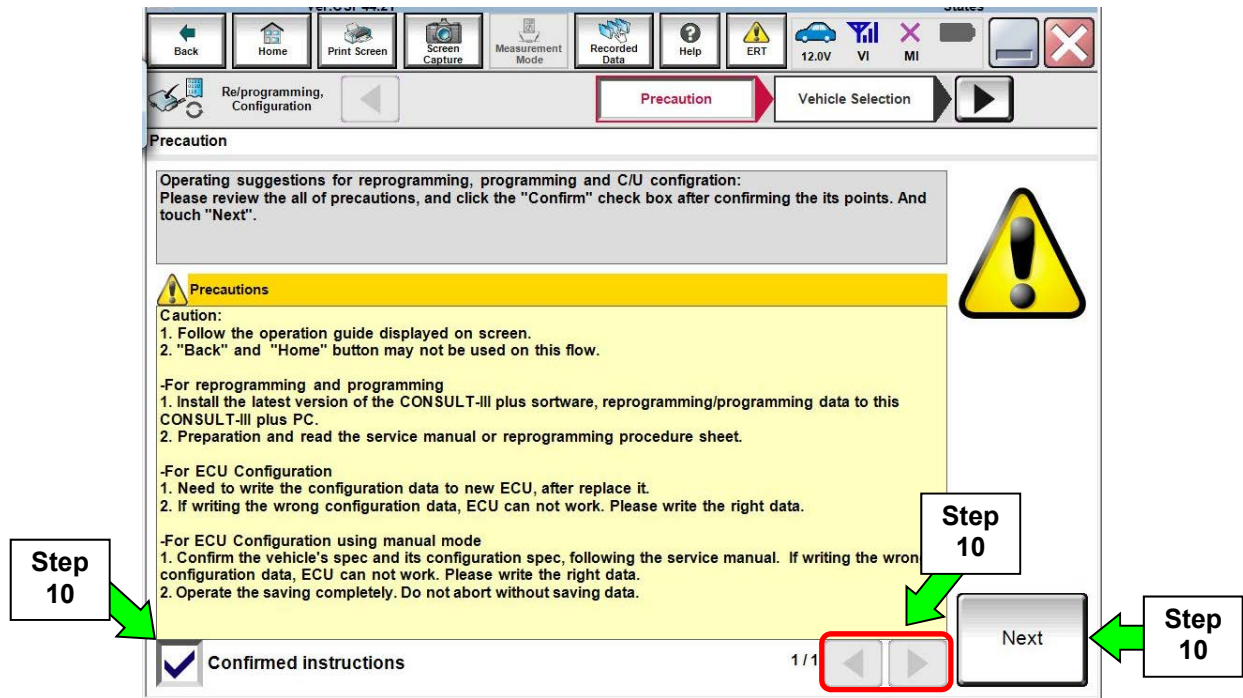
Figure 2

10. Use the arrows (if needed) to view and read all precautions, check the **Confirmed Instructions** box, and then select **Next**.

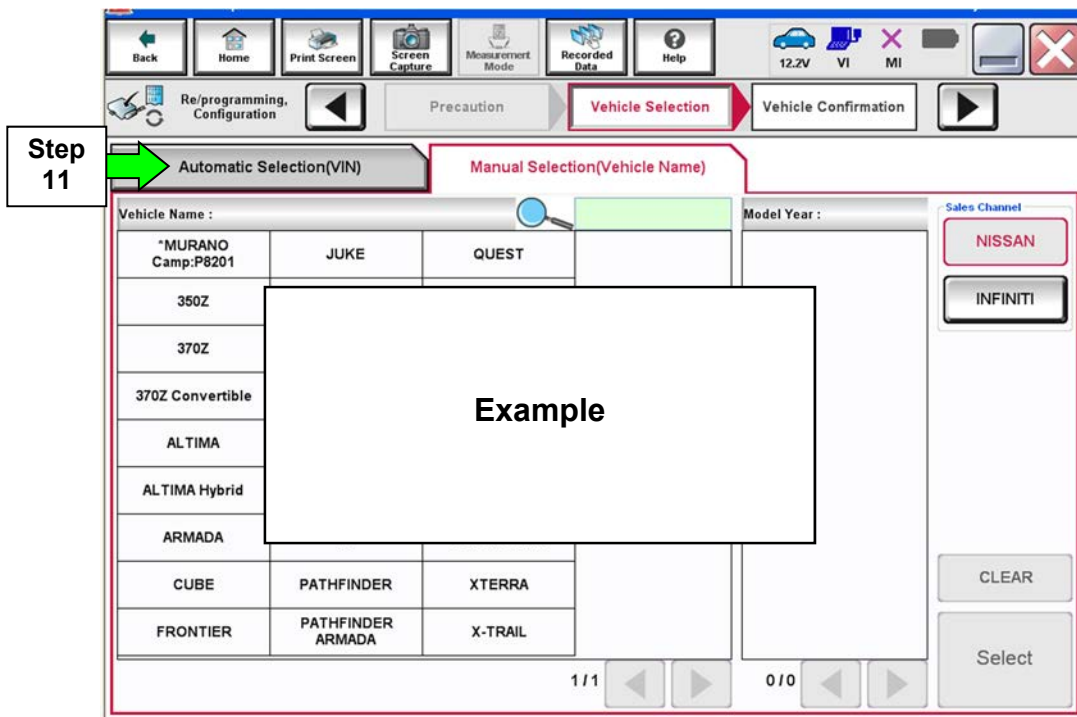
Figure 3

11. Select **Automatic Selection(VIN)**.

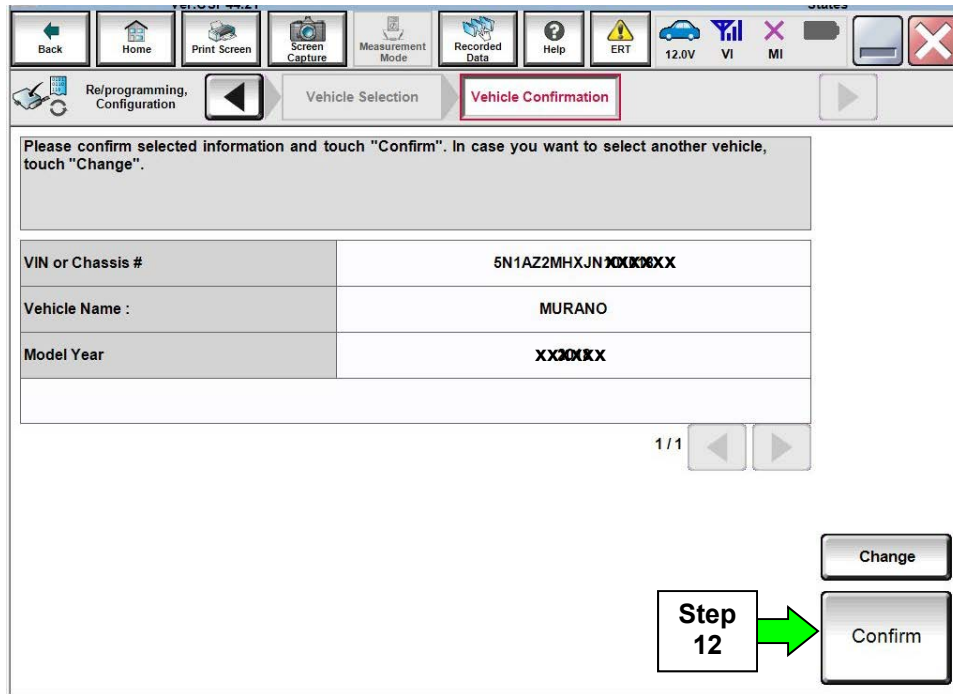
12. If the **VIN or Chassis #** matches the vehicle's VIN, select **Confirm**.

- If the screen in Figure 4 does not display, skip to step 12.

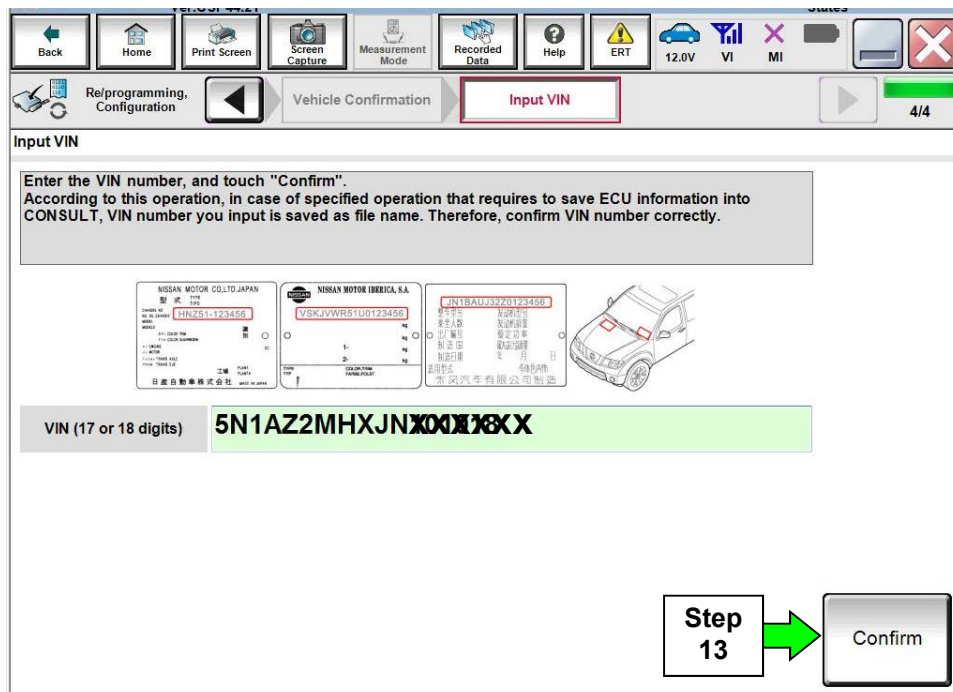
Figure 5

13. Select **Confirm**.

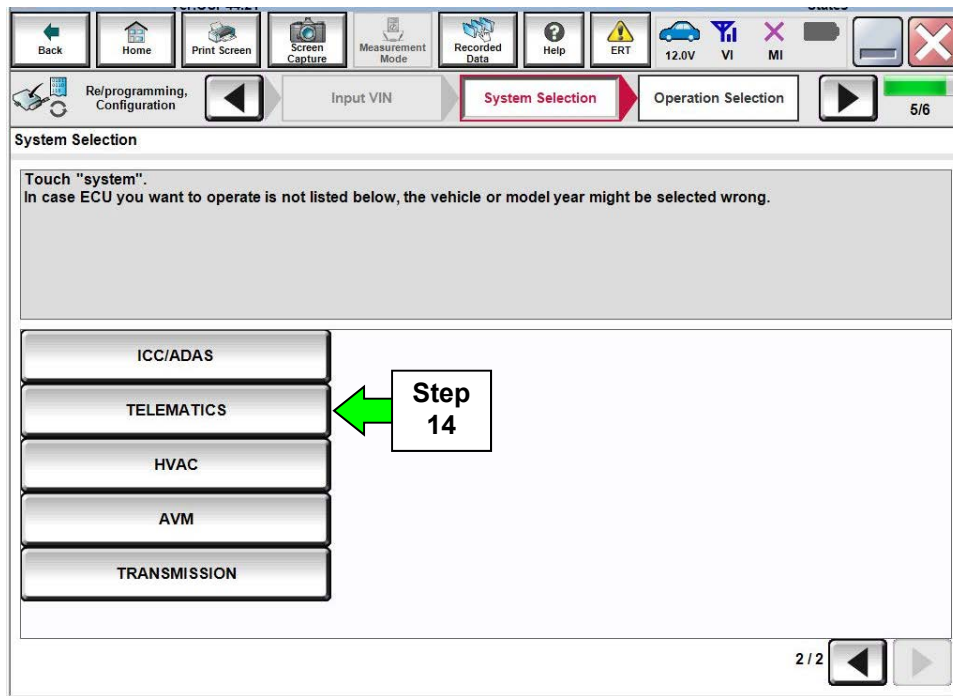
Figure 6

## 14. Select **TELEMATICS**.

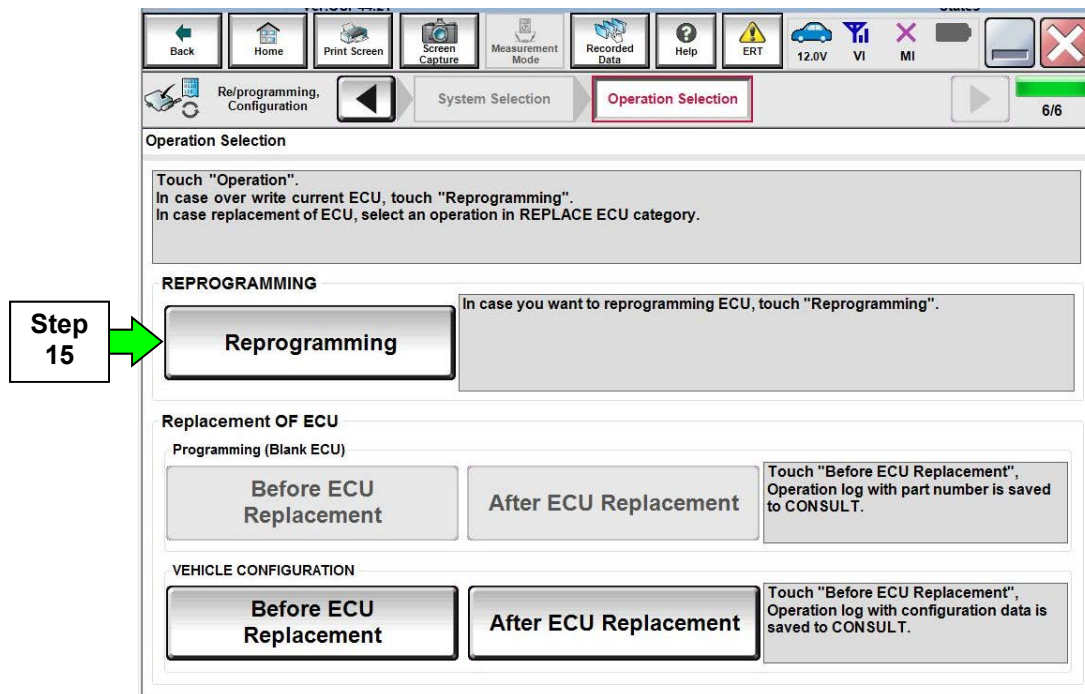
Figure 7

## 15. Select **Reprogramming**.

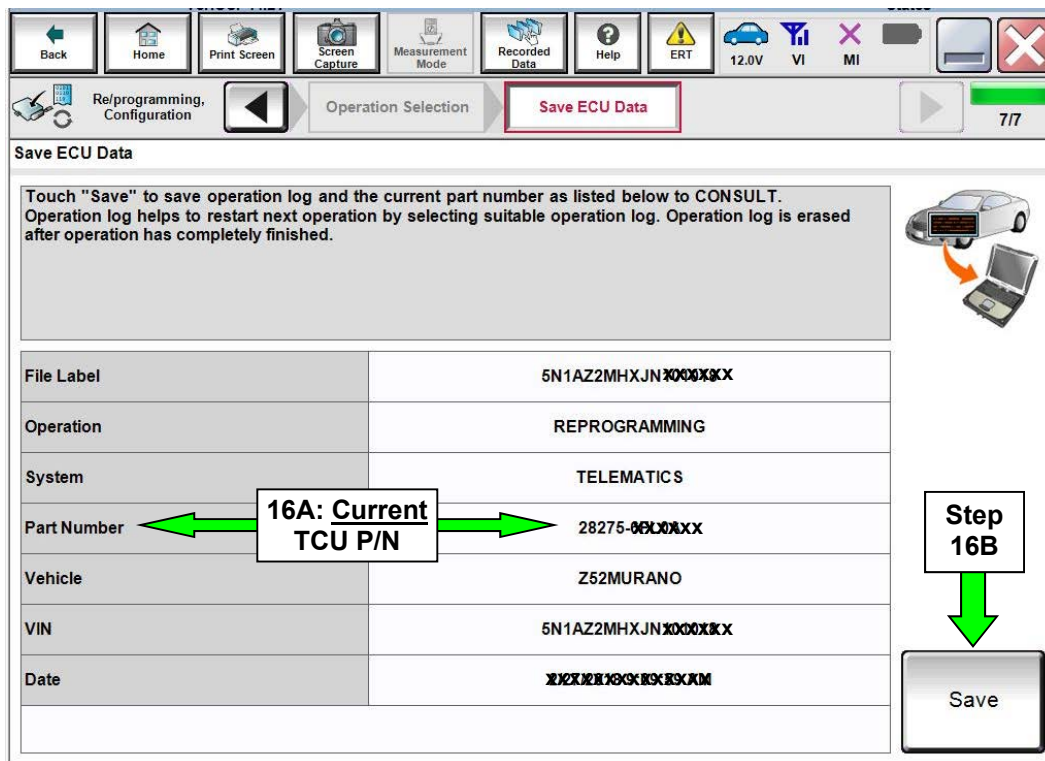
Figure 8

16. When you get to the screen shown in Figure 8, confirm this bulletin applies as follows.

A. Find the TCU **Part Number** and write it on the repair order.

**NOTE:** This is the current TCU Part Number (P/N).

B. Compare the P/N you wrote down to the numbers in the **Current TCU Part Number** column in **Table A** below.

- If there is a match, select **Save**, and then continue with the reprogramming procedure on page 7.
- If there is not a match, this bulletin does not apply. Refer to ASIST for further diagnostic and repair information.

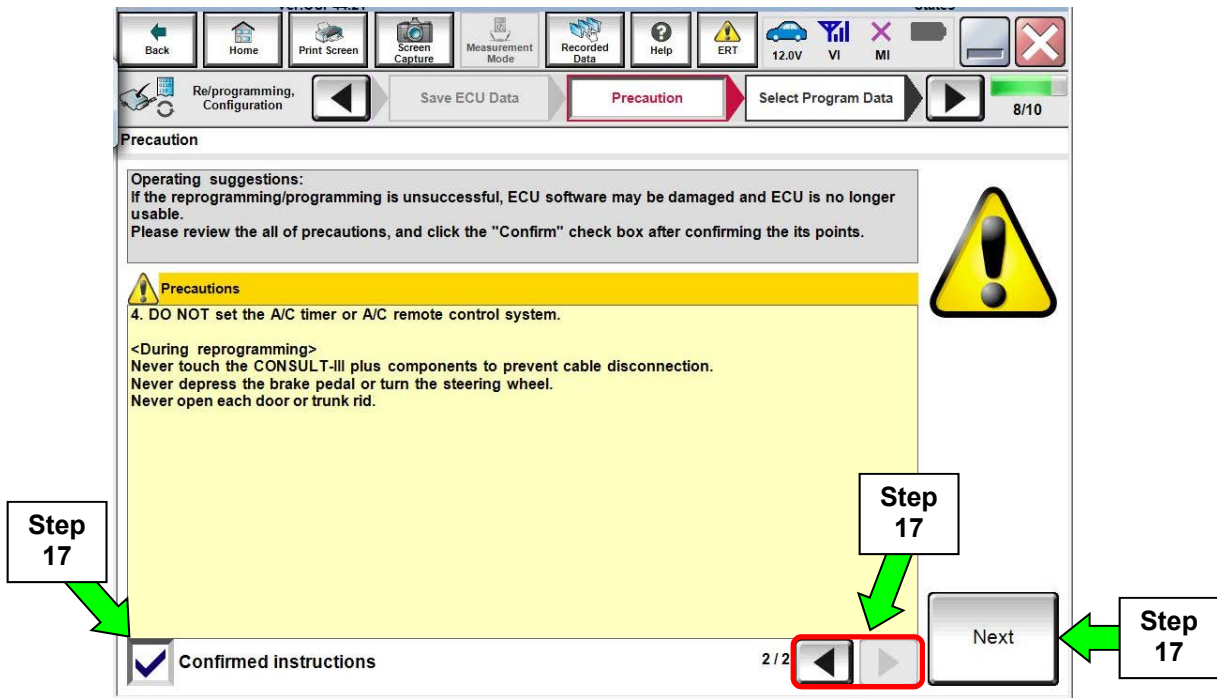
Figure 9

17. Use the arrows (if needed) to view and read all precautions, check the **Confirmed Instructions** box, and then select **Next**.

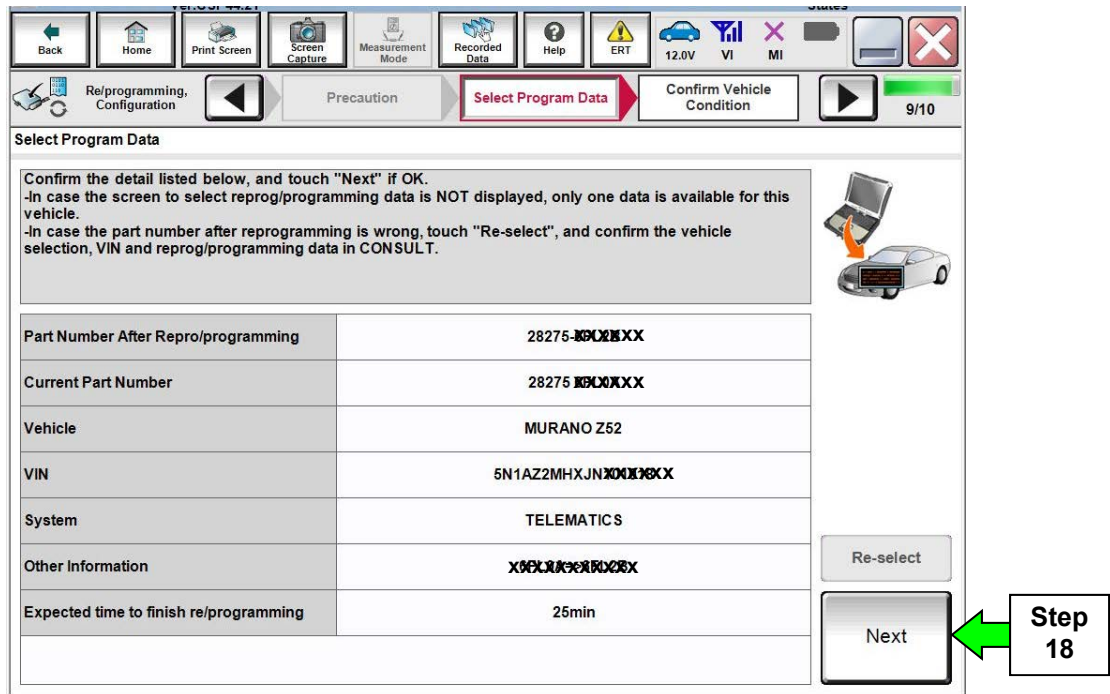
Figure 10

18. Verify the **Current Part Number** and **Part Number After Reprogramming** are different, and then select **Next**.

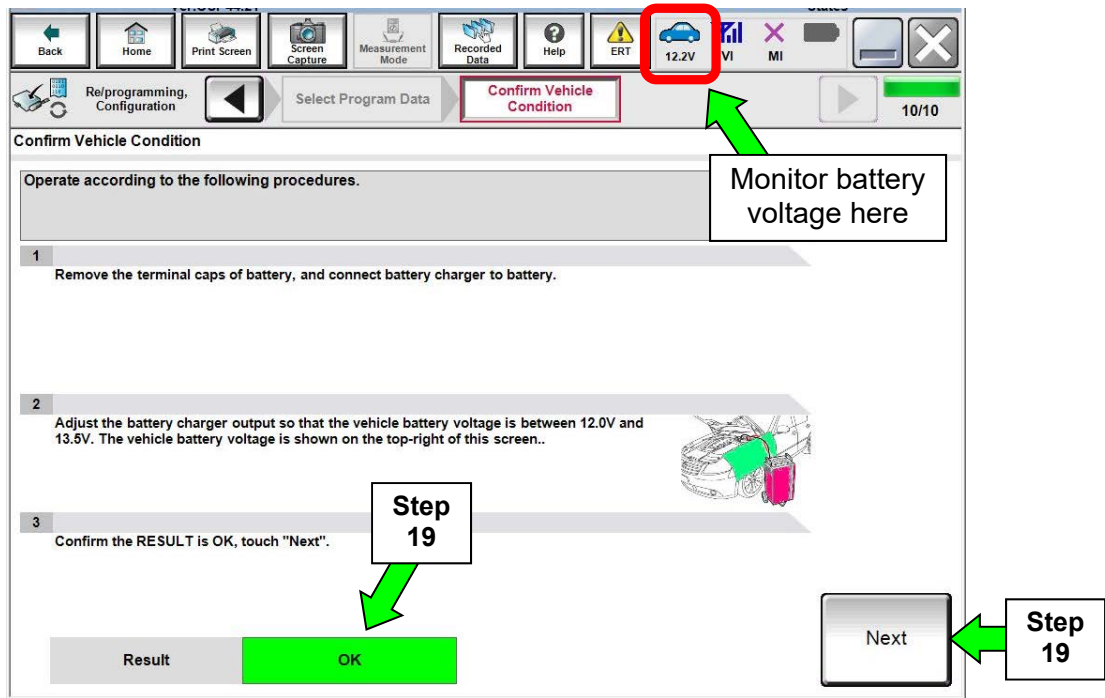
Figure 11

19. Verify **OK** is highlighted **green** (battery voltage must be between **12.0 and 15.5 volts**), and then select Next.

**IMPORTANT:** Battery voltage must stay between **12.0 and 15.5 volts** during reprogramming. If not, reprogramming may be interrupted and the TCU may be damaged.

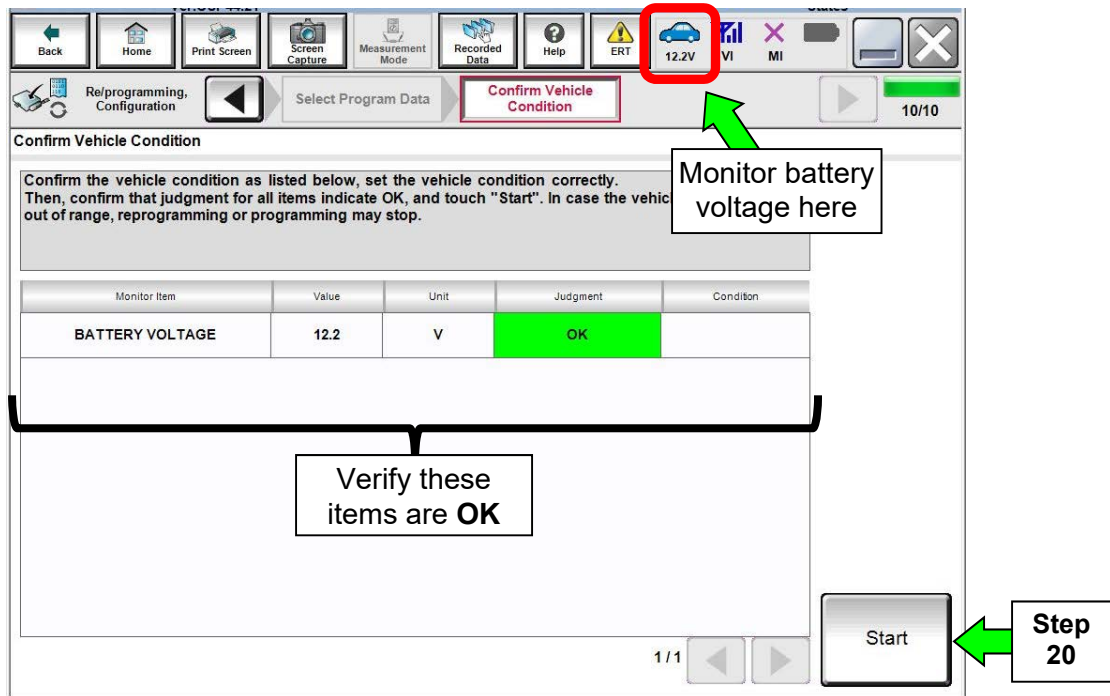
Figure 12

20. Verify all items listed under **Confirm Vehicle Condition** are **OK**, and then select **Start**.

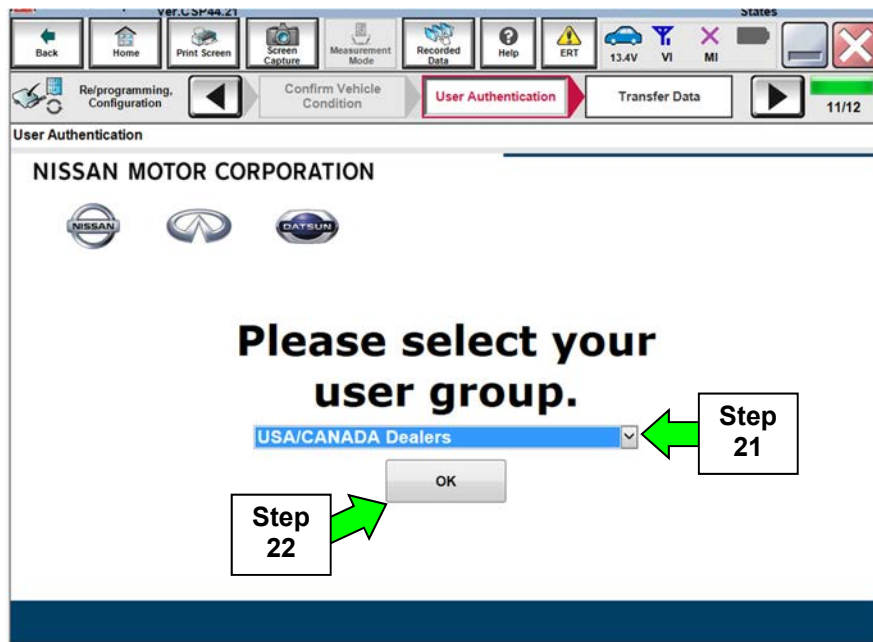
Figure 13

21. Select **USA/CANADA Dealers**.

22. Select **OK**.

- The above screen may not display if the CONSULT PC has remained ON since the last reprogramming.
- If the CONSULT PC is not connected to the Internet, the screen in Figure 14 will display.

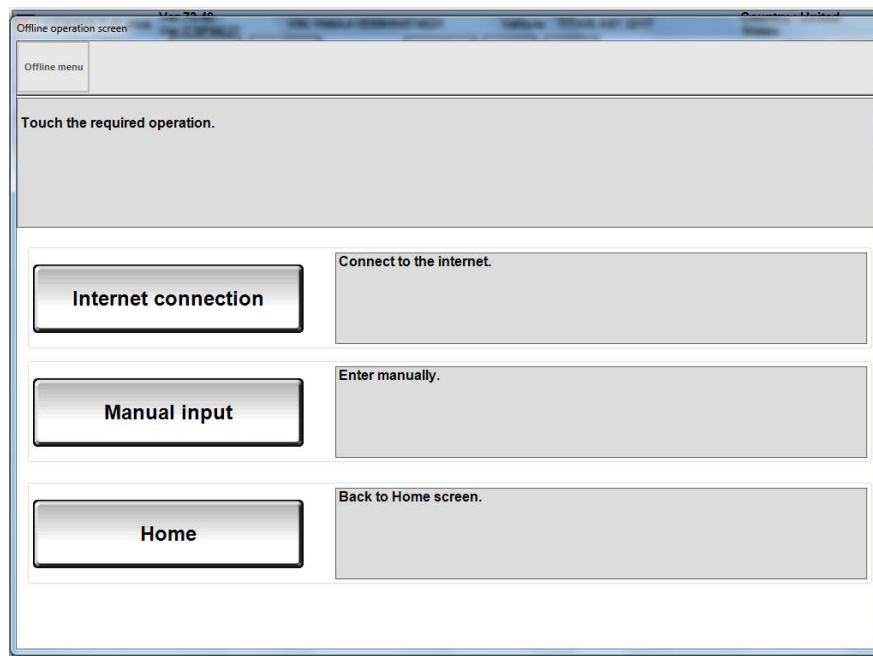
Figure 14

- Before reprogramming will start, you will be required to enter your **Username** and **Password**.
- The CONSULT PC must be connected to the Internet (Wi-Fi or cable).
- If you do not know your **Username** and **Password**, contact your service manager.

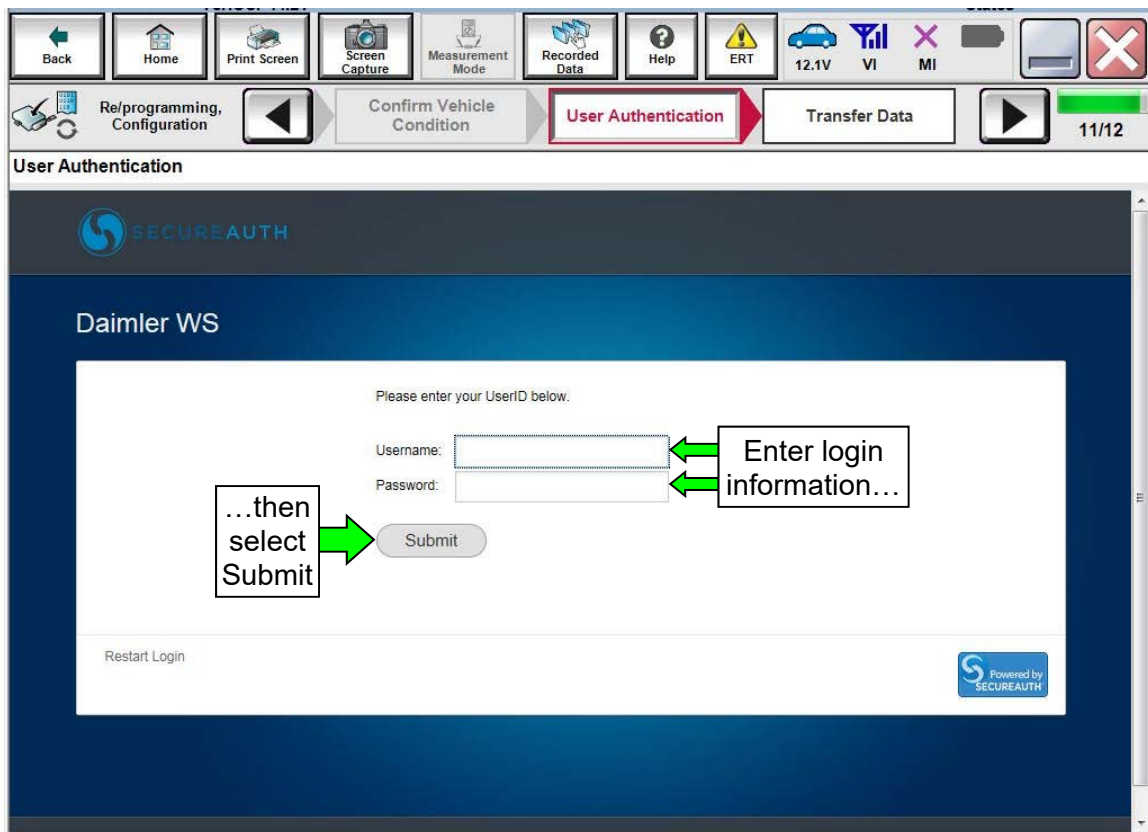
Figure 15

23. Start the reprogramming process by selecting **Submit**.

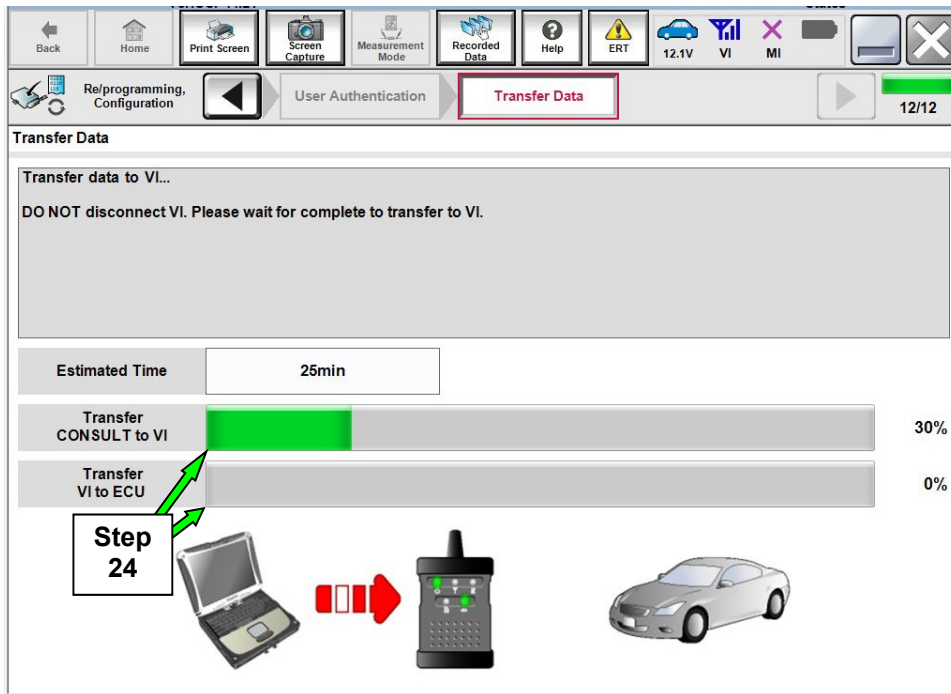
Figure 16

24. Wait for both progress bars to complete.

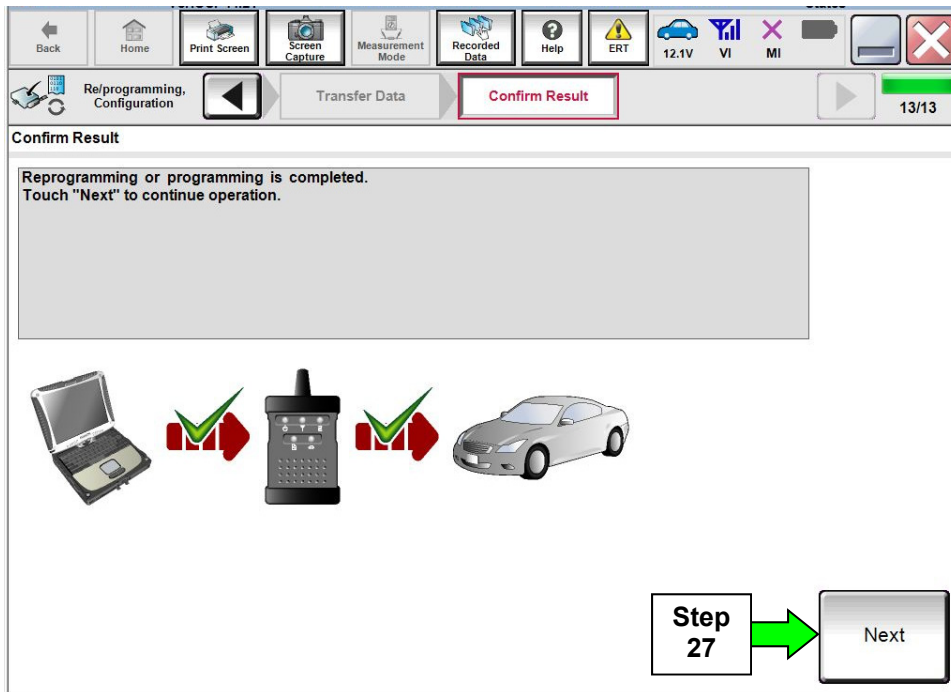
25. When the screen in Figure 17 displays, TCU reprogramming is complete.

**NOTE:** If the screen in Figure 17 does not display (indicating that reprogramming did not complete), refer to the information on the next page.

27. Select **Next**.

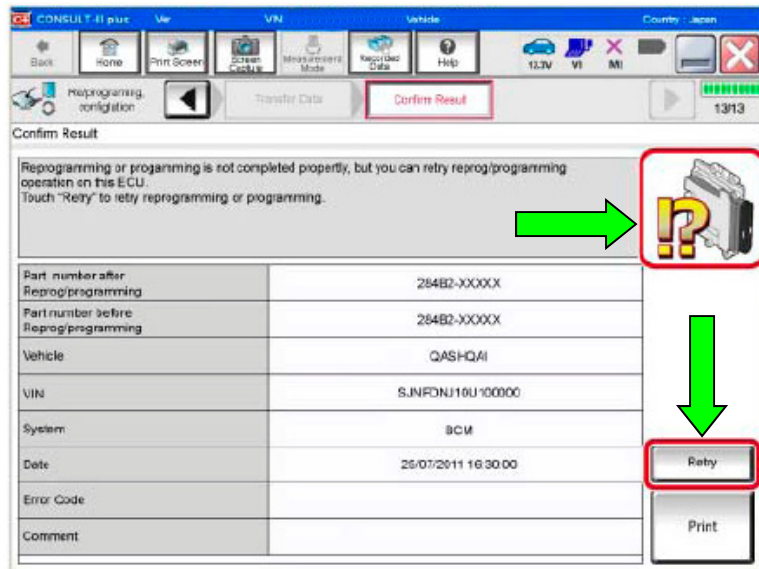
Figure 18

If reprogramming does not complete and the “!?” icon displays as shown in Figure 18:

- Check battery voltage (12.0–15.5 V).
- Ignition is ON, engine OFF.
- External Bluetooth® devices are OFF.
- All electrical loads are OFF.
- **Select retry and follow the on screen instructions.**
- “Retry” may not go through on first attempt and can be selected more than once.

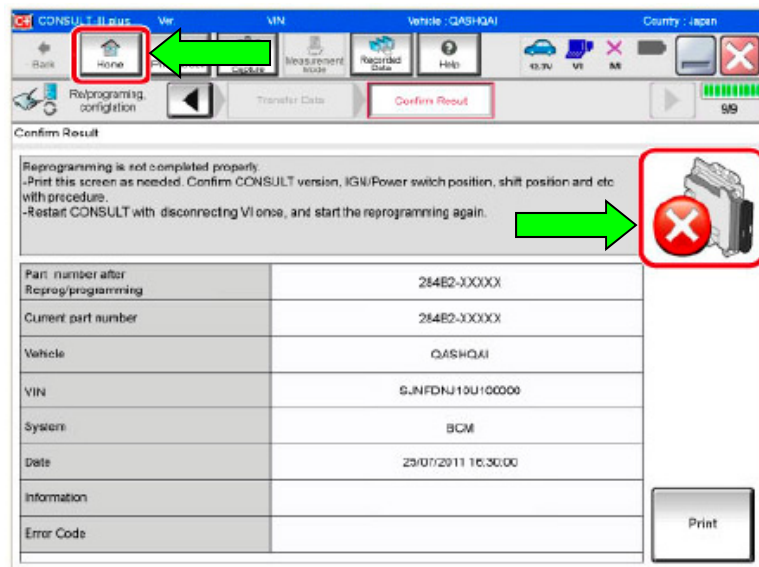
Figure 19

If reprogramming does not complete and the “X” icon displays as shown in Figure 19:

- Check battery voltage (12.0 – 15.5 V).
- CONSULT A/C adapter is plugged in.
- Ignition is ON, engine OFF.
- Transmission is in Park.
- All C-III plus / VI cables are securely connected.
- All C-III plus updates are installed.
- **Select Home, and restart the reprogram procedure from the beginning.**

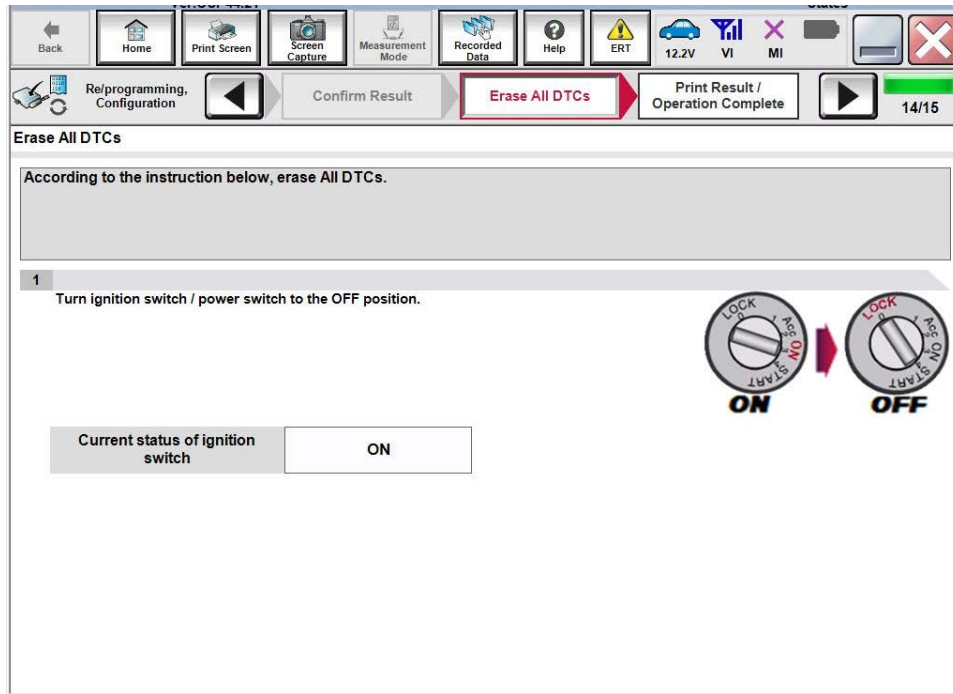
Figure 20

28. Erase all DTCs as follows:

- a. Turn the ignition OFF.

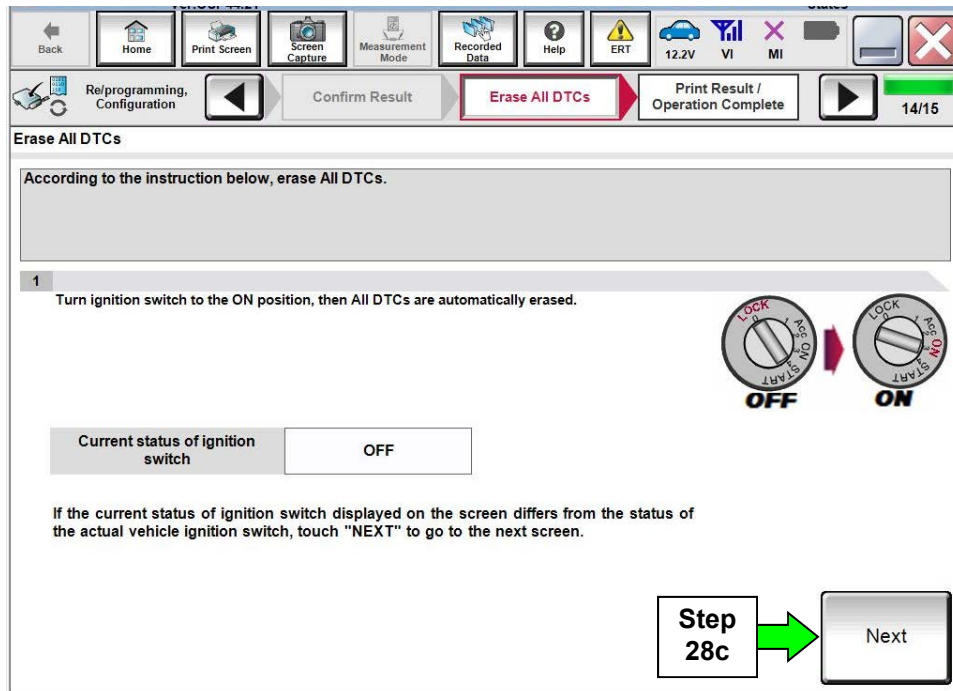
Figure 21

- b. Turn the ignition ON.
- c. Wait for DTC erase to complete, and then select **Next**.

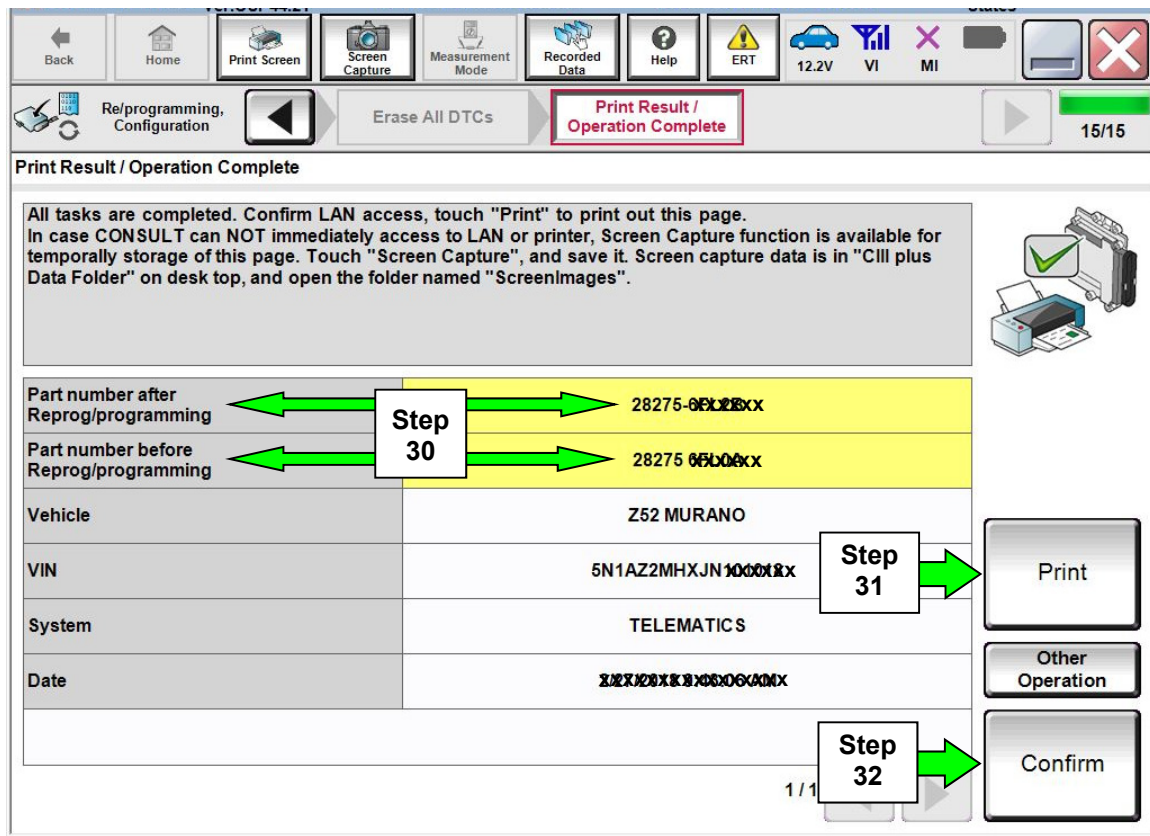
29. When the entire reprogramming process is complete, the screen in Figure 22 will display.
30. Verify the before and after part numbers are different.
31. Print a copy of this screen (Figure 22) and attach it to the repair order for warranty documentation.
32. Select **Confirm**.
