April 6, 2018

## GPS Shows Vehicle in the Wrong Location

Year	Model	Trim	VIN Range
2017	MDX	All with navigation.	ALL

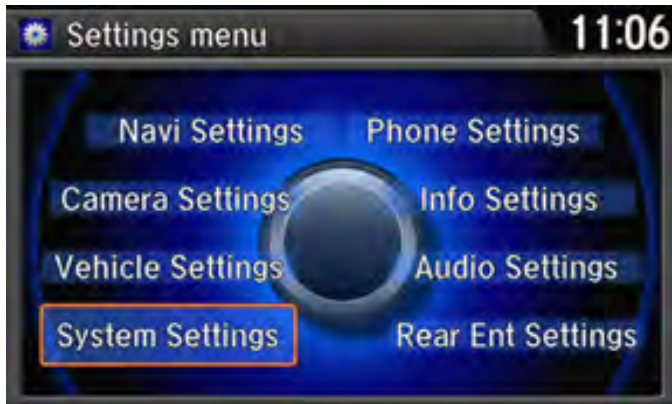
- If the update is not detected or it does not start automatically, the vehicle may already have the latest software installed. Go to step 12 to check the software version.
  - The software update will take about 30 minutes to complete. No input is required during the update so you do not need to stay with the vehicle during this time.
- After the navigation system finishes loading, select **SETTINGS** on the center switch panel, then select **System Settings**.

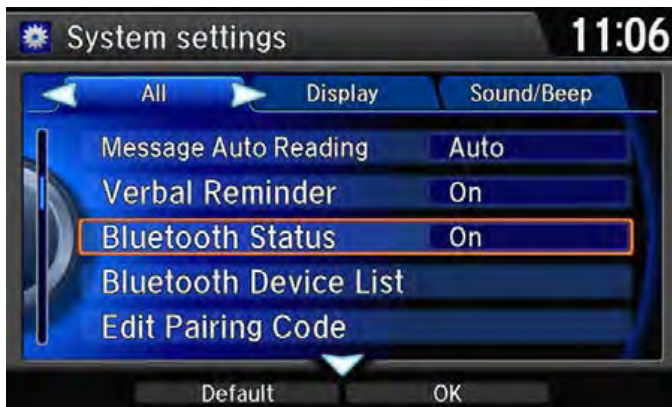
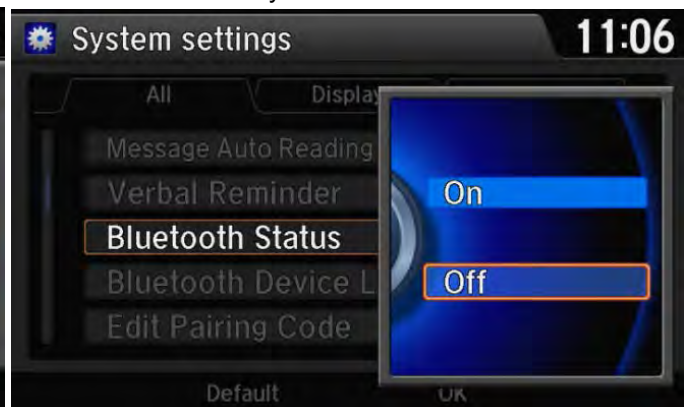
- Scroll down to **Bluetooth Status** and select **Off** to turn off *Bluetooth* connectivity.

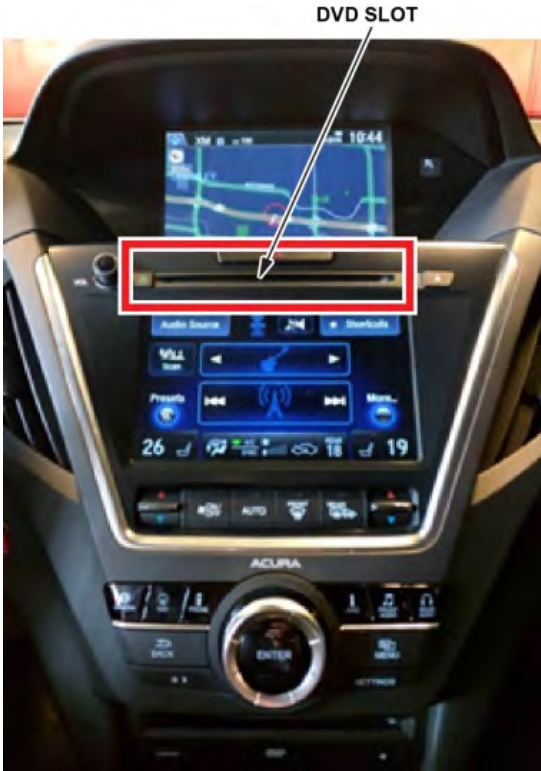
4. Insert the DVD update disc into the upper slot on the center console. The DVD contains an auto-run program that launches the software update automatically after the DVD is inserted. Go to TOOL INFORMATION for additional information about the DVD.

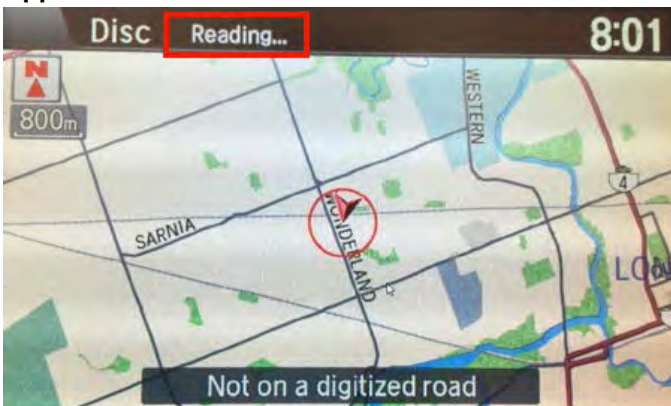
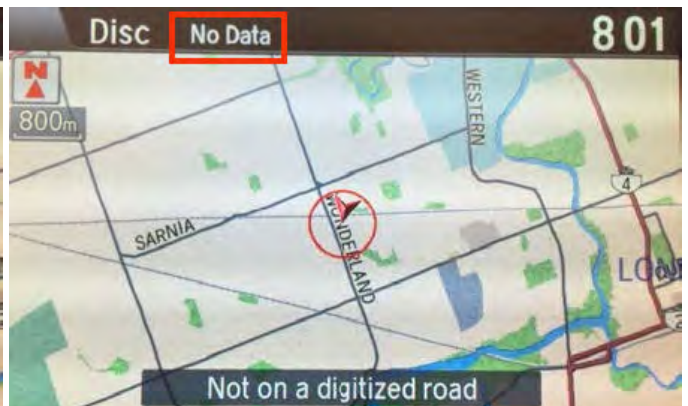
**Upper screen**

5. When the DVD is inserted, the navigation screen (upper display) will show "**Disc Reading...**", and then "**Disc No Data.**" The ODMD screen (lower display) will display a "**No Data**" message. It may take up to 1 minute to begin the update, **do not eject the disc**. If the unit does not go to the next screen after 1 minute, go to step 12 because the unit may already have the latest software.

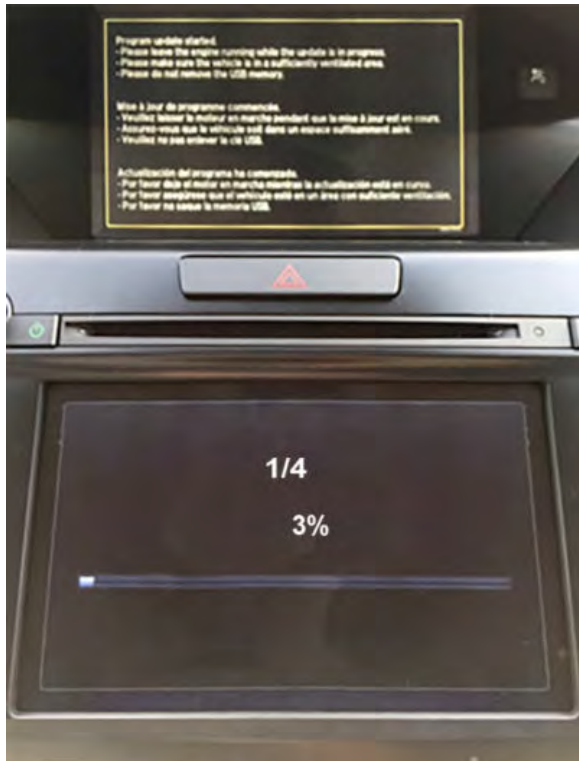
- The software update will begin after the upper and lower screen shuts off for a few seconds and reboots. The upper screen will show "**Program update started**", and the lower screen will display 4 updates with a progress bar.

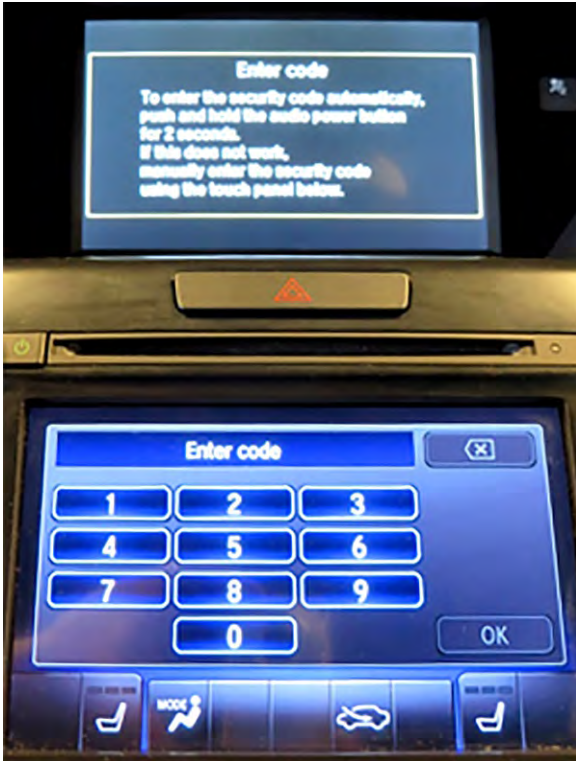
- When the update has completed, the system will reboot a couple of times. Wait until the "**Enter Code**" message appears on both the upper and lower display screens before doing the next step. There will also be a keypad on the lower screen.

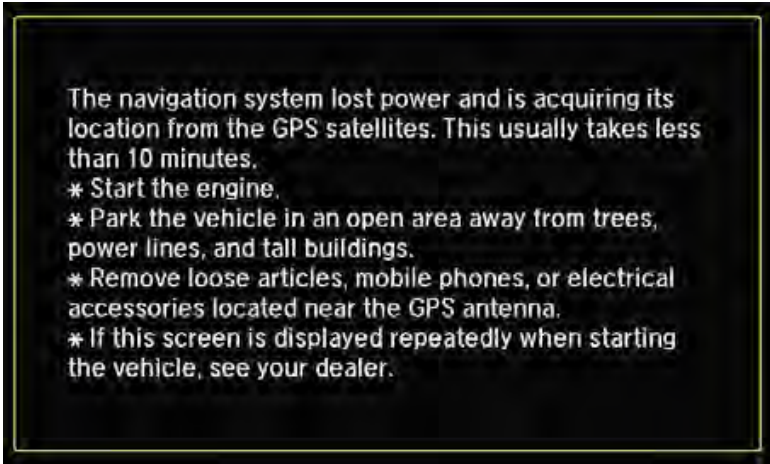
11. The navigation screen will show the GPS initialization message.

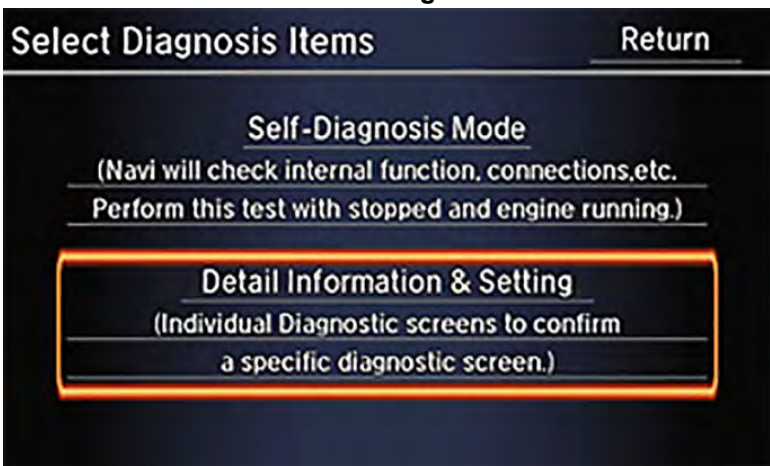
12. Press and hold the **NAVI**, **BACK**, and **MENU** buttons until the Select Diagnosis Items screen appears.

13. Select **Detail Information & Setting**.

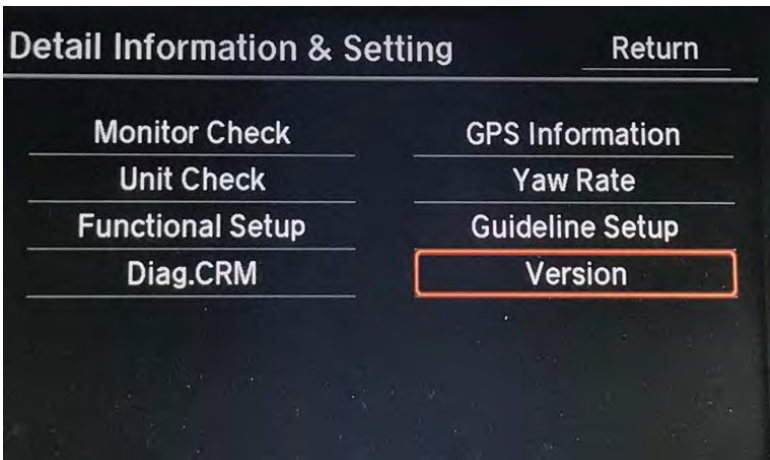
14. Select **Version**.

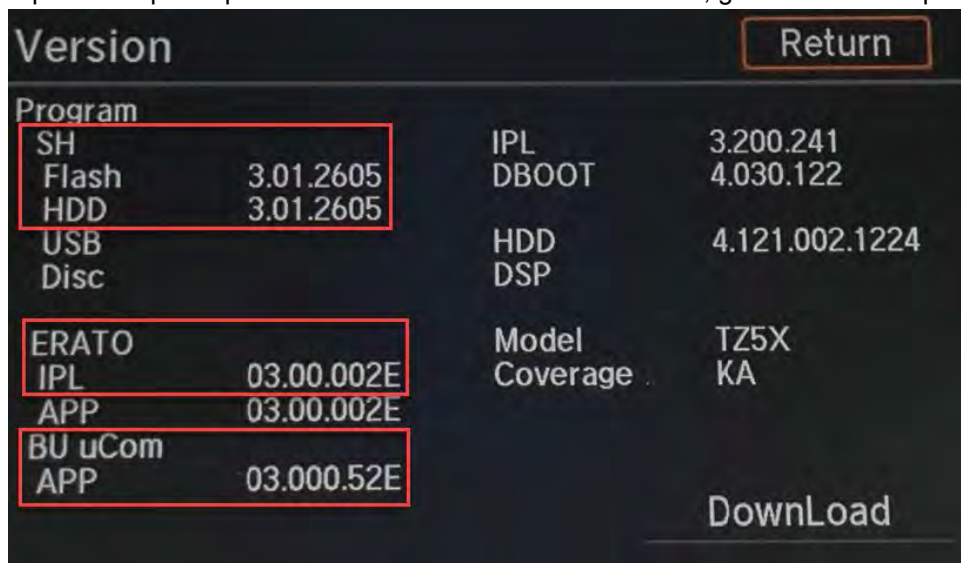
15. Check the **SH-Flash**, **ERATO IPL**, **BU uCom APP** and **HDD** version numbers and make sure they match the table below. If the version numbers do not match the numbers below, turn the vehicle OFF and go back to step 2 and repeat the update procedure. If the version numbers match, go to the next step.

SH-Flash	3.01.2605
ERATO IPL	03.00.002E
BU uCom APP	03.000.52E or 03.000.42E

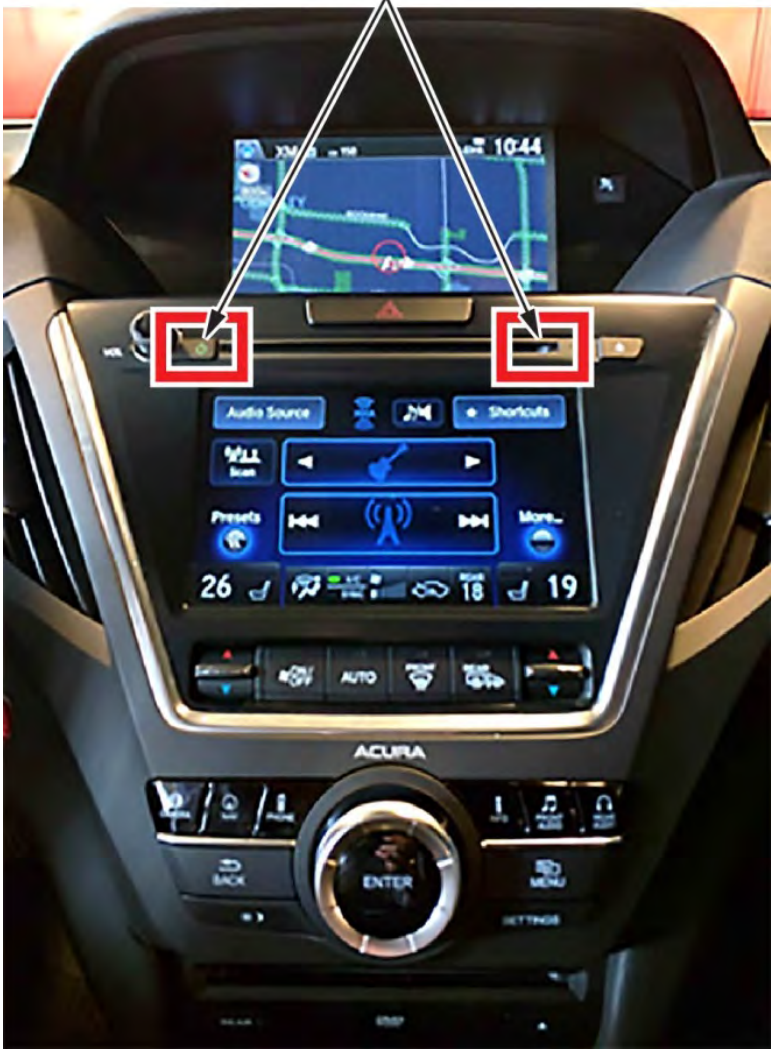
**GREEN LED**

6. Make sure the green LEDs on both sides of the upper CD slot are blinking. This indicates the recovery process is working. Repeat the RECOVERY PROCEDURE FOR LOCKED UNIT procedure if the LEDs are not blinking.
