FSB 284-067, Engine Control Module (ECM) and Aftertreatment Control Module (ACM), Reprogramming

(March 2018)

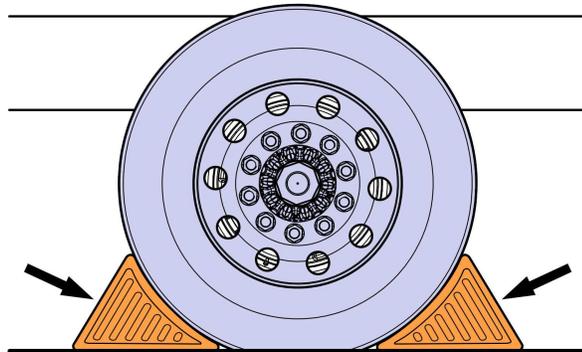
W7086748

- 1 Park the vehicle on a level surface.
- 2 Apply the parking brake.
- 3 Place the transmission in neutral or park.
- 4 Install the wheel chocks.

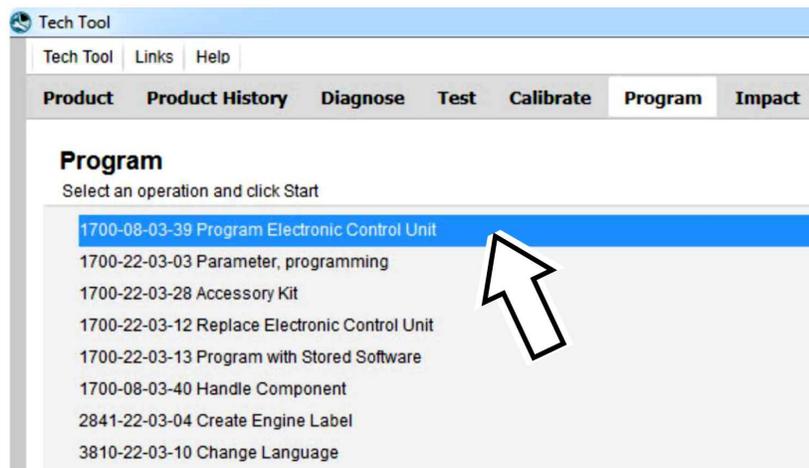
W2115478

- 9 From the Main Menu select Program and **then** Program Electronic Control Unit 1700-08-03-39. Then click Start.

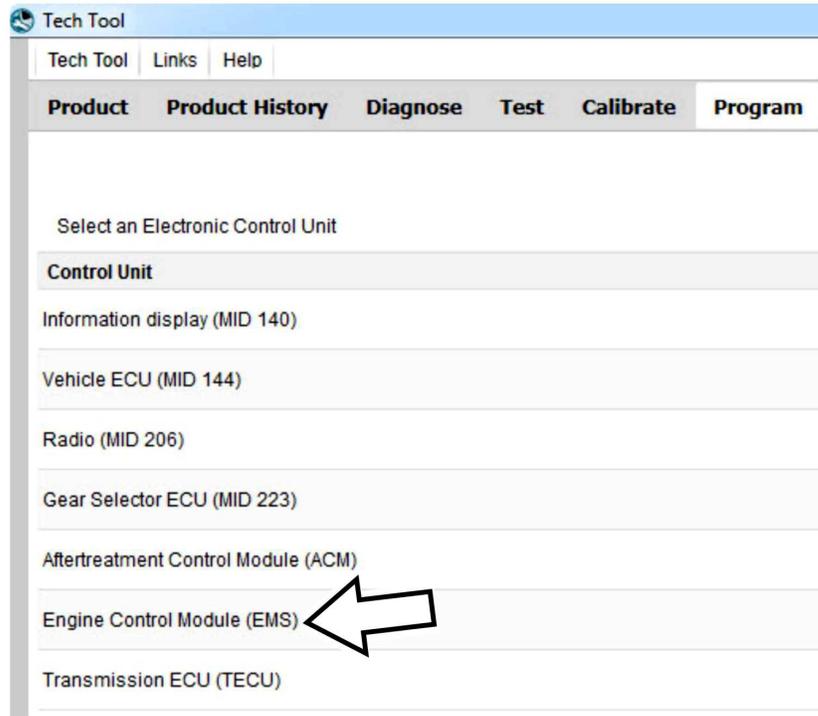
W2115479

10 Select **Engine Control Module (EMS)**.

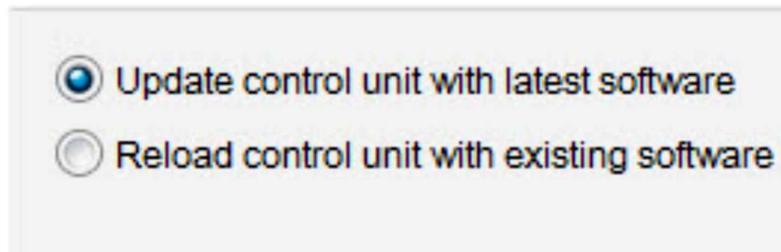
W2115480

11 Select Program to update the **ECM** with the latest software.

Programming options

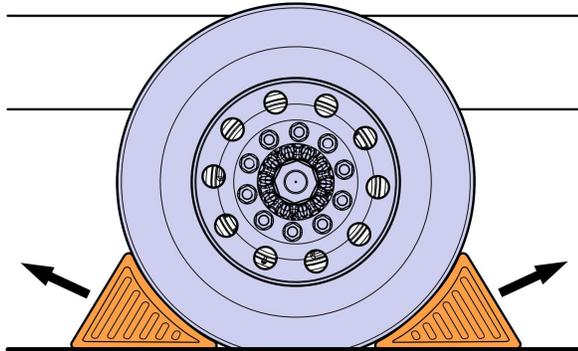
W7086759

- 14 When programming is complete, click Exit to return to Main Menu to program the ACM.
- 15 When all programming is complete, clear any diagnostic trouble codes (DTC) and Finish Work.
- 16 Remove the wheel chocks.
