WJ15 - Re-Programming Control Unit for High-Voltage Charger (Workshop Campaign)

Vehicle Type: **Panamera 4 E-Hybrid (971)
Panamera Turbo S E-Hybrid (971)**

Subject: **Control unit for high-voltage charger**

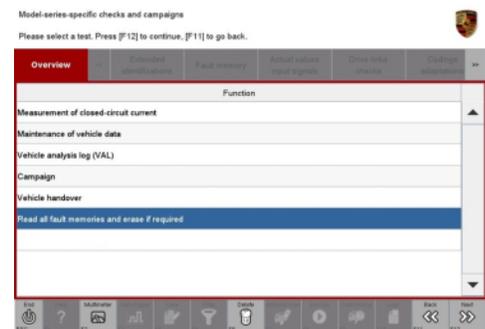
Erasing fault memories

- Plug the PIWIS Tester diagnostic connector into the diagnostic socket again and restore communication with the vehicle.
 - Read out the fault memory again and delete any fault memory entries that are stored.
- 6 Once you have erased the fault memories, select the '**Overview**' menu to return to the control unit selection screen ⇒ *Control unit selection*.
