US 63932068-02

Software update of thin-film transistor instrument cluster

INITIAL INFORMATION FOR THE RETAILER ORGANISATION.

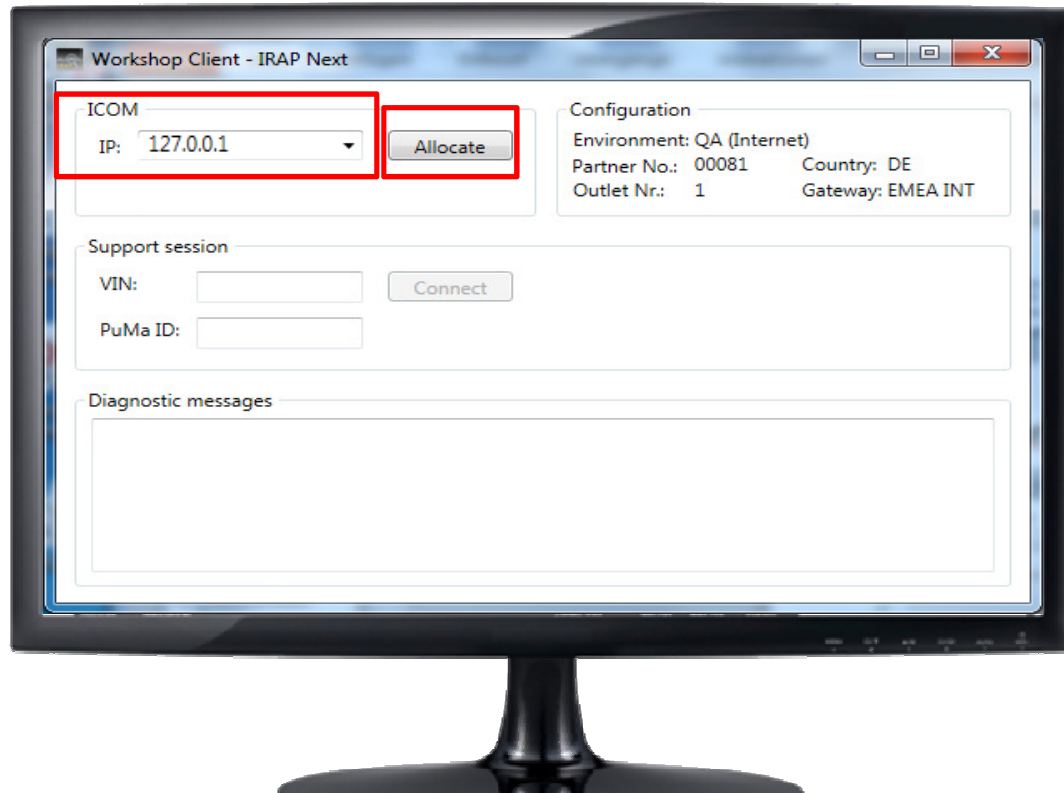
**Reserve the ICOM using IRAP Next directly in the system.**

When you are requested in a PuMA measure to create an IRAP connection, then start IRAP Next on any registered computer.

Enter the IP address of the ICOM in the mask and reserve the ICOM now directly from the system with the "Allocate" button.

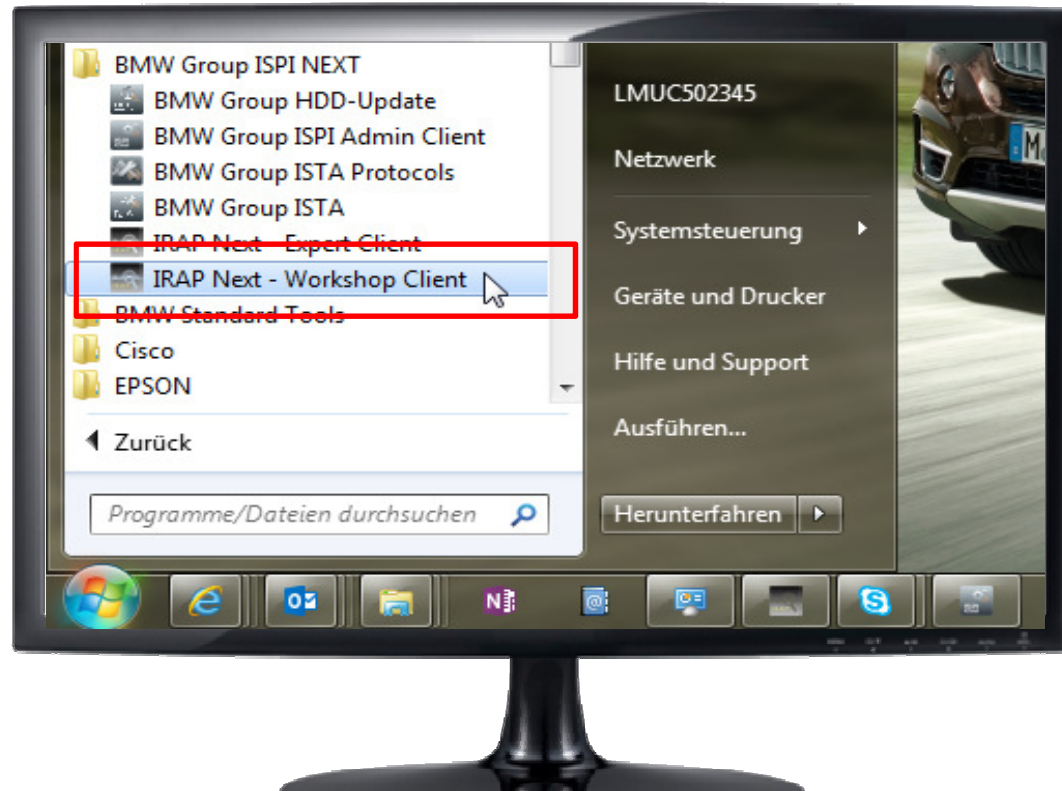
## Immediate availability of the program.

After completion of the installation process the IRAP Next program is available to you on all registered workshop systems.
