SI B65 13 16
Audio, Navigation, Monitors, Alarms, SRS

UPDATE! NBT-EVO Head Unit Cannot be Swapped between Vehicles for Testing. 'Component Protection Active'

Affects vehicles with SA609 - Navigation System Professional (NBT-EVO HU-H2)

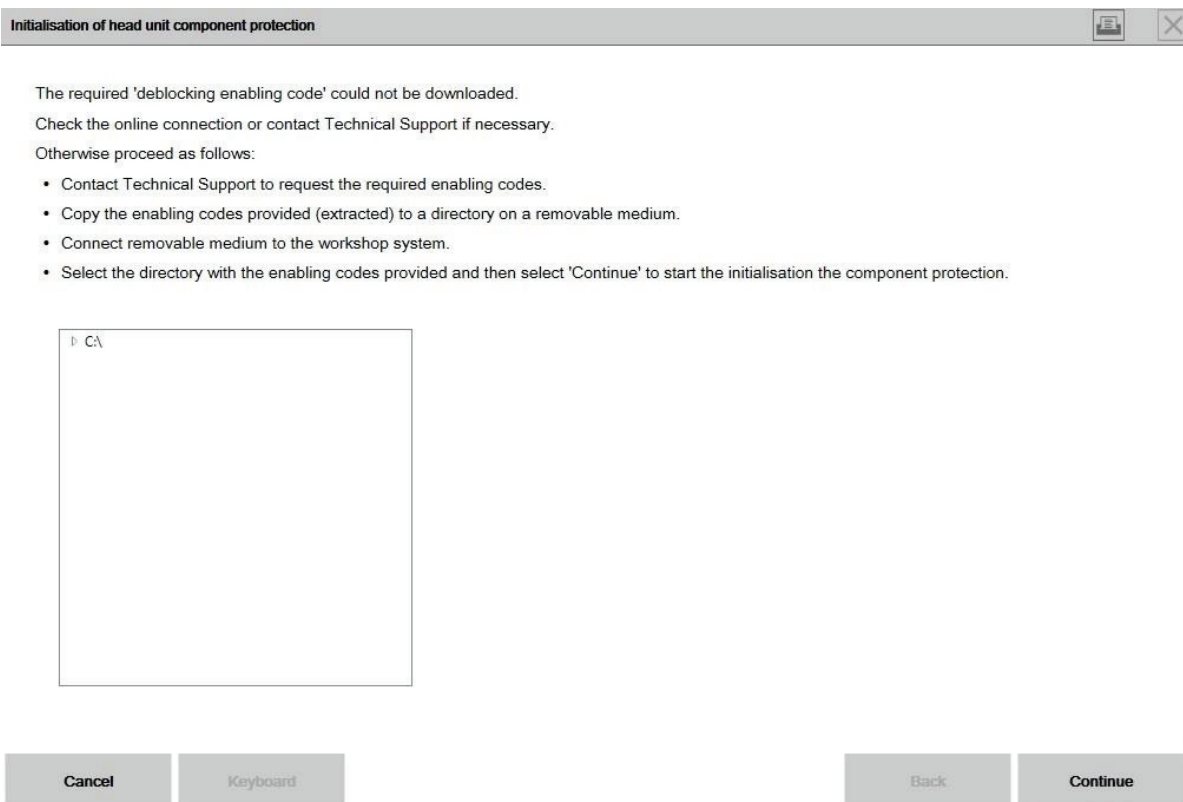
12. Select the "Import" checkbox in the dialogue on the manual import of enabling codes. Then confirm the dialogue.

13. Select the storage location (folder) of the unpacked enabling codes in the next dialogue.
