NA_MACK_Vehicle_Range

Title (customer effect) Mack Chassis - Diagnostic Trouble Code (DTC) P249C Intermittently Lighting The Malfunction Indicator Lamp (MIL) - **US14+OBD15 And US14+OBD16 (Non-Common Rail Fuel System) Emissions, Commonly Model Years 2016 And 2017**

Cause OBD15 And US14+OBD16 (Commonly Model Year 2016 and 2017) Chassis may log DTC P249C under High RPM and Light load conditions

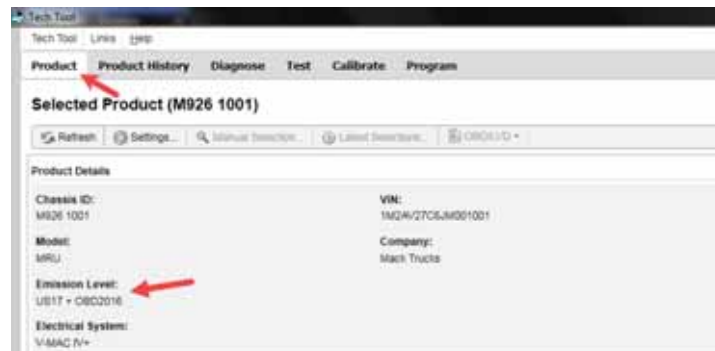
Verify the chassis emissions level

- Details can be found in the Product Details box on the Product tab in PTT as seen below:
