Service Campaign

CC-18-00-02

MODEL: Karma Revero

TITLE: Baseline BL1040 Firmware Release

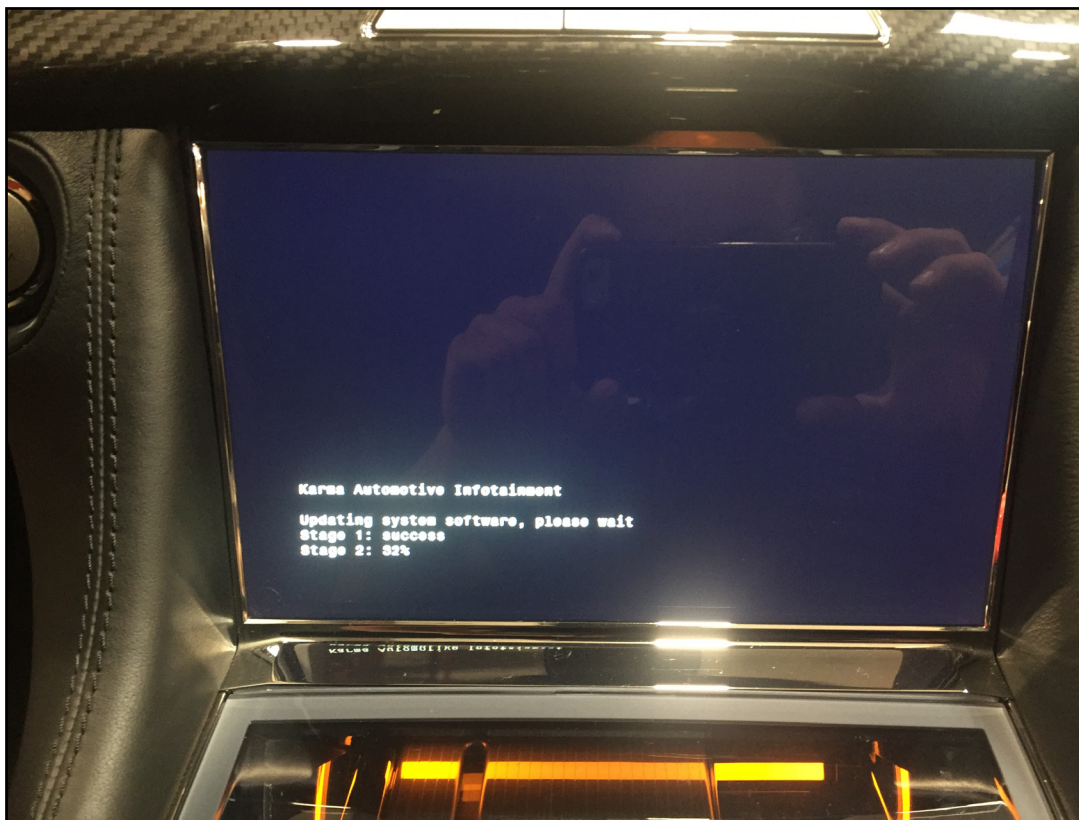
fig. 3

Below are the screens of the TPI read out as the CIU is updating (fig.3) When this is completed updating, the screen may go blank or black or cycle on and off, normal function will resume upon cycling the mode button.

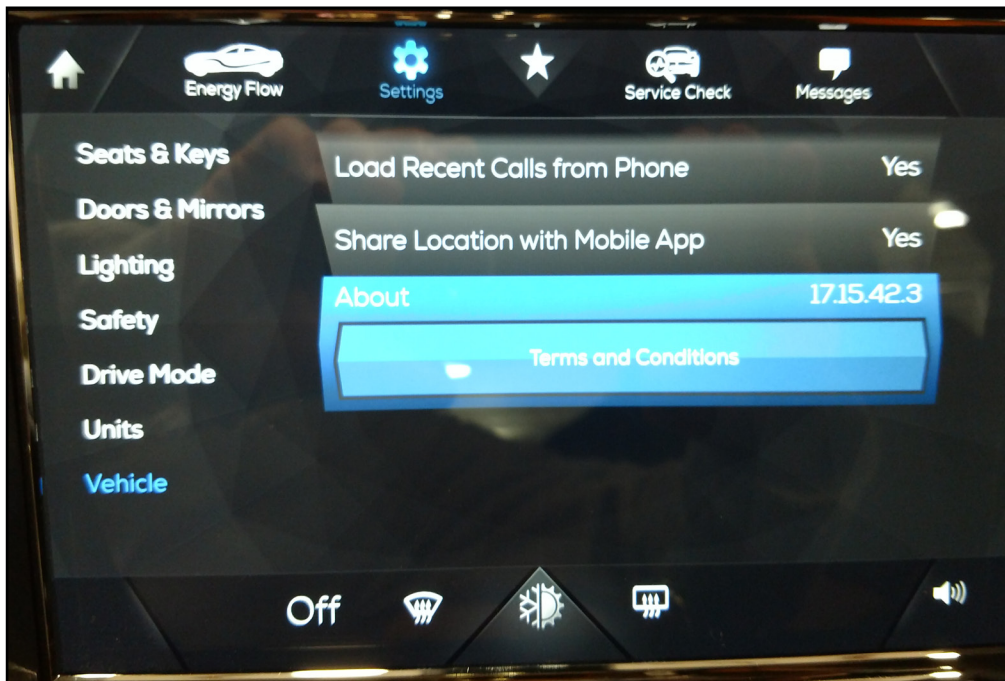
fig. 4

3. Verify the CIU software ID in the TPI after the vehicle has been placed in ready mode. go to Settings >Vehicle > About, the version should be displayed above the Terms and Conditions bar (fig. 4)

The CIU Software ID should be as displayed- 17.15.42.3

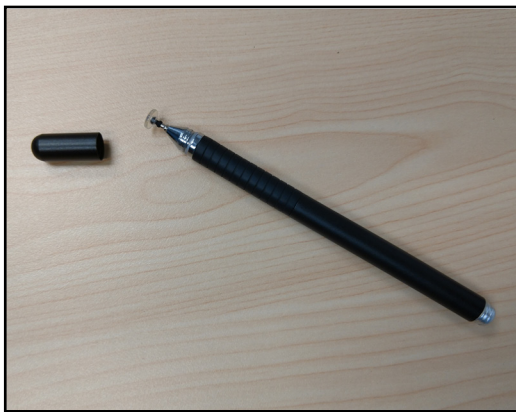
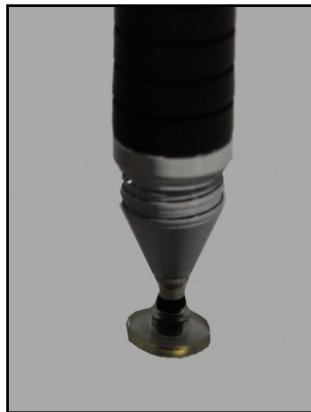
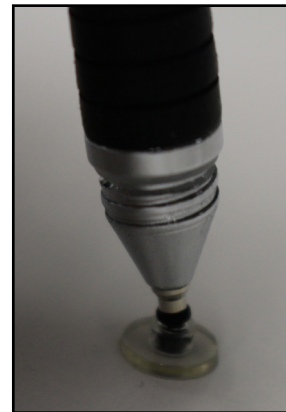
Use the supplied stylus from previous updates, which will be used for the screen calibration. Unscrew the cap to expose the tool tip, this flexible end is the contact point for calibration of the touch panel. The touch panel is best calibrated with the stylus tip at or about 90° to the panel surface as shown. Press and hold stylus to the target for calibration (fig 5a,5b,5c)

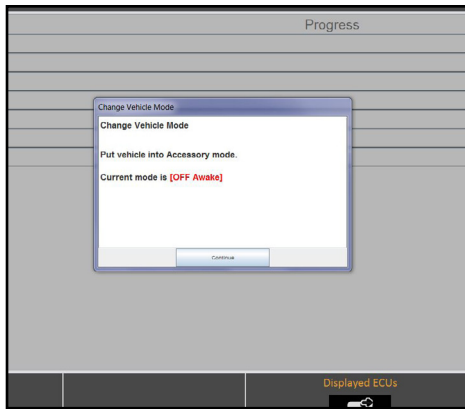
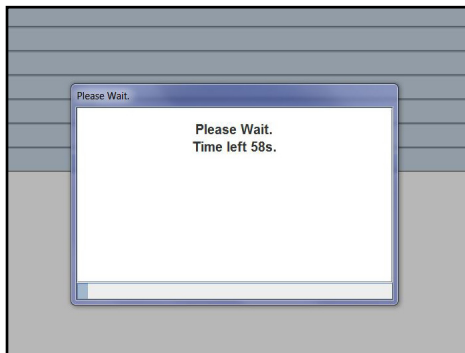
As instructed place vehicle in the requested mode (fig.16a). Do not walk away from the vehicle, as you will be prompted to switch modes.

23. Follow the prompts and place the vehicle into Accessory or Ready mode (fig.16). It is normal for the vehicle to appear to be 'stuck on' during this step of the programming. Follow the prompts and do as directed (fig 16a,16b,16c,16d).
