Service Campaign

CC-18-00-02

MODEL: Karma Revero

TITLE: Baseline BL1040 Firmware Release

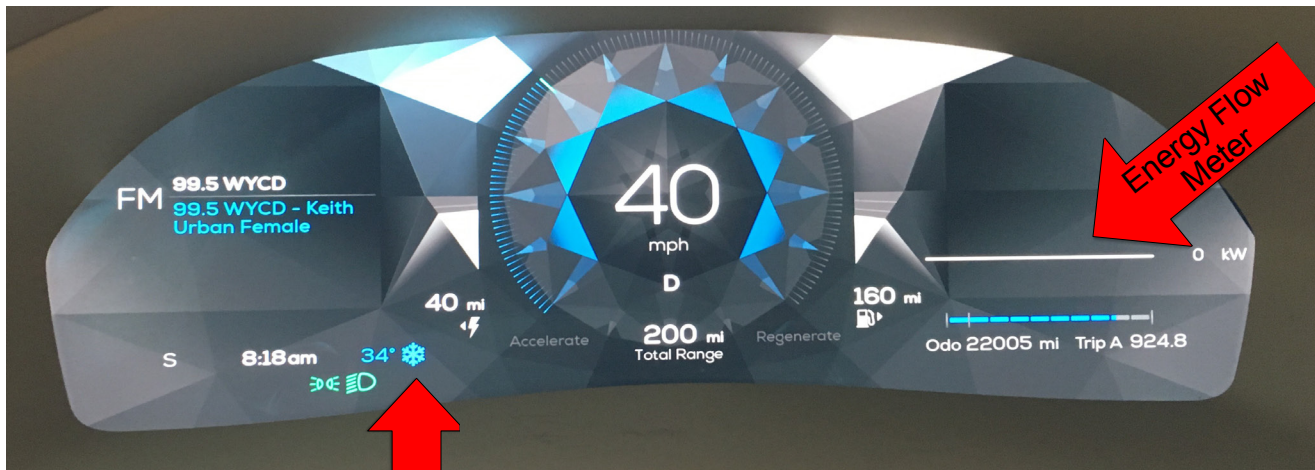
fig. 1a

New CIU / DIS Features (fig.1a)

Shown above we see the newly introduced “Snowflake icon” for possible icy road conditions and the energy flow meter. This is flat when the vehicle is not moving, a wave form will display when the throttle is being applied and released.

CIU/ DIS: Refinements introduced, low temperature (possible icy road conditions) will display a blue snowflake icon in the DIS. Energy flow display added as well

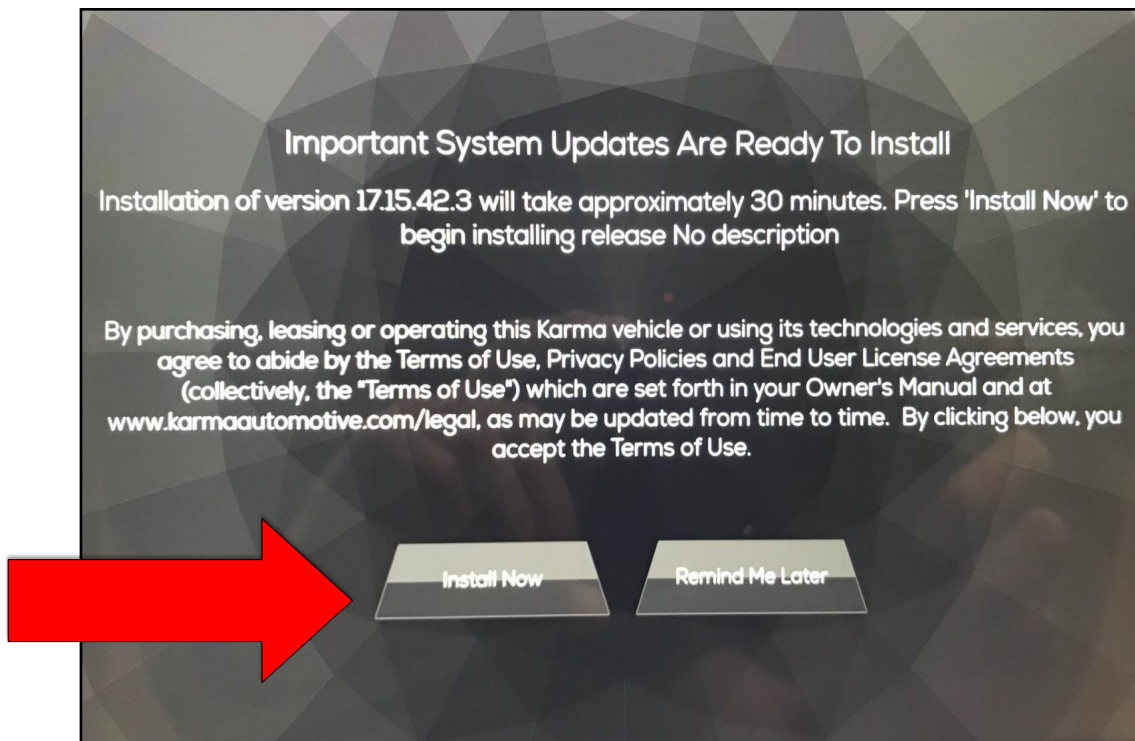
fig. 2

2. Keep the door latched (closed position) the update will not show up on TPI until power button is powered off with door still latched. This is when you can verify the TPI for update available messaging screen. If the download completed, the vehicle will prompt to accept the update (fig. 2) Accept this and allow the vehicle to update. Note that changing the door latch state will interrupt the accessory delay and shut down the TPI. If the TPI shuts down at power off, the update available screen will not display.

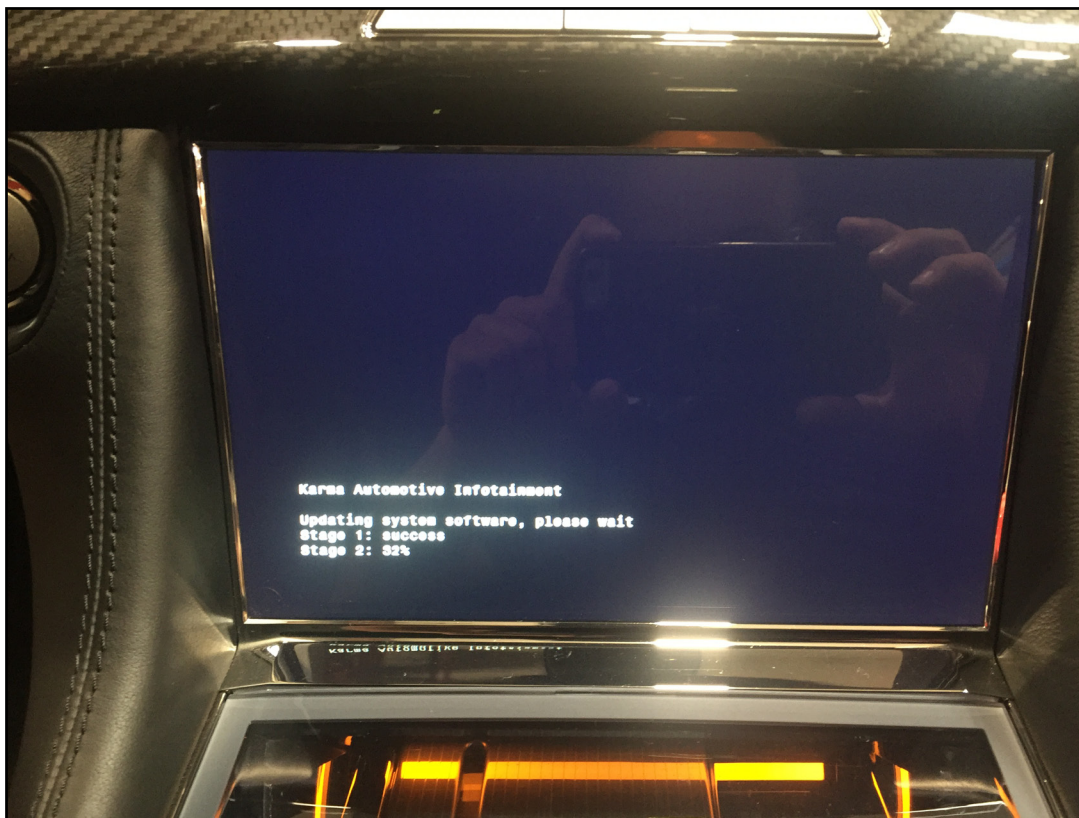
fig. 3

Below are the screens of the TPI read out as the CIU is updating (fig.3) When this is completed updating, the screen may go blank or black or cycle on and off, normal function will resume upon cycling the mode button.

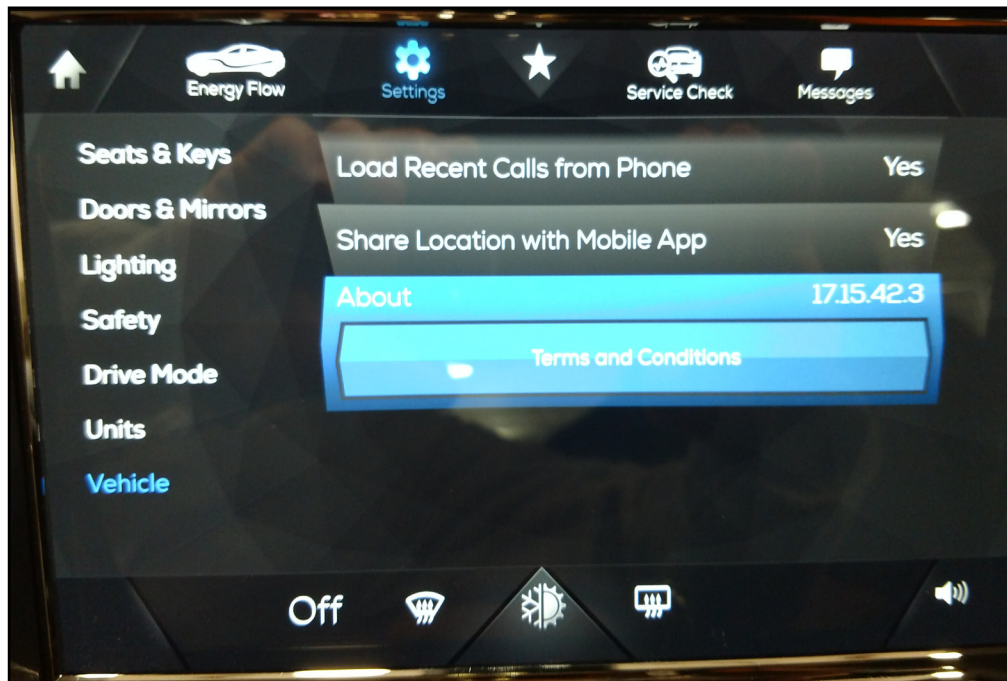
fig. 4

3. Verify the CIU software ID in the TPI after the vehicle has been placed in ready mode. go to Settings >Vehicle > About, the version should be displayed above the Terms and Conditions bar (fig. 4)

The CIU Software ID should be as displayed- 17.15.42.3

NOTE: The CIU software version ID is found in the TPI, go to; Settings > Vehicle > About

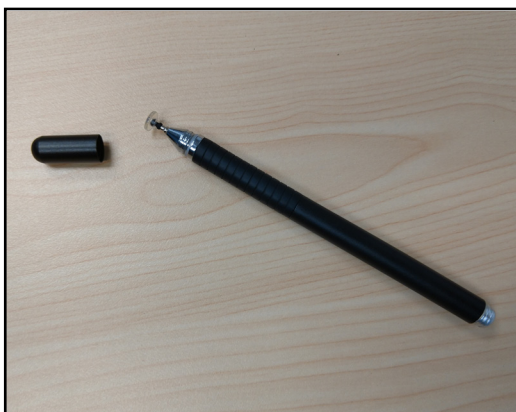
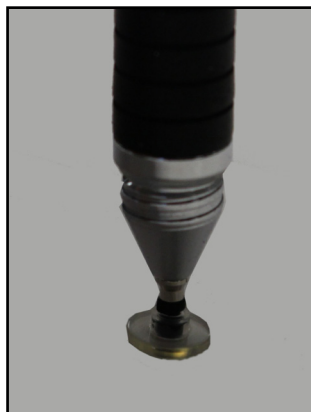
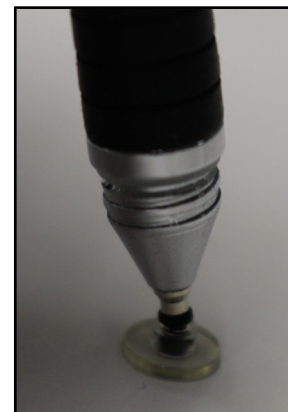
Use the supplied stylus from previous updates, which will be used for the screen calibration. Unscrew the cap to expose the tool tip, this flexible end is the contact point for calibration of the touch panel. The touch panel is best calibrated with the stylus tip at or about 90° to the panel surface as shown. Press and hold stylus to the target for calibration (fig 5a,5b,5c)

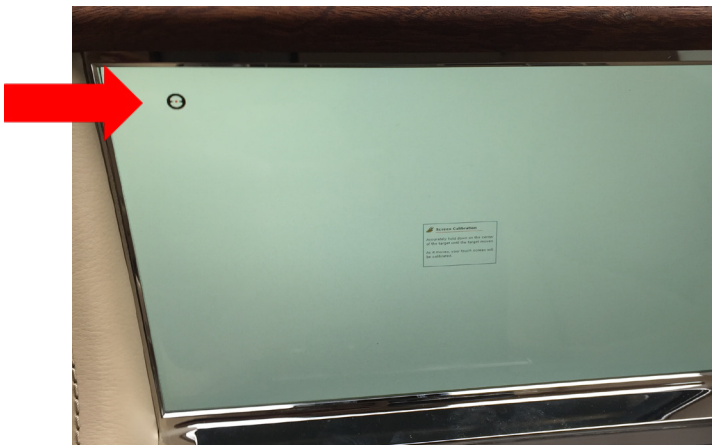
fig.6b

- Begin with the upper left shown here in car and graphically as shown (fig.6 and 6c)

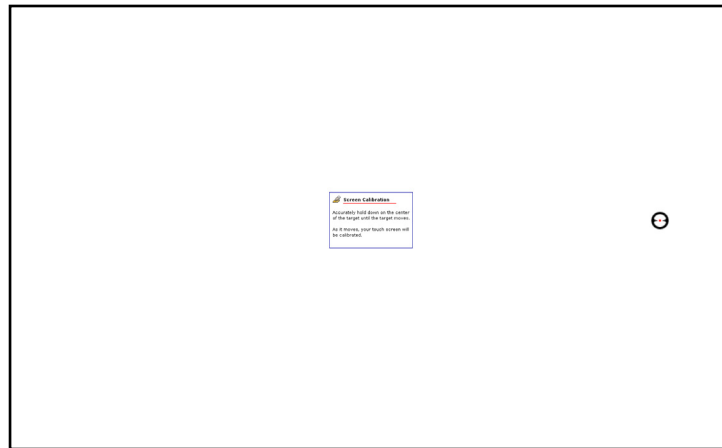
fig.6d

- Proceed to the right side target shown here (fig 6d).

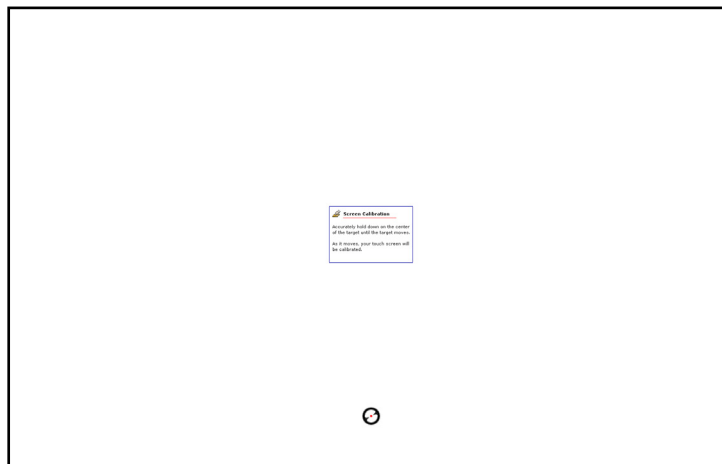
fig.6e

- the last target is as indicated- central and near the bottom of the TPI screen (fig 6e).

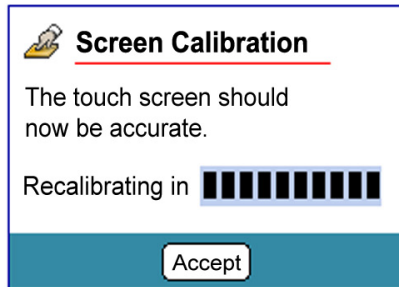
fig.6f

- Final step, confirm the and accept the calibration.
This is also a target! Maintain accuracy, as shown (fig. 6f).
It will appear smaller on the TPI than on this page.
- Reboot and finish a calibration

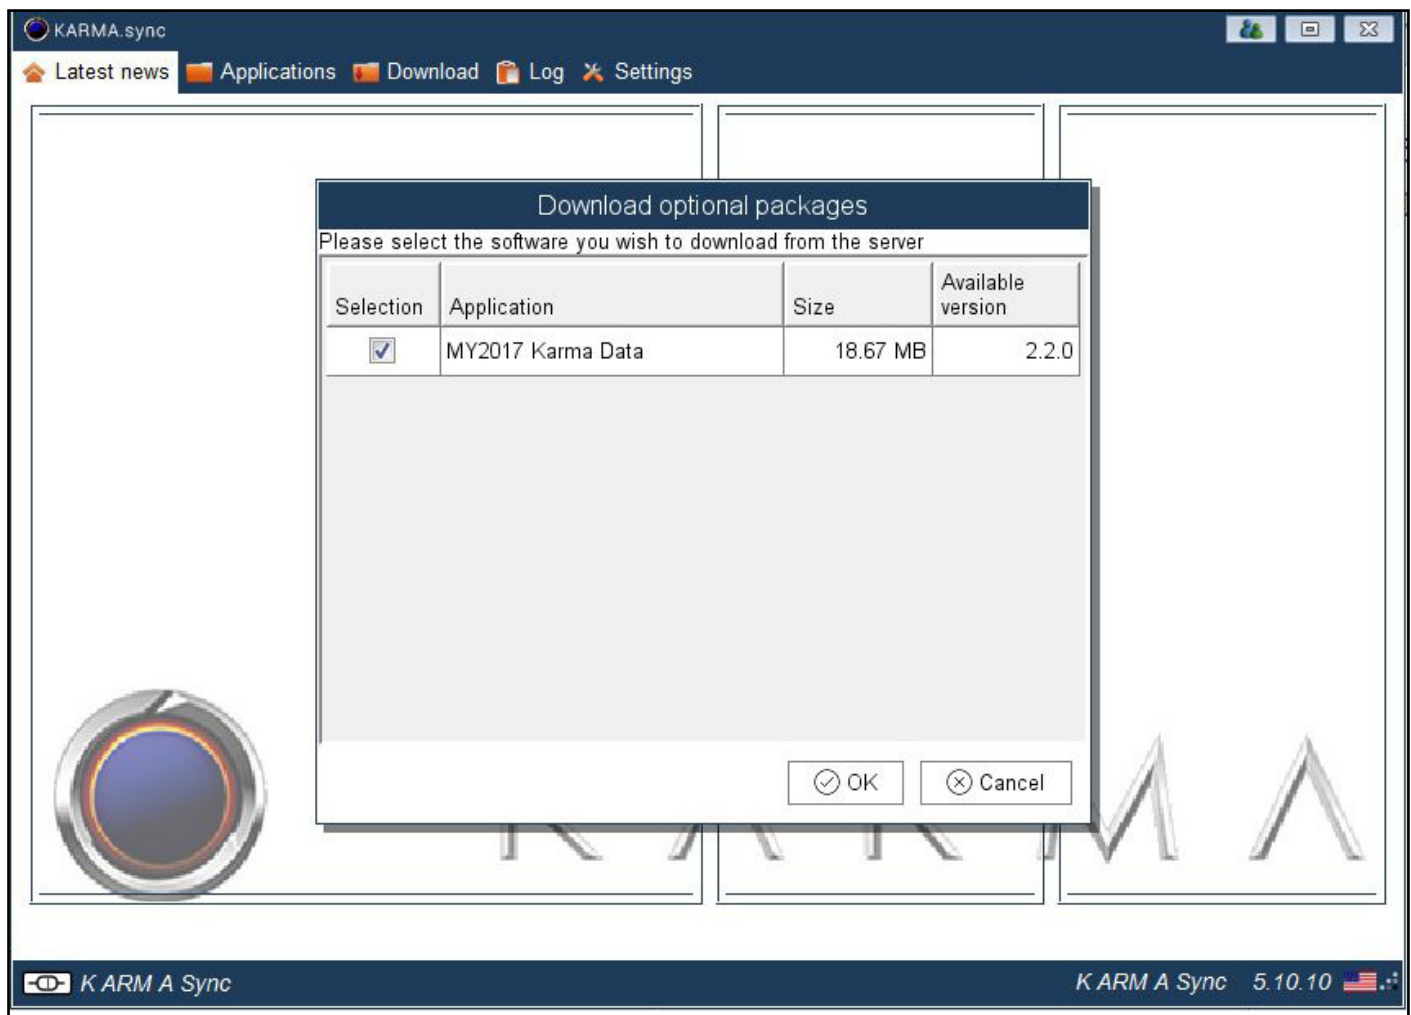
fig.7

6. Launch the Karma Sync application or close and relaunch if already open
Upon launch of the scan tool you may be prompted to enter user credentials
When a software update is available an update dialog box should appear with the new software package (fig.1). Configuration files version 1040.0.0 will load.

7. Click "Ok" to install. (fig. 7)

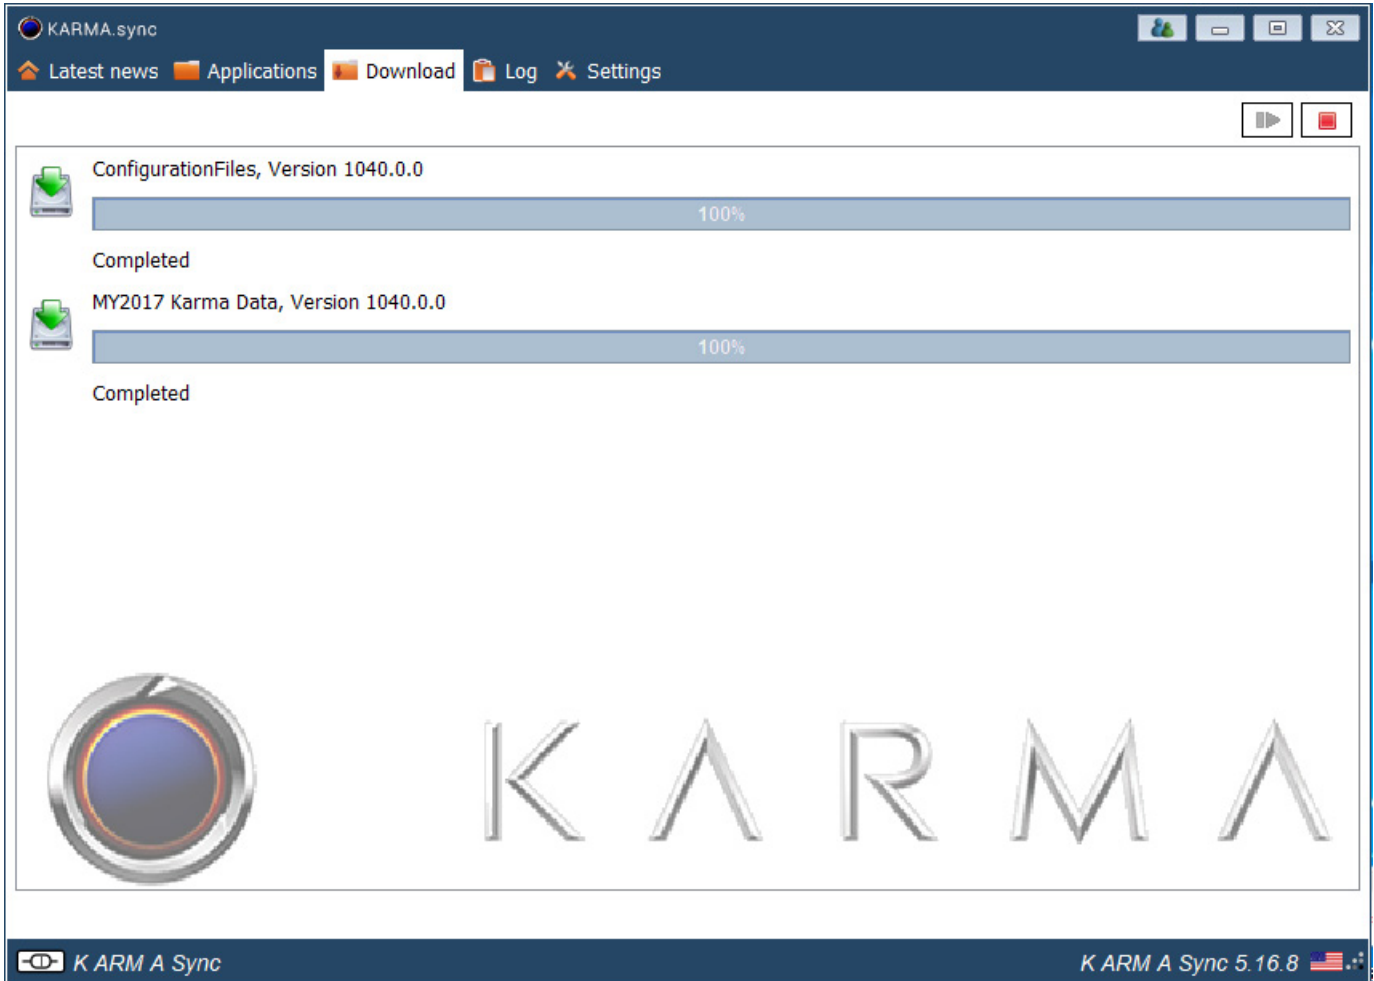
fig.7a

The package will then download (fig.7a).

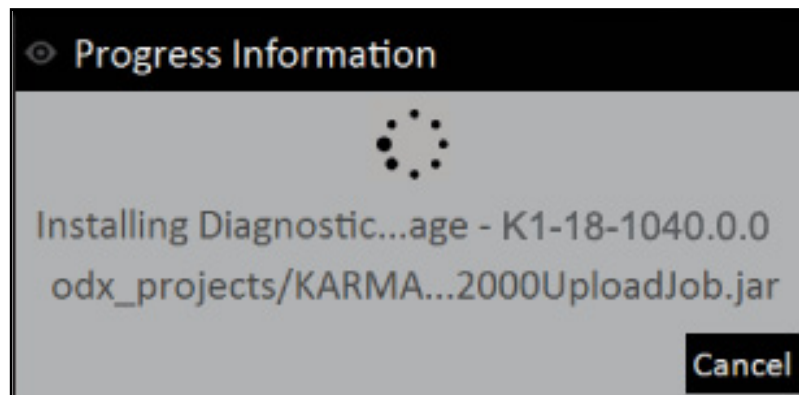
fig.9b

A progress screen will pop up after (fig.9b)

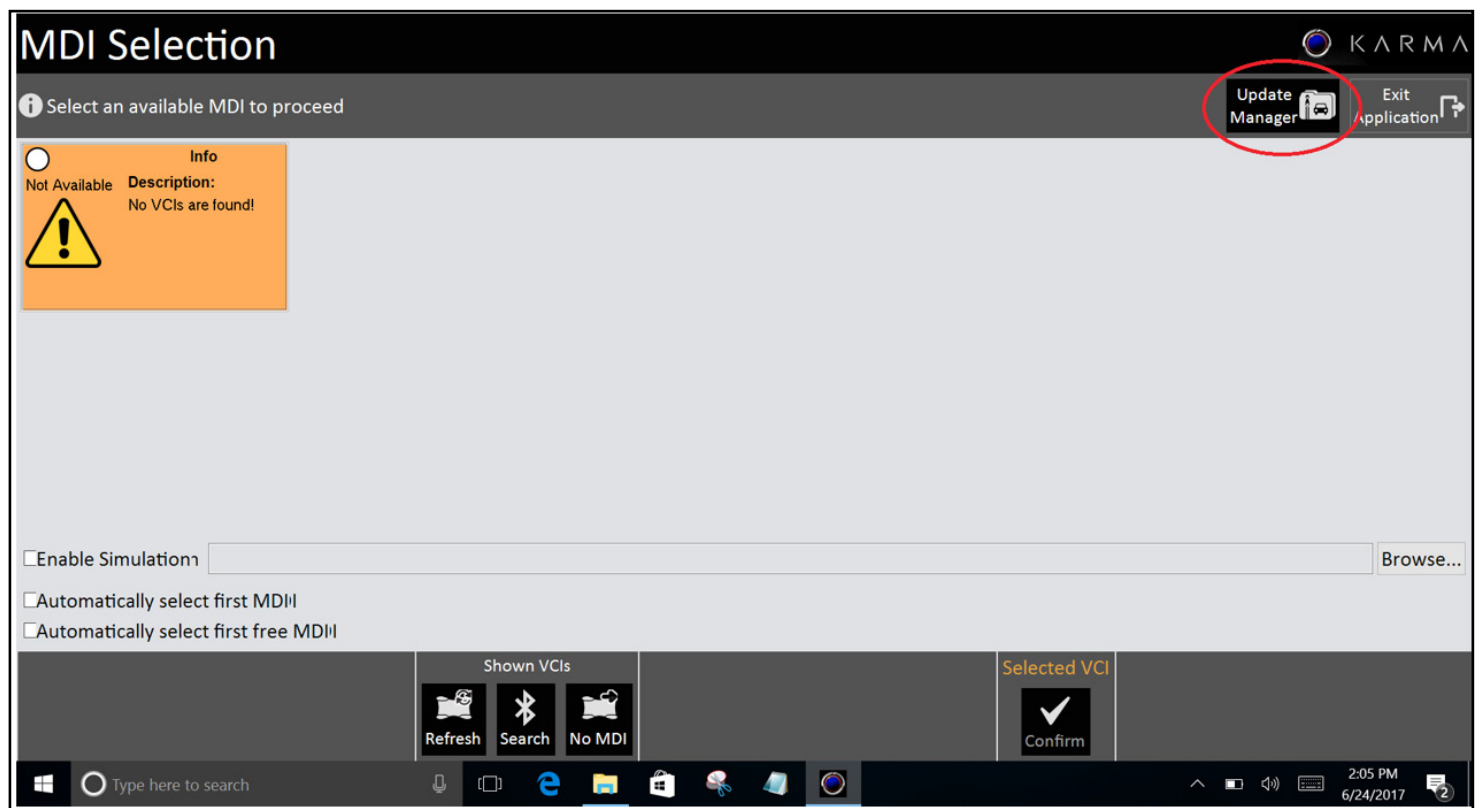
fig.10

9. Verify the package installed by clicking on update manager (fig.10)

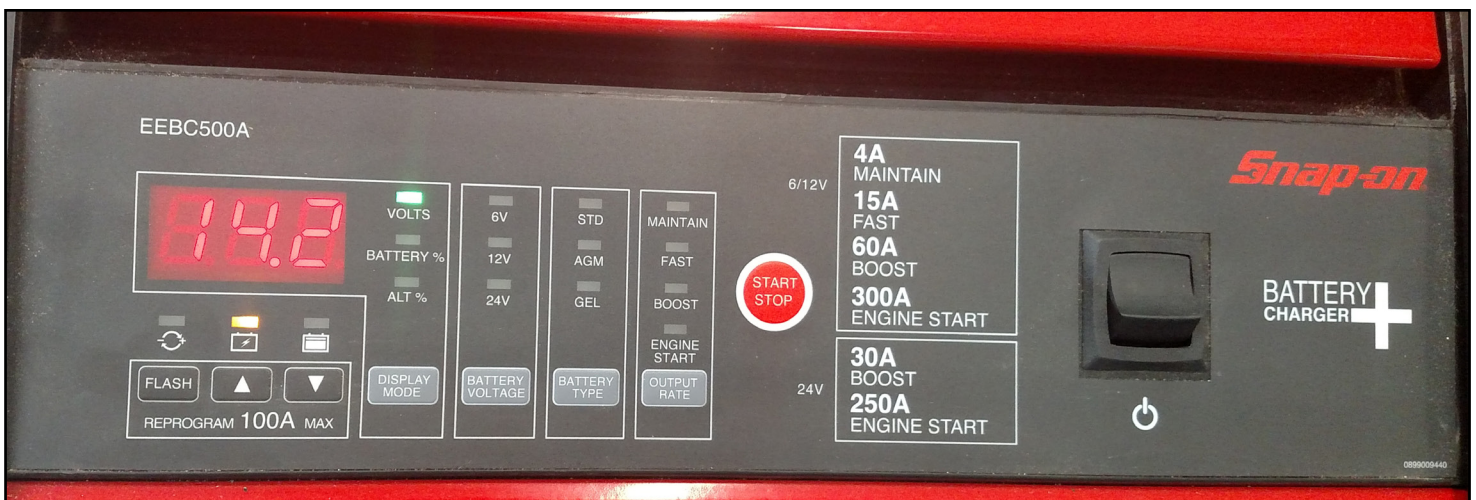
fig.12b

Below is an example of a suitable and recommended power supply (fig.12b)

Always flash vehicle with an external 12V battery charger active.

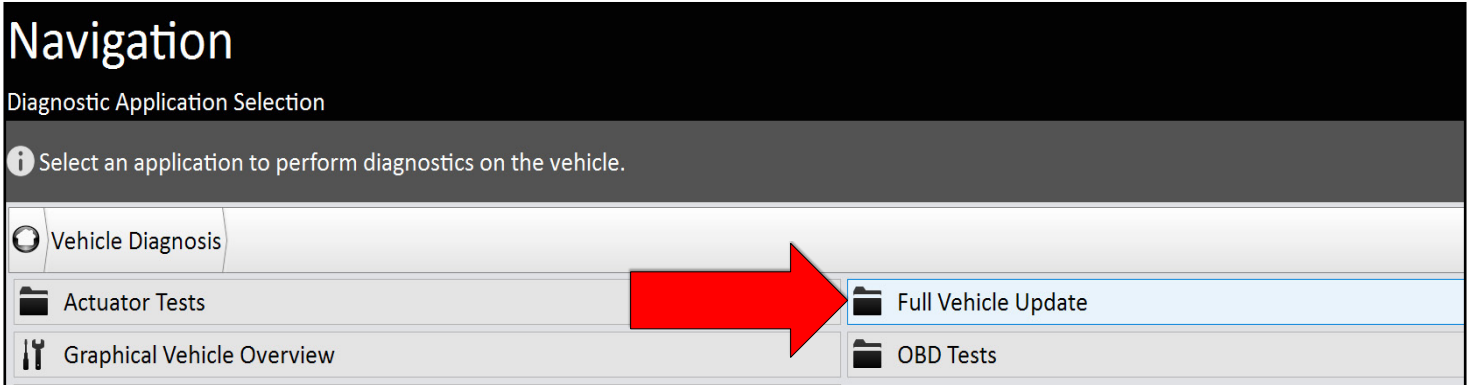
fig.13a

19. Return to the vehicle diagnosis menu and select full vehicle update as in (fig.13a) and select K1-18-1040.0.0 as shown below (fig.13b).

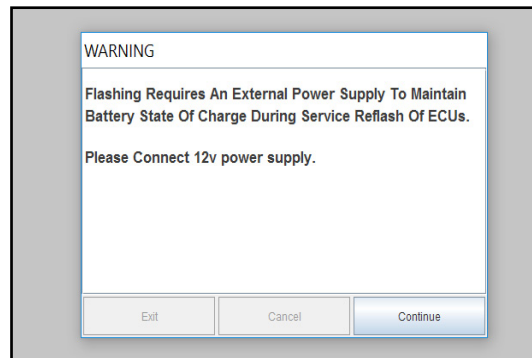
fig.14

20. Follow the prompts and make sure that a suitable 12V power supply is connected to the vehicle. Click continue (fig.14)

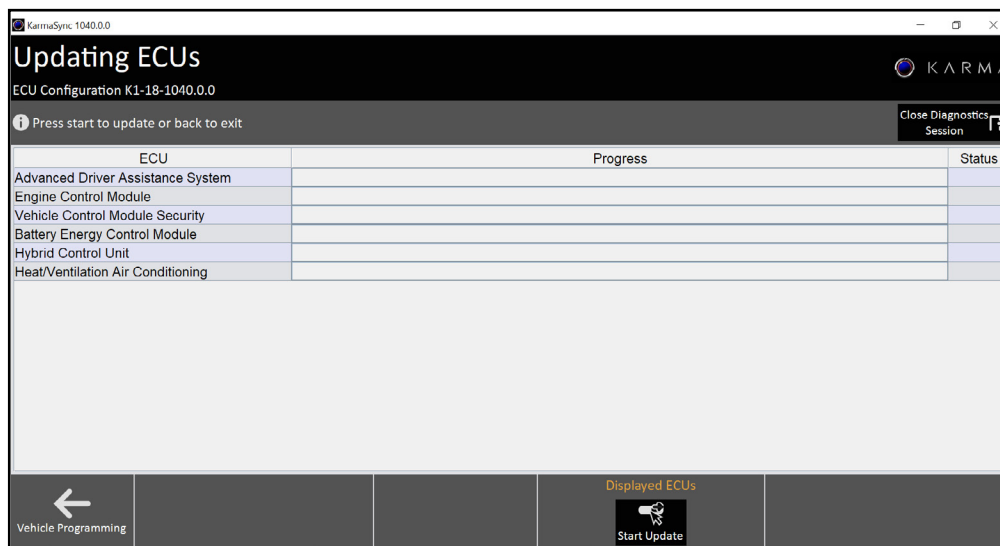
fig.15b

22. Click **START UPDATE**. The modules which will update are displayed, (fig.15b).

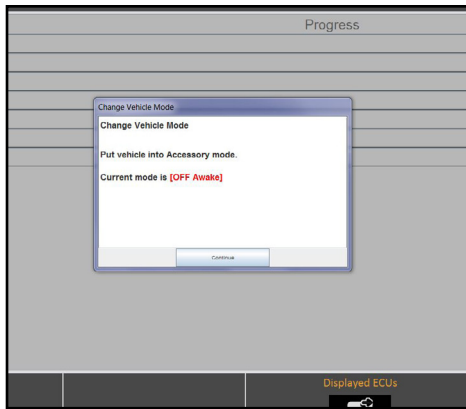
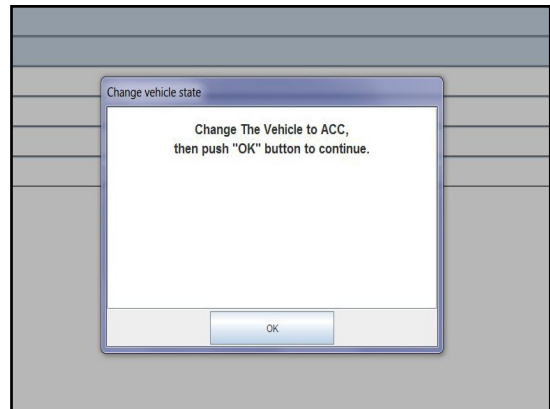
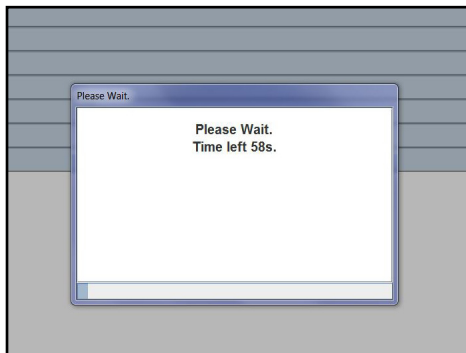
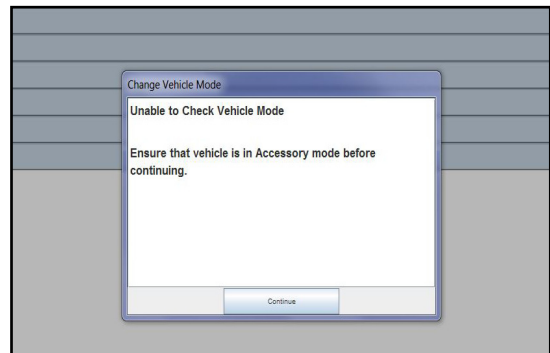
As instructed place vehicle in the requested mode (fig.16a). Do not walk away from the vehicle, as you will be prompted to switch modes.

23. Follow the prompts and place the vehicle into Accessory or Ready mode (fig.16). It is normal for the vehicle to appear to be 'stuck on' during this step of the programming. Follow the prompts and do as directed (fig 16a,16b,16c,16d).

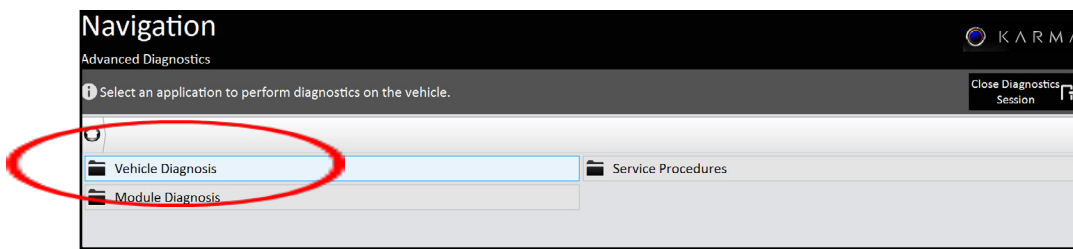
24. The update is complete with Karma Sync. Any codes need to be cleared in READY state. Ignore the pop-up of cycling state to ACCESSORY in Karma SYNC. Proceed to clear any DTC's present in the system. (fig.19a, 19b, 19c)

-If nothing is able to clear allow the vehicle to sleep for 10 minutes and make another attempt.

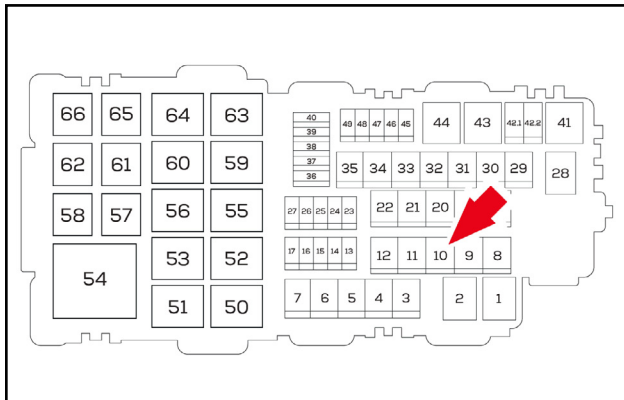
fig.21a

1. Open the fuse box under the hood (PDC) and remove fuse 10 (fig.21a, SPBC - solar panel boost controller)
2. Disconnect the main 12V ground disconnect (fig.21b)
3. Reconnect in reverse
4. Reconnect 12 volt main connector
5. Reinstall Fuse #10 for solar roof (SPBC)
6. Calibrate all windows
7. Calibrate the Parking Brake
8. Clear all DTC's
9. Verify all settings are correct: (Clock Time, Dimming and Light Levels, Seat Position, etc.)

NOTE: Do not install the solar fuse before connecting the main 12V ground as this will cause under voltage to the control units and may cause new concerns.
