# QUALITY ACTION

## CAMPAIGN BULLETIN ECM Reprogram Dealer Inventory

Reference: P8307  
Date: April 5, 2018

Affected Models/Years:	Affected Population:	Dealer Inventory:	SERVICE COMM Activation date:	Stop Sale In Effect
MY2018 Sentra (B17) SR and NISMO equipped with 1.6L engine	NA	1,013	April 5, 2018	<b>NO</b>

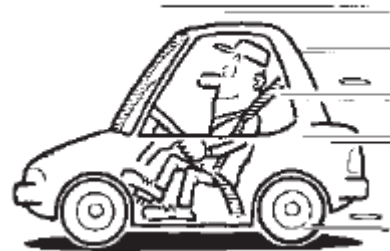
Figure A

- Most instructions for reprogramming with CONSULT-III plus (C-III plus) are displayed on the CONSULT PC screen.
- Take the vehicle for a 10 minute drive in order to meet the following Idle Air Volume Learn (IAVL) conditions:
  - Engine coolant temperature: 70 -100°C (158 -212°F)
  - Battery voltage: More than 12.9V (At idle)
  - Transmission: Warmed up
- After reprogramming is complete, you will be required to perform Throttle Valve Closed Position, Idle Air Volume Learn, Accelerator Closed Position, and DTC erase.
