09086 Version 2

2017 Ridgeline: Judder from the Torque Converter Lock-Up Clutch (Snapshot Required)

Supersedes 17-025, dated April 13, 2017, to revise the information highlighted in yellow

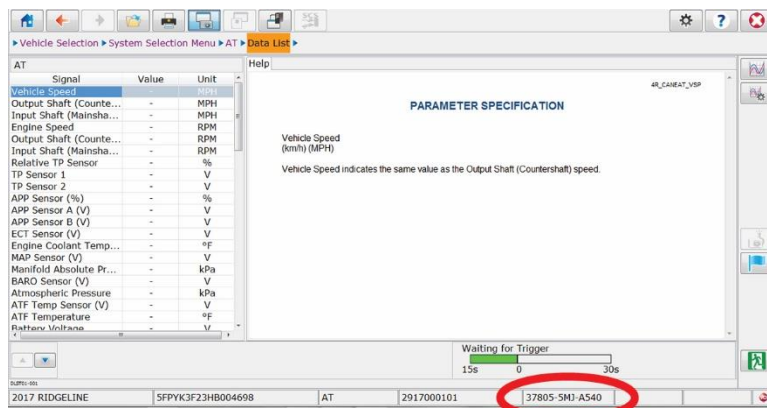
1. Connect the i-HDS, and go to the A/T Data List. Check to see if the software has been updated by comparing the program P/N against the table below.

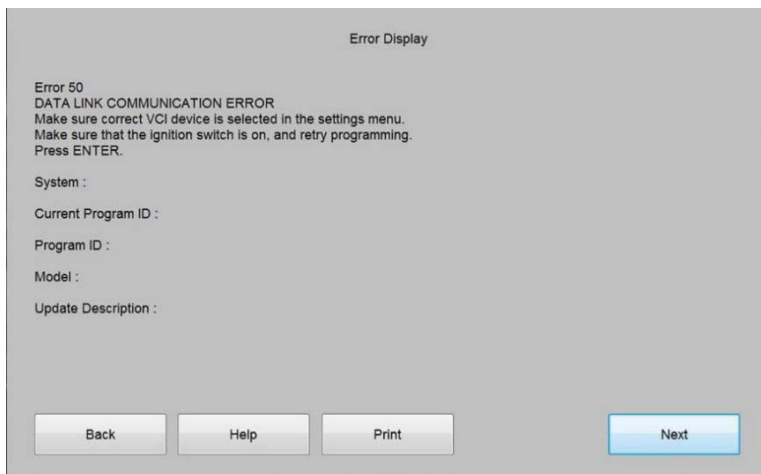
- You can't update the vehicle using the MVCI as a standalone tool.
- **Do not** use the MongoosePro VCI tool.
- Make sure the 12 volt battery is fully charged before starting an update.
- Connect a fully charged jumper battery to the vehicle and leave it connected during the entire procedure to maintain steady voltage.
- Never turn the ignition to OFF or ACCESSORY during the update. If there is a problem with the update, leave the ignition turned to ON.
- To prevent PCM damage, do not operate anything electrical (headlights, audio system, brakes, A/C, power windows, door locks, etc.) during the update.
- If you see the following Error Display, check that you are using the correct tool (MVCI or DST-i) with the i-HDS.

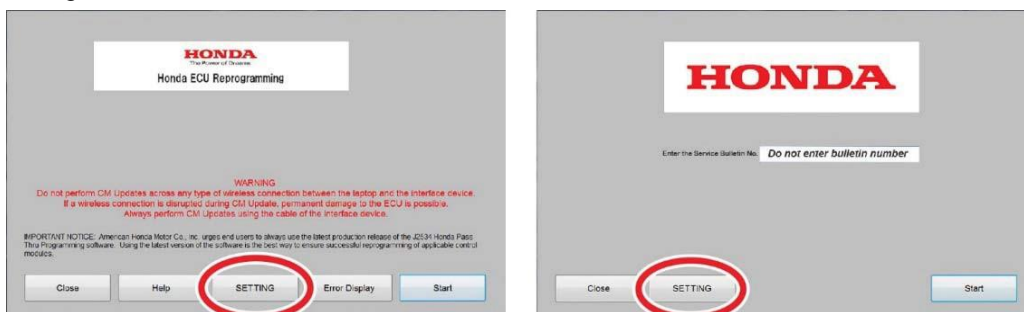
To change this, click on either of the SETTING selection buttons at the bottom of the J2534 initial screens as shown.

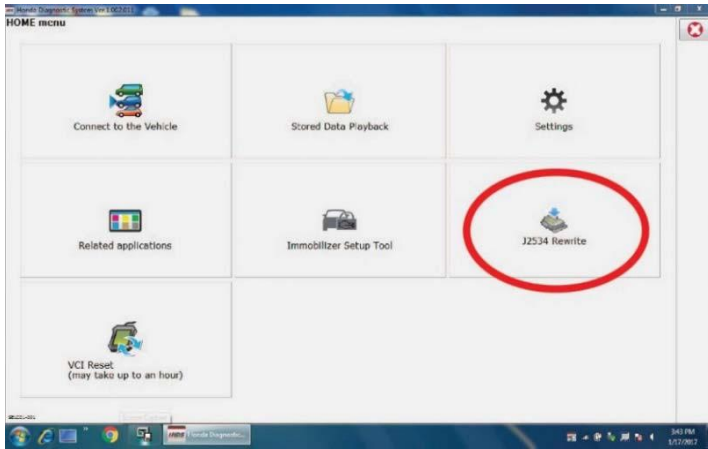
4. Select **J2534 Rewrite**.

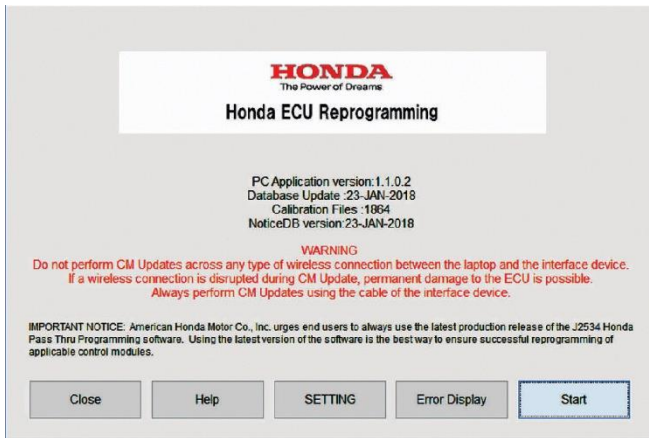
5. Confirm the software is the same **or later** as listed in SOFTWARE INFORMATION.

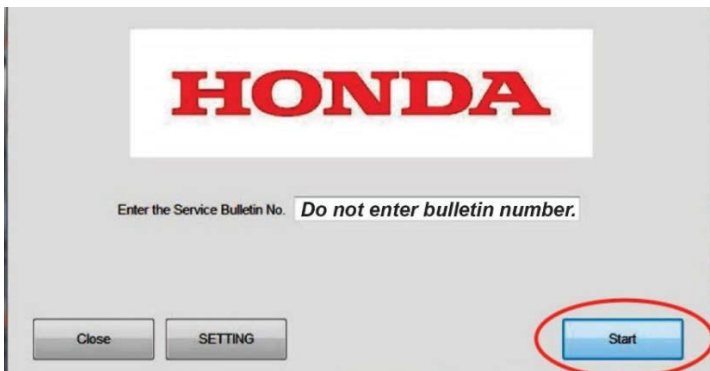
- **Don't enter a bulletin number.**
- If you receive a message that the vehicle has been already updated or that no update is available, check the transmission data list. The header should indicate one of the following numbers (or later).

37805-5MJ-A050	37805-5MJ-A550	37805-5MJ-A750
----------------	----------------	----------------

- If the program part numbers do not match those listed above, the i-HDS software needs to be reinstalled. Contact the Special Tools Hotline at **800-346-6327** for assistance.
