**Mack Model** LR , LEU , MRU , CHU , CXU , GU , TD

**Volvo Model** VNX , VNL , VNM , VHD , VAH

**Title** Fuel Injector Offset Learning Diagnostic Trouble Codes ( DTC ) / Fault Codes Logged In Engine Control Module ( EMS ); Possible Rough / Uneven Idle - **US14+OBD15 Emissions, Commonly Model Year 2016**

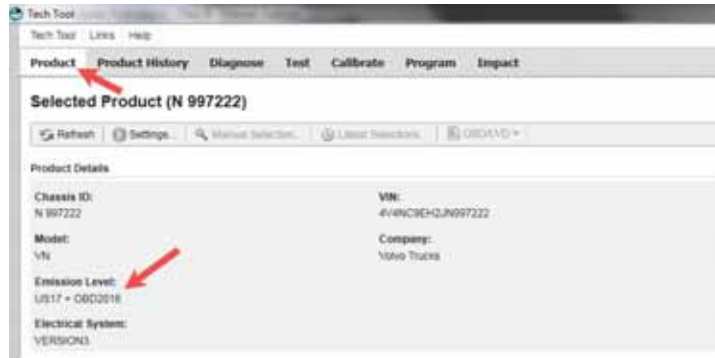
- Details can be found in the Product Details box on the Product tab in PTT as seen

below:
