SERVICE BULLETIN

Classification: EC13-007c	Reference: NTB13-054c	Date: May 11, 2018
------------------------------	--------------------------	-----------------------

ALTIMA AND ROGUE; ENGINE TURNS OFF OR HESITATES WHEN ACCELERATING FROM A STOP DURING HOT AMBIENT TEMPERATURES (+100° F)

APPLIED VEHICLES: 2013-2017 Altima Sedan (L33)
2014-2017 Rogue (T32)

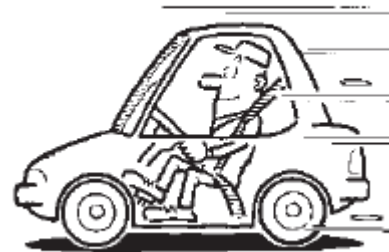
Figure A

- Take the vehicle for a 10 minute drive in order to meet the following Idle Air Volume Learn (IAVL) conditions:
 - Engine coolant temperature: 70 -100°C (158 -212°F)
 - Battery voltage: More than 12.9V (At idle)
 - Transmission: Warmed up
