Volvo Model VNX , VNL , VNM , VHD , VAH

Title Volvo Chassis - Telematics Gateway (TGW, MID 142) Communication Loss With Instrument Cluster (IC); "Volvo Link Hardware Failure Use Paper Log" Displayed In Driver Information Display; Counts Of Fault Code MID 140 PSID 239 FMI 12 Data Link, Volvo Link Possible Following Engine Start; TGW Possibly Missing From Product Information In Premium Tech Tool - **US10+OBD13 Through US17+OBD16 Emissions With TGW1 Or TGW2, Prior To 2018 Facelift ONLY**

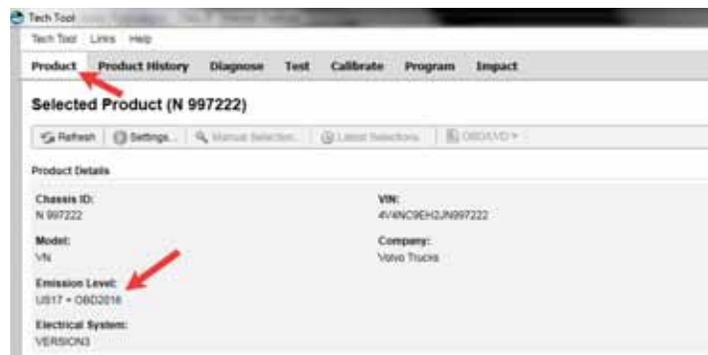
- Details can be found in the Product Details box on the Product tab in PTT as seen below:
