Lack of A/C Performance at Idle in High Ambient Temperature

YEAR(S)	MODEL(S)	ADDITIONAL INFORMATION
2015	Tacoma

Some 2015 model year Tacoma vehicles may exhibit a condition where the air conditioning system shuts down and stops blowing cool air during periods of extended engine idle with ambient temperatures greater than 100° Fahrenheit. Follow the procedure in this bulletin to address this condition.

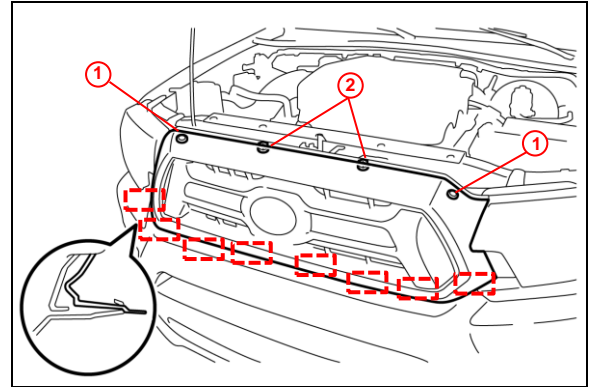
Figure 1.

4. Remove the radiator grille.
 - A. Disconnect and remove the battery.
 - B. Remove the two screws holding the grille in place.
 - C. Using a clip remover, remove the two clips.
 - D. Disengage the eight guides and remove the radiator grille.

1	Clip
2	Screw

Guide

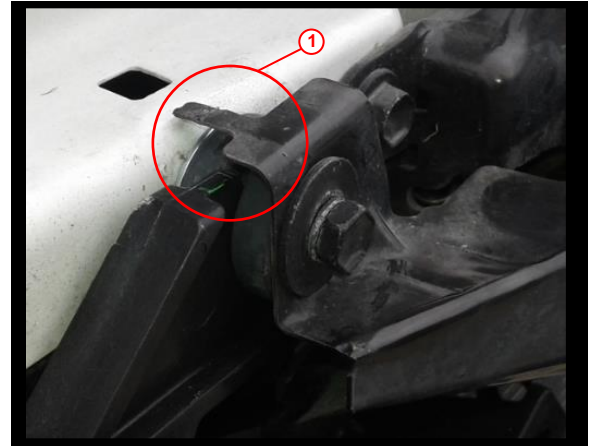
Figure 6.

- B. Bend the locating tab up for fan clearance.

1	Bend Here
----------	------------------

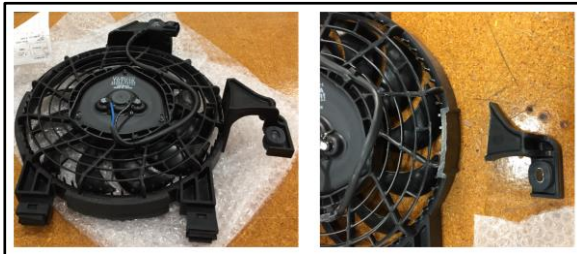
Figure 7.

- 7. Modify the additional condenser fan for the automatic transmission oil cooler.

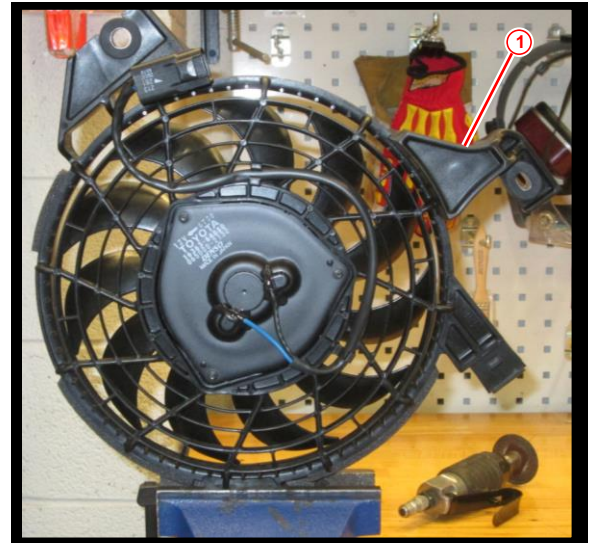
Figure 9.

8. Cut off the side bracket to eliminate interference with the automatic transmission cooler mount.
 - A. Gently hold the base mount of the condenser fan in a vise.

1	Side Bracket
----------	--------------

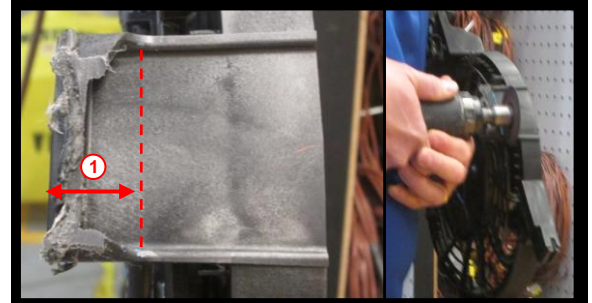
Figure 11.

- C. Measure 25 mm from the top of the mount and cut off the remaining portion.

1	25 mm
----------	--------------

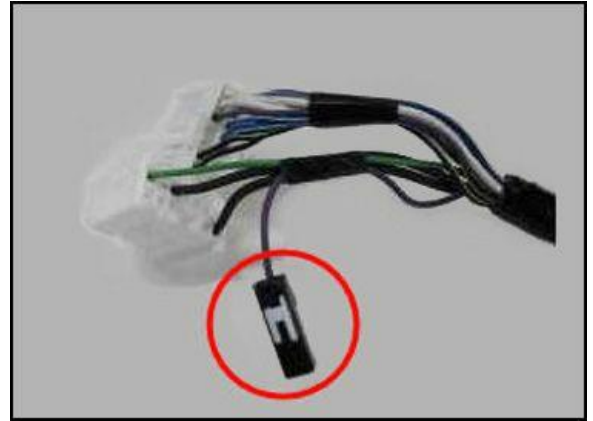
Figure 20.

15. Install the purple wire (that was removed from the EA1 connector in step 13) into the connector body that was removed from the sub-wire harness in step 14.

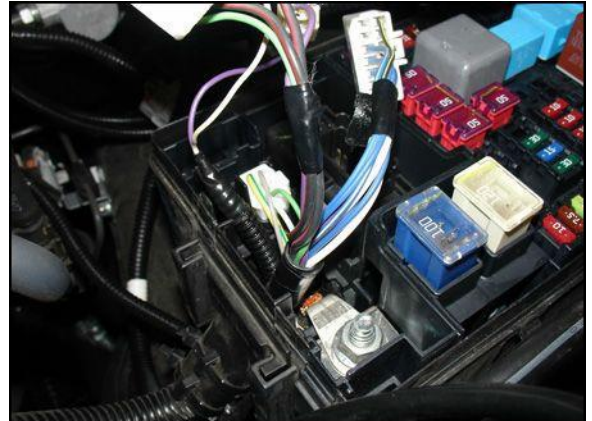
Figure 23.

18. Route the harness into the relay block and ensure that the wire harness is NOT pinched.

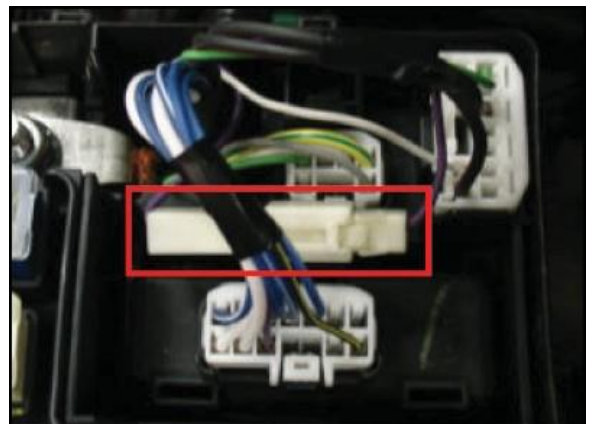
Figure 24.

19. Plug the connectors back into the relay block. The sub-wire connector will sit in the relay block between the connectors.

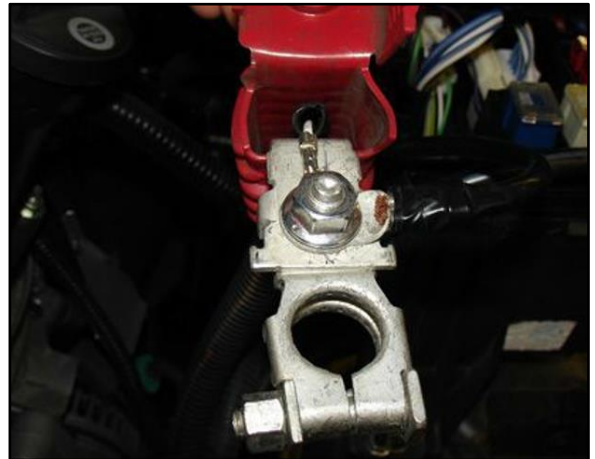
Figure 25.

20. Unscrew the nut from the stud bolt on the positive battery cable. Put the ring terminal from the sub-wire harness (white) onto the stud bolt. Tighten the nut.

Torque: 9.8 – 15.7 N*m
(103 – 159 kgf*cm, 7.5 – 11.5 ft*lb)

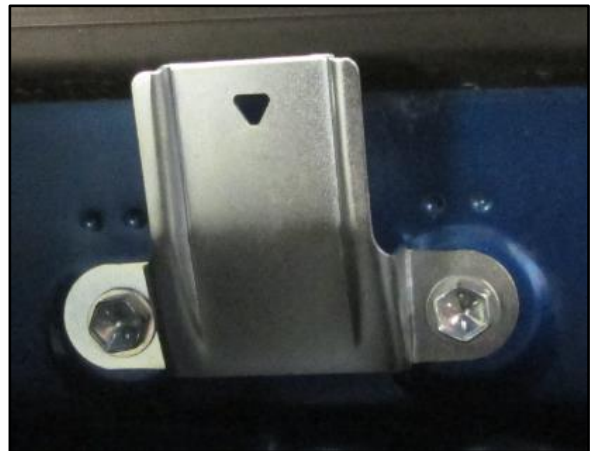
Figure 26.

21. Locate the bolt holes on the driver side inner fender. Attach the bracket included in the kit to the inner fender with the bolts included in the kit.

Torque: 9.8 – 18.1 N*m
(100 – 185 kgf*cm, 7.5 – 13ft*lb)

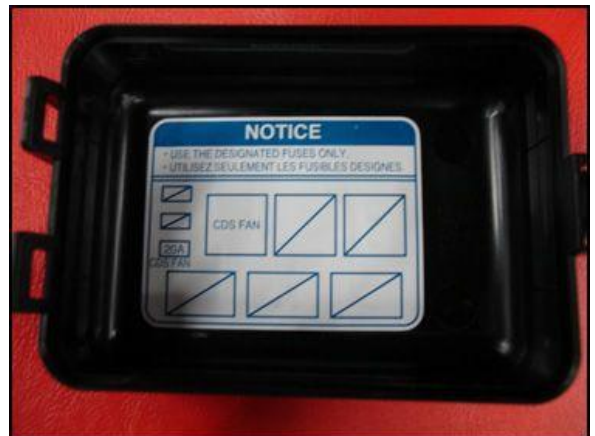
Figure 27.

22. Install the supplied notice label on the inside of the additional relay block relay cover.

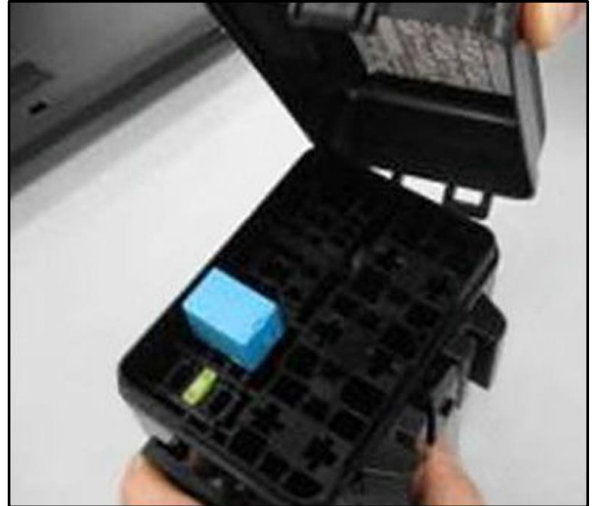
Figure 28.

23. Install the relay included in the kit into the CDS FAN location as indicated on the Notice label.

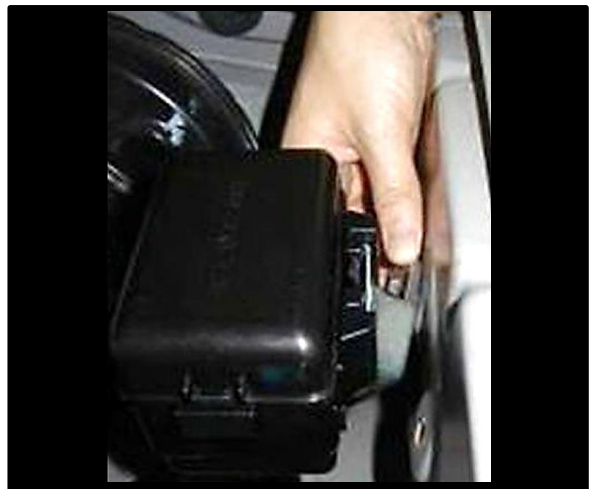
Figure 29.

24. Attach the relay block to the bracket installed in step 21.

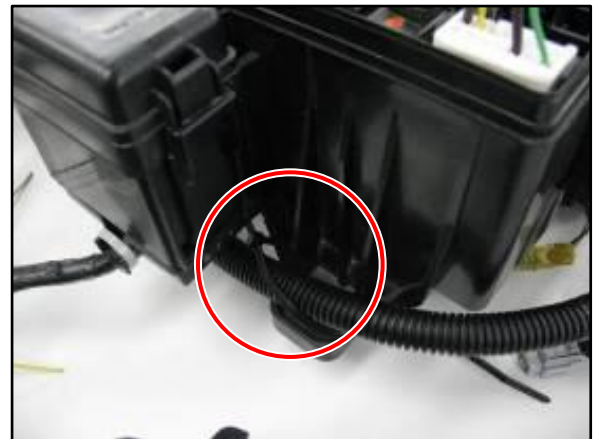
Figure 31.

26. Secure the sub-wire harness to the relay block as shown with a tie band and cut off the excess.

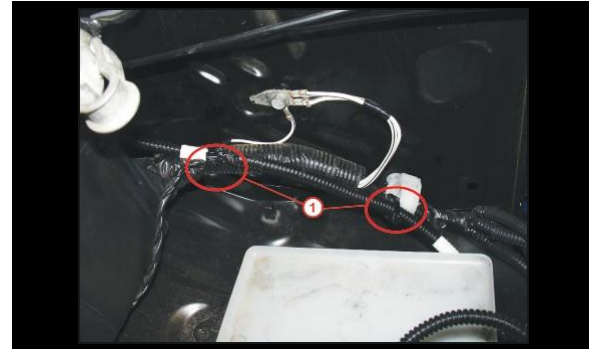
Figure 32.

27. Remove the ground terminal from the engine room main harness.
 - A. Attach the ring terminal from the sub-wire harness white wire.
 - B. Reinstall the ground terminal into the original position.

Torque: 7 – 9.8 N*m
(71 – 100 kgf*cm, 5 – 7.2 ft*lbf)
 - C. Attach the sub-wire harness to the engine harness with the tie bands as indicated and cut off the excess.

1	Tie Band
----------	-----------------

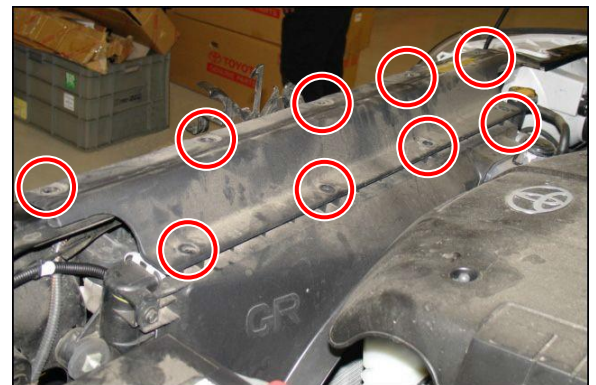
Figure 33.

28. Remove the radiator support shroud by disengaging the nine clips.

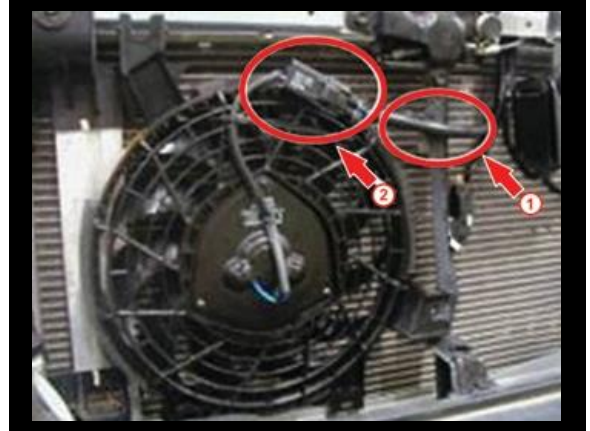
Figure 35.

30. Connect the sub-wire harness connector to the cooling fan added from the kit and attached the sub-wire harness with a tie band to the hood lock support brace and cut off the excess.

1	Tie Band
2	Connector

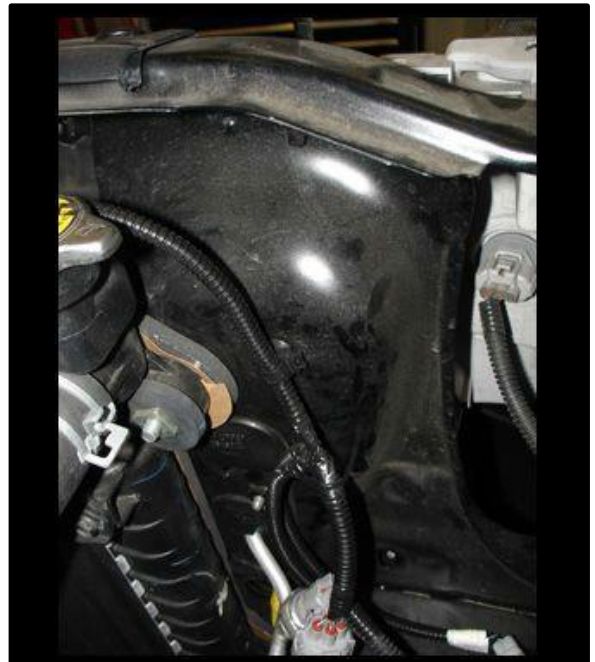
Figure 36.

31. Attach the sub-wire harness as shown.

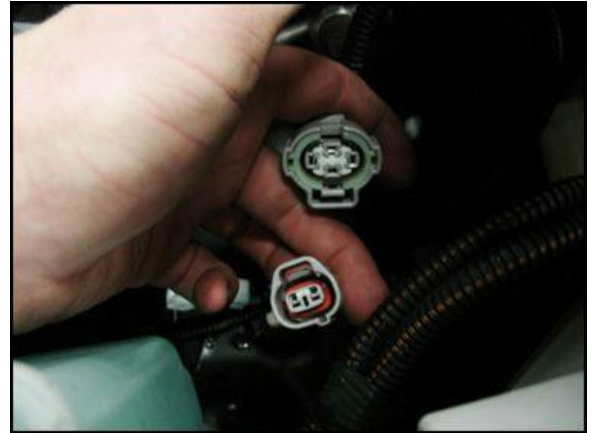
Figure 37.

33. Connect the vehicle 2 pin connector to the sub-wire harness 2 pin connector. Connect the sub-wire 4 pin connector to the 4 pin pressure switch installed in step 32.

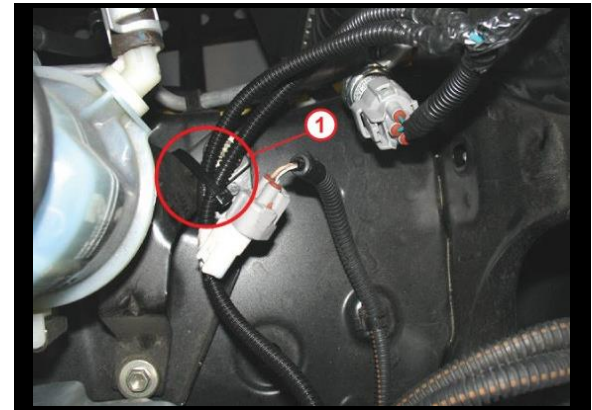
Figure 38.

34. Attach the sub-wire harness to the leg of the bracket under the power steering reservoir tank with a tie band and cut off excess.

1	Tie Band
----------	----------

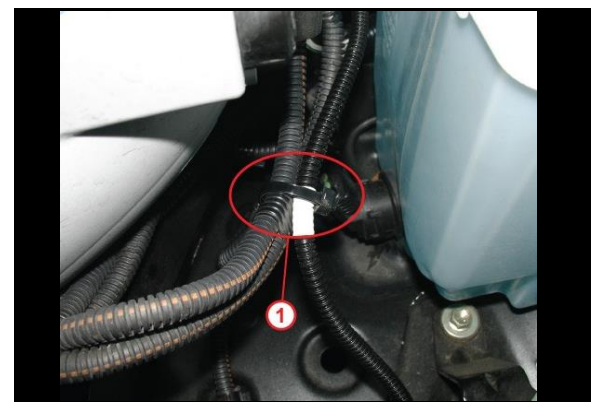
Figure 39.

35. Attach the sub-wire harness to the engine wire harness in front of the windshield washer reservoir with a tie band and cut off the excess.

1	Tie Band
----------	----------

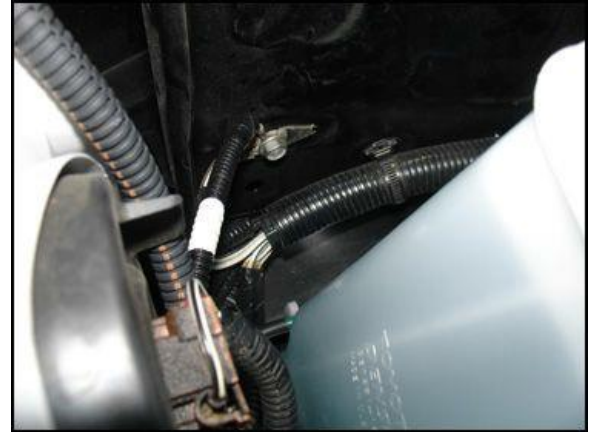
Figure 40.

36. Remove the windshield washer reservoir and attach the sub-wire harness ground terminal to the ground point behind the reservoir.

Torque: 7 – 9.8 N*m

(70 – 100 kgf*cm, 5 – 7.2 ft*lbf)

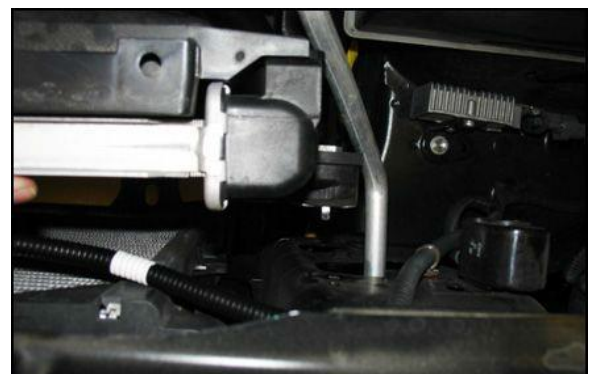
Figure 42.

41. Lift up and push back on the radiator, releasing the hooks holding it in place.

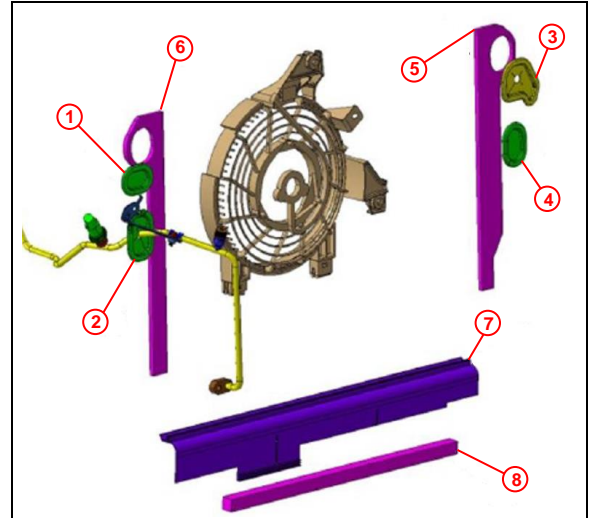
Figure 43.

42. Install the eight radiator core support body plugs and seals included in the kit.

1	Body Plug, Upper RH
2	Body Plug, Lower RH
3	Body Plug, Upper LH
4	Body Plug, Lower LH
5	Radiator Seal, LH
6	Radiator Seal, RH
7	Lower Radiator Seal
8	Skid Plate Seal

- B. Reinstall the four radiator support bolts.
- C. Install the NEW body plugs included in the kit in the indicated locations. Reference step 42 for location positions.

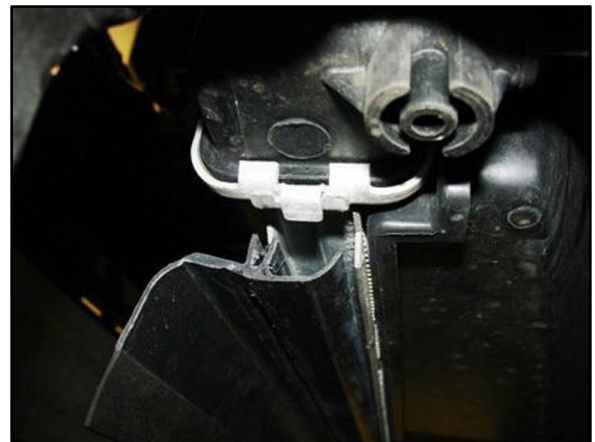
Figure 47.

- E. Install the lower radiator seal as shown.

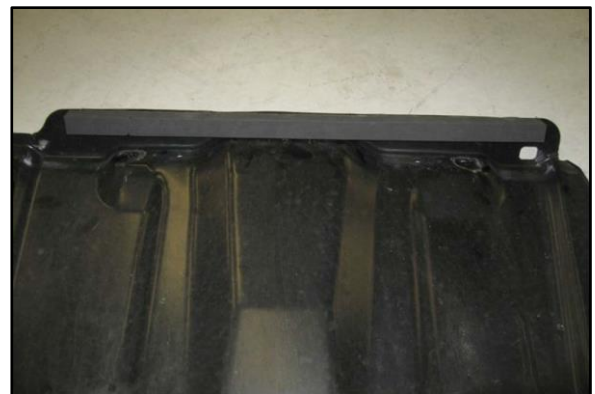
Figure 48.

- F. Install the skid plate seal included in the kit in the position as shown.
