**Service Solution Title** - SS - 1033412 Eagle Dash Cruise Icon Missing

**Applicable Vehicles** - Certain R.E.V. Eagle chassis with the Viper II instrument panel and multiplex chassis wiring.

## Medallion Instrument Panel Software Update to 5.1.4\_D

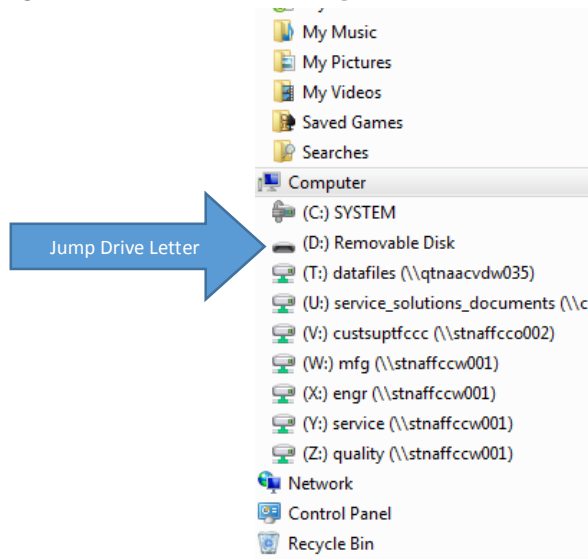
Fig. 1, Drive Letter Assigned to the Flash Drive

1. Install the correct flash drive in an open port on the laptop. Make a note of the drive letter that flash drive was assigned (A:, B:, C:, etc.). See [Fig. 1](#).

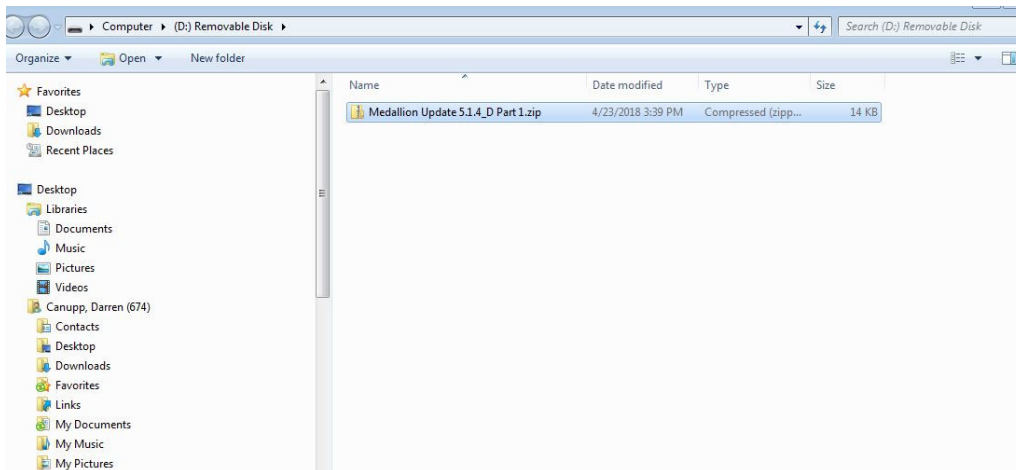
**Fig. 6, Downloaded Zip File is on Flash drive (D:) In this example.**

6. When the download is complete, select "Open Folder" at the bottom of the screen and verify that it was downloaded to the flash drive. [See Fig. 6](#). In this example, "Medallion Update to 5.1.4\_D Part 1" was downloaded on the flash drive marked in drive D: on the laptop.

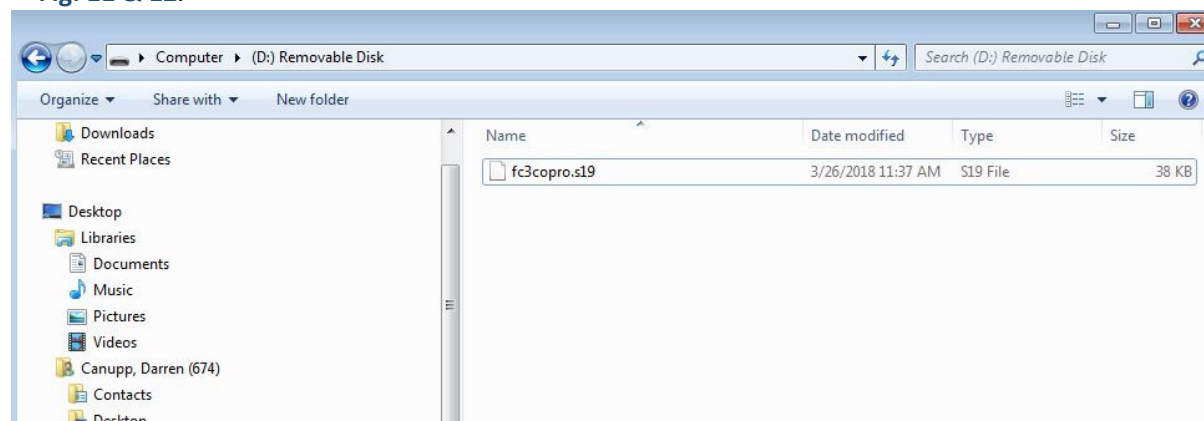
**Fig. 11, This should be the only file on the drive for part 1**

11. Delete the two Medallion folders shown in **Fig. 10**. Only the file(s) should be left on the drive. See **Fig. 11 & 12**.

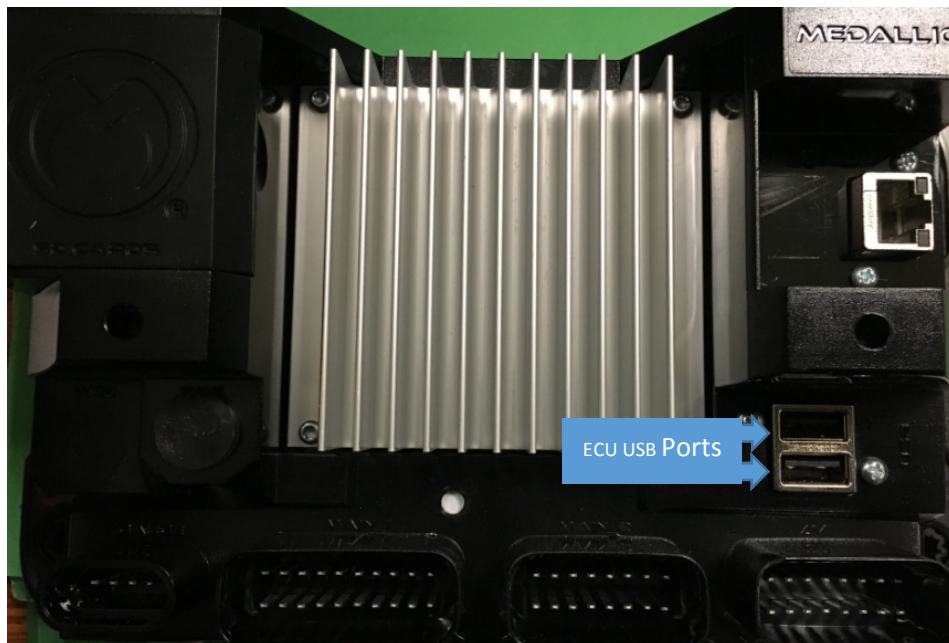
**Fig. 13, Instrument panel ECU USB port locations**

NOTE: Each chassis should be equipped with a USB extension cable that should be routed from the ECU to the diagnostic connector by the body builder. If a USB cable is not installed, locate the ECU and plug the flash drive directly into either USB port on the ECU. See [Fig. 13](#)

Note: The instrument panel ECU is located behind the dash. The top cover of the dash will pop up; tools are not needed to access the ECU.

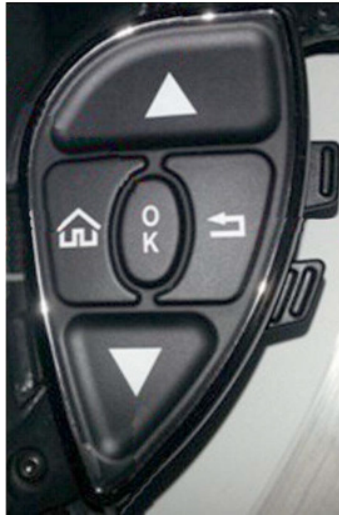
**Fig. 14, Menu Navigation Buttons**

5. Use the menu navigation buttons on the right-hand side of the steering wheel to access the menu options. See [Fig. 14](#).

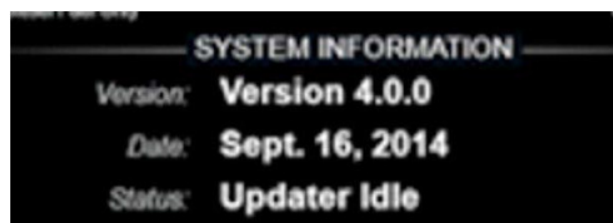
**Fig. 16, System Information**

6. Press the home button, then press the down arrow and select "Diagnostics".
7. After selecting "Diagnostics," use the down arrow again and select "System Information," shown in Fig. 15, then press the OK button. System information will display in the center of the instrument panel. See Fig. 16 for an example of the system information.

8. When "System Information" is displayed as shown in Fig. 14, and the correct flash drive plugged into the cable or either of the two ECU USB ports. Press and hold the OK button until the ECU begins the software update. Once the software update begins, release the OK button.
