Engine Control Module (ECM) and  
Aftertreatment Control Module (ACM),  
Reprogramming  
CHU, CXU, GU, LEU, MRU, TD, LR

## **FSB 284-064 Engine Control Module (ECM) and Aftertreatment Control Module (ACM), Reprogramming**

Software updates with enhancements are available for the engine control module (ECM) and aftertreatment control module (ACM) for MACK MP7, MP8 and MP10 engines on OBD2015 vehicles built from January 1, 2015 to December 31, 2015.

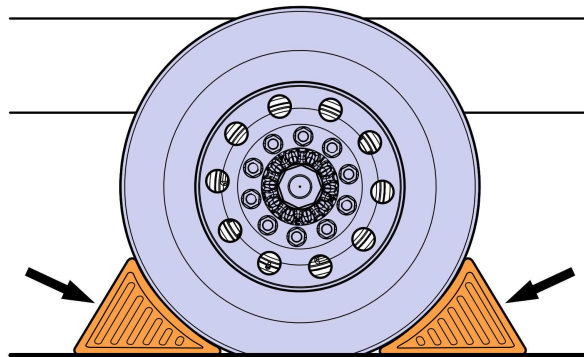
W7086748

- 1 Park the vehicle on a level surface.
- 2 Apply the parking brake.
- 3 Place the transmission in neutral or park.
- 4 Install the wheel chocks.

- 5 Connect Premium Tech Tool (PTT) to the vehicle diagnostics connector using the 16 pin OBD cable 88890304 and Communication Interface 88890300. Connect the PC to a functional LAN or modem connection and a 120 Volt AC source.

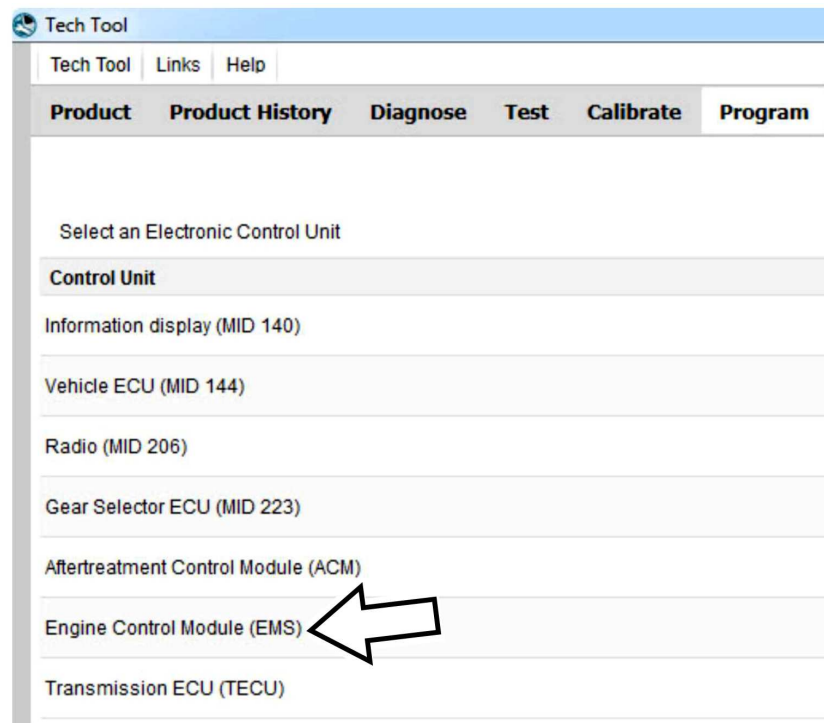
W2115479

10 Select **Engine Control Module (EMS)**.

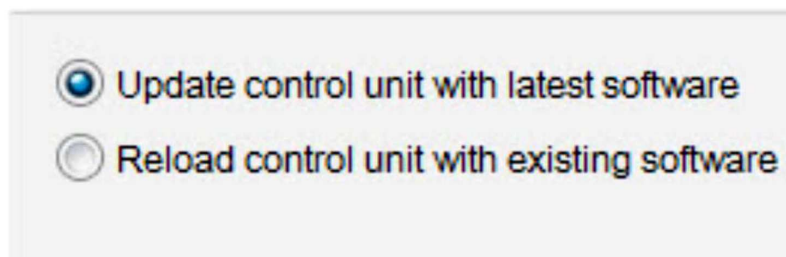
W2115480

11 Select Program to update the **ECM** with the latest software.

## Programming options

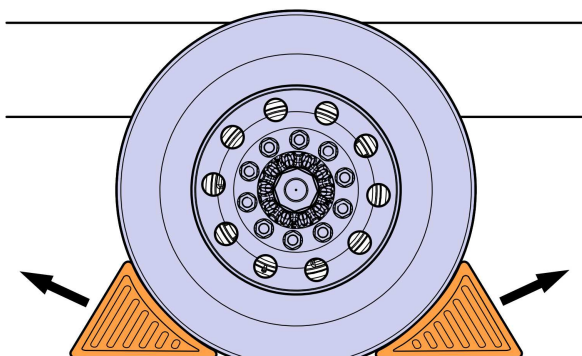
W7086759

- 14 When programming is complete, click Exit to return to Main Menu to program the ACM.
- 15 When all programming is complete, clear any diagnostic trouble codes (DTC) and Finish Work.
- 16 Remove the wheel chocks.
