## **FSB 284-065, Engine Control Module (ECM) and Aftertreatment Control Module (ACM), Reprogramming**

(June 2018)

Software updates with enhancements are available for the engine control module (ECM) and aftertreatment control module (ACM) for MACK MP7, MP8 and MP10 engines on OBD2016 vehicles built from January 1, 2016 to December 31, 2016.

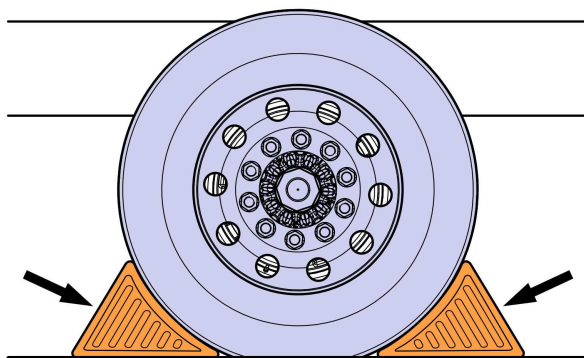
W7086748

- 1 Park the vehicle on a level surface.
- 2 Apply the parking brake.
- 3 Place the transmission in neutral or park.
- 4 Install the wheel chocks.

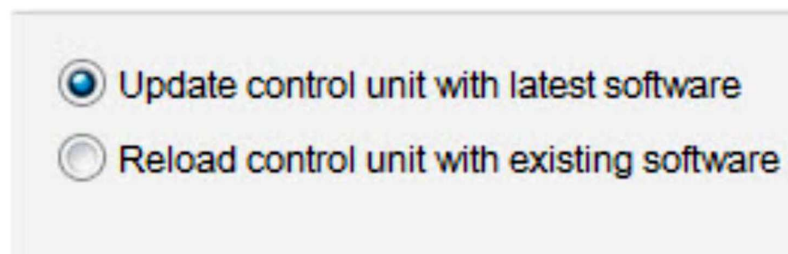
W2115480

11 Select Program to update the **ECM** with the latest software.

## Programming options

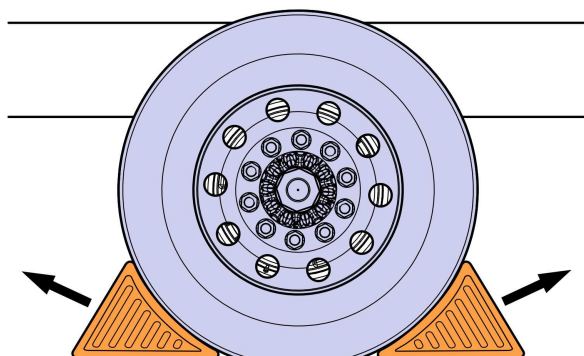
W7086759

- 14 When programming is complete, click Exit to return to Main Menu to program the ACM.
- 15 When all programming is complete, clear any diagnostic trouble codes (DTC) and Finish Work.
- 16 Remove the wheel chocks.
