GROUP CAMPAIGN	NUMBER 18-01-002-2
DATE JUNE, 2018	MODEL(S) SONATA HYBRID (LF HEV) SONATA PLUG-IN HYBRID (LF PHEV)

SUBJECT: 2017 SONATA HYBRID/PLUG-IN HYBRID NAVIGATION SOFTWARE UPDATE (SERVICE CAMPAIGN T2S)

Description: This bulletin describes the procedure for updating the Navigation System Software for 2017 Model Year Sonata Hybrid and Plug-In Hybrid vehicles. This update allows for the driving information to be updated in the Electric Motor Use chart. The software update will take approximately 35 minutes to complete.

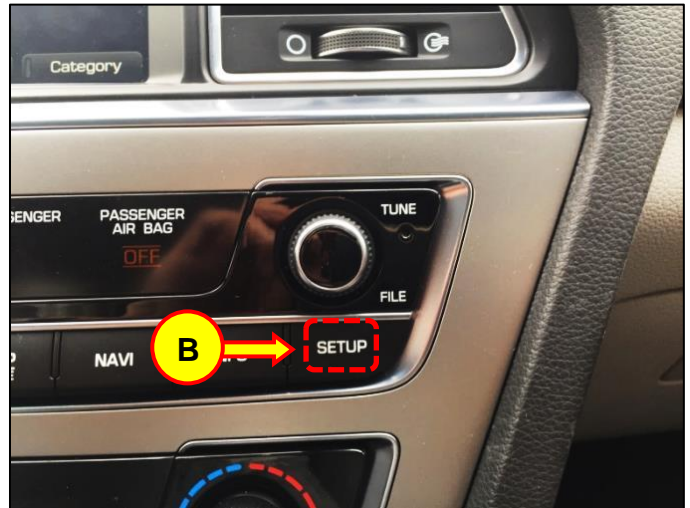
2. Press the 'SETUP' button (B) to enter the Setup menu.

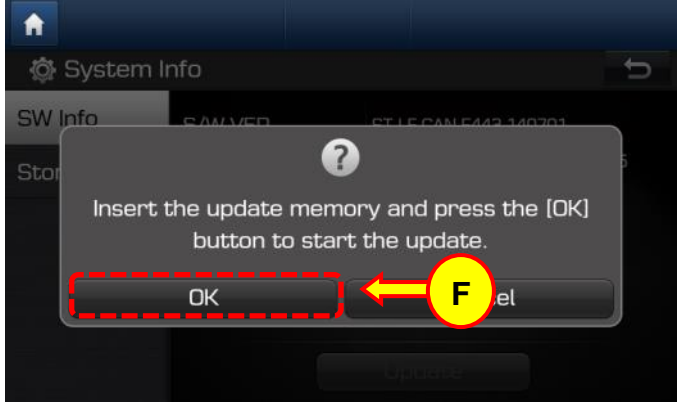
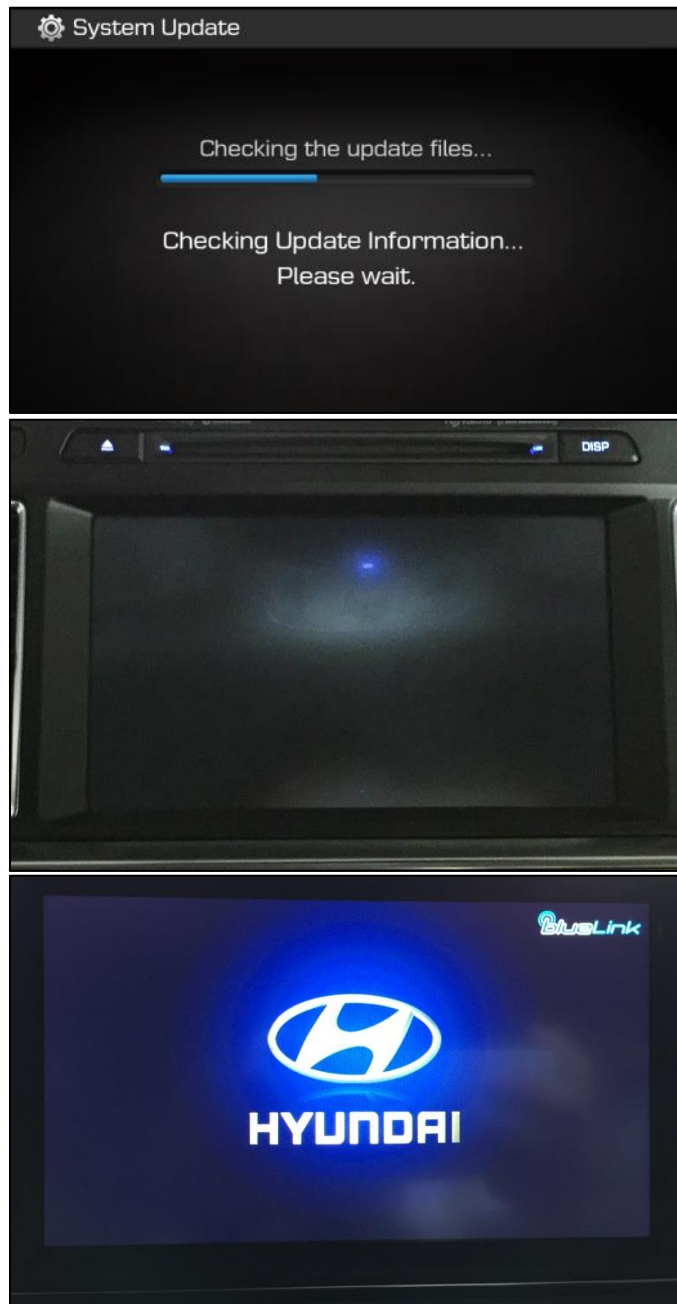
The software will automatically update through 6 steps:

0. Checking the update files
1. Copying Files (1/6)
2. a. Preparing System Update (2/6) *(System automatically reboots twice during this step. Blank screen will momentarily appear.)*
b. Updating the System
3. Updating Modem (3/6)
4. Updating GPS (4/6)
5. Updating Sub Micom (5/6)
6. Updating Main Micom (6/6)

It will take approximately 35 minutes to complete the update process.

There will be multiple occurrences where the Hyundai logo will appear or display will be black during the update process. This is normal.

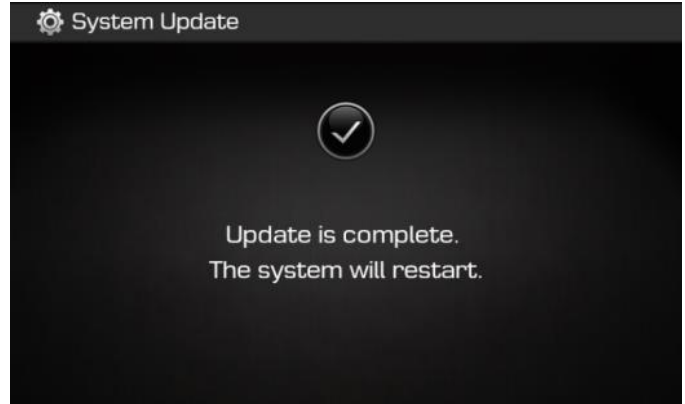
8. The system will reboot automatically after the “Update is complete” message appears.

The software update is completed after the system reboots and the Disclaimer or the Home screen is displayed.

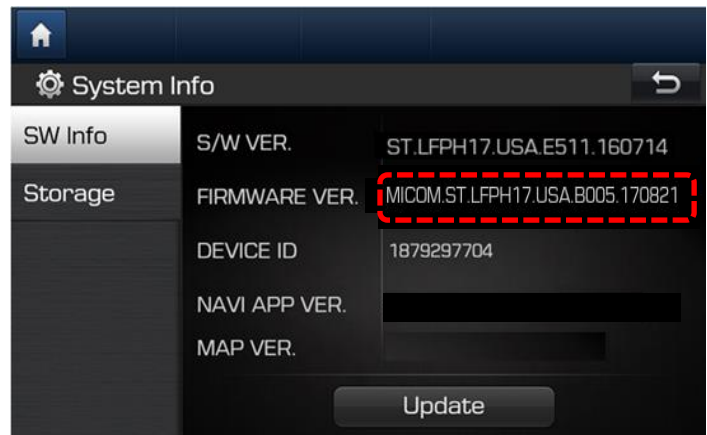
10. Remove the S/W Update SD Card from the slot and insert your original Map DB SD Card. The system will reboot automatically.

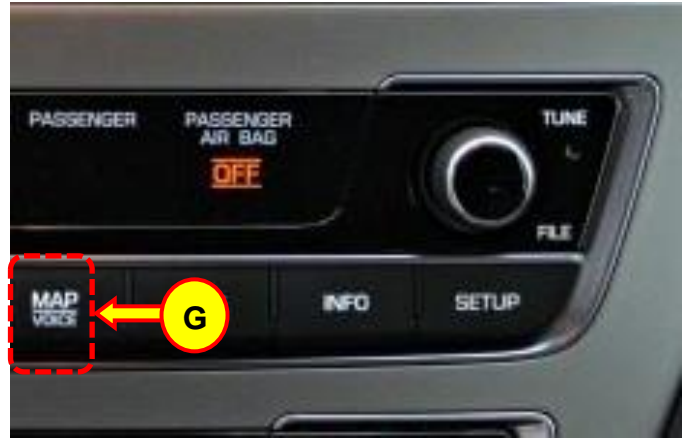
11. Once the system has rebooted, confirm that the Navigation map populates. Press the MAP button (G).
