# Technical Service Bulletin

SUBJECT:		No: <b>TSB-18-13-001</b>	
<b>MIL ILLUMINATION WITH DTC P0068</b>		DATE: <b>June 2018</b>	
		MODEL: <b>2018 Eclipse Cross</b>	
CIRCULATE TO:	<input type="checkbox"/> GENERAL MANAGER	<input checked="" type="checkbox"/> PARTS MANAGER	<input checked="" type="checkbox"/> TECHNICIAN
<input checked="" type="checkbox"/> SERVICE ADVISOR	<input checked="" type="checkbox"/> SERVICE MANAGER	<input checked="" type="checkbox"/> WARRANTY PROCESSOR	<input type="checkbox"/> SALES MANAGER

On certain vehicles, a MIL may illuminate with DTC P0068, and vehicle speed is restricted to a maximum of 62 mph (100 km/h).

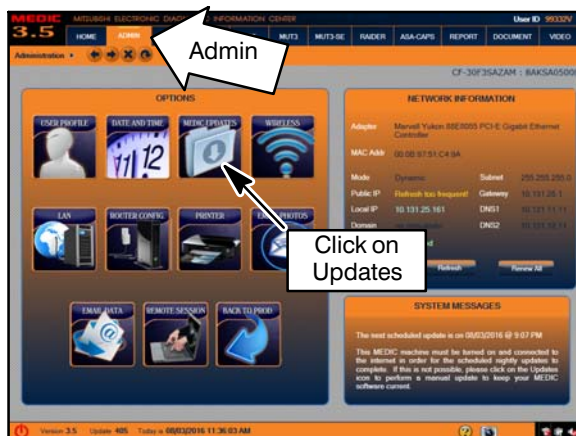
3. Select the MEDIC 3.5/4 Admin tab and click on "Updates."

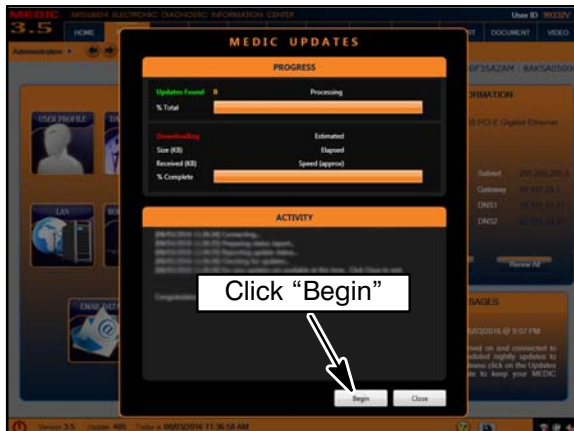
4. IF the MEDIC update screen advises updates are available, click the "Begin" button. After all updates are complete, **GO TO THE REPROGRAMMING PROCEDURE.**

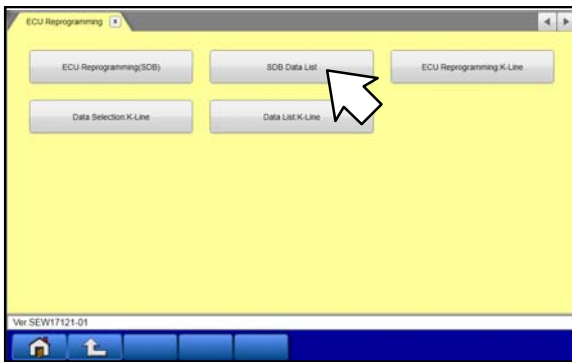
c. Click “SDB Data List.”

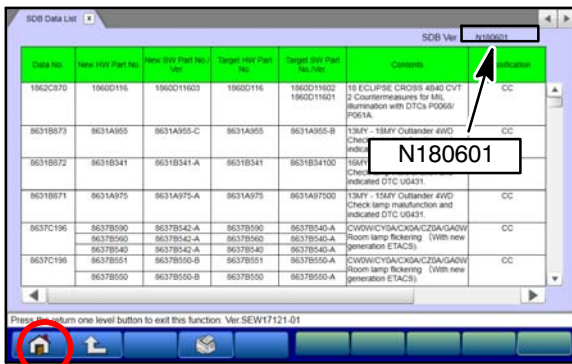
d. Confirm that the database number displayed in the upper right above the chart is **N180601** or higher

- If the database number displayed on your MUT3-SE is N180601 or greater, continue to the next section.
- If the reprogramming database number displayed on your MUT3-SE is **lower** than **N180601**, then the MUT3-SE database needs to be updated.

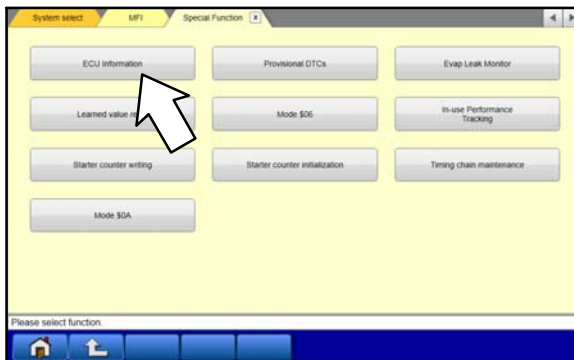
- c. Select “ECU Information.”

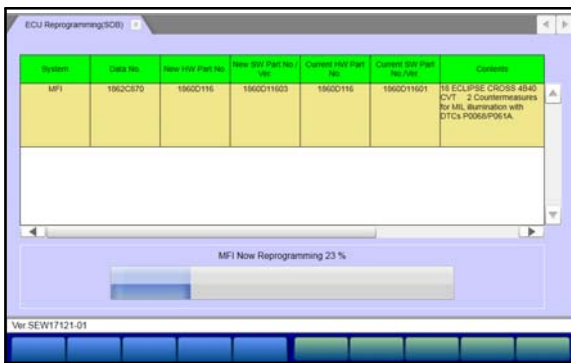
g. Once the reprogramming is initiated, the screen shown will indicate the reprogramming progress.

**NOTE: Do NOT disturb the cables or turn off the ignition during reprogramming.**
