# Technical Service Bulletin

SUBJECT:		No: <b>TSB-18-13-002</b>	
<b>MIL ILLUMINATION WITH DTC P061A</b>		DATE: <b>June 2018</b>	
		MODEL: <b>2018 Eclipse Cross</b>	
CIRCULATE TO:	<input type="checkbox"/> GENERAL MANAGER	<input checked="" type="checkbox"/> PARTS MANAGER	<input checked="" type="checkbox"/> TECHNICIAN
<input checked="" type="checkbox"/> SERVICE ADVISOR	<input checked="" type="checkbox"/> SERVICE MANAGER	<input checked="" type="checkbox"/> WARRANTY PROCESSOR	<input type="checkbox"/> SALES MANAGER

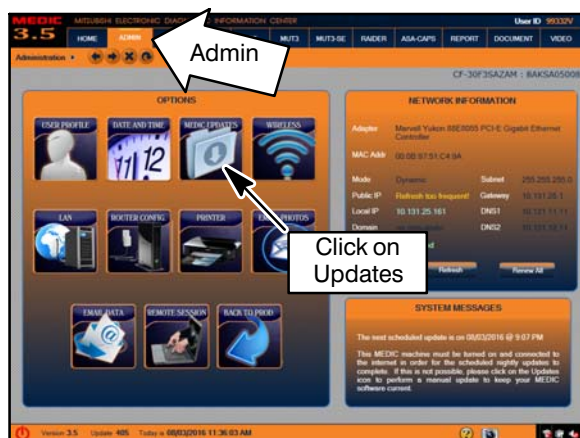
2. Verify the MEDIC 3.5/4 is at version 3.5 and at update **532** or higher.

If your **MEDIC 3.5/4 update is at least 532**, continue with the Reprogramming Procedure.

If your **MEDIC 3.5/4 update is below 532**, update your MEDIC as follows.

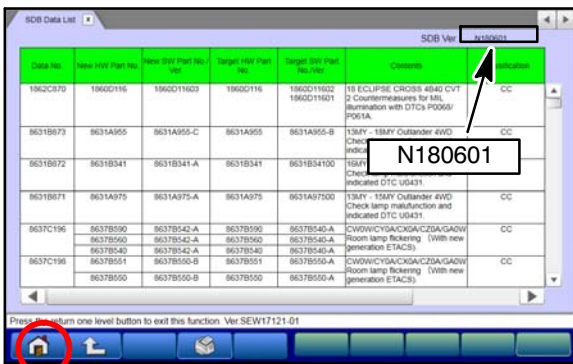
c. Click “SDB Data List.”

d. Confirm that the database number displayed in the upper right above the chart is **N180601 or higher**
