Technical Service Bulletin

SUBJECT:			No: TSB-18-23-001
4WD WARNING INDICATOR ILLUMINATES WITH DTC U0431			DATE: June 2018
			MODEL: 2014-18 Outlander
CIRCULATE TO:	<input type="checkbox"/> GENERAL MANAGER	<input checked="" type="checkbox"/> PARTS MANAGER	<input checked="" type="checkbox"/> TECHNICIAN
<input checked="" type="checkbox"/> SERVICE ADVISOR	<input checked="" type="checkbox"/> SERVICE MANAGER	<input checked="" type="checkbox"/> WARRANTY PROCESSOR	<input type="checkbox"/> SALES MANAGER

PURPOSE

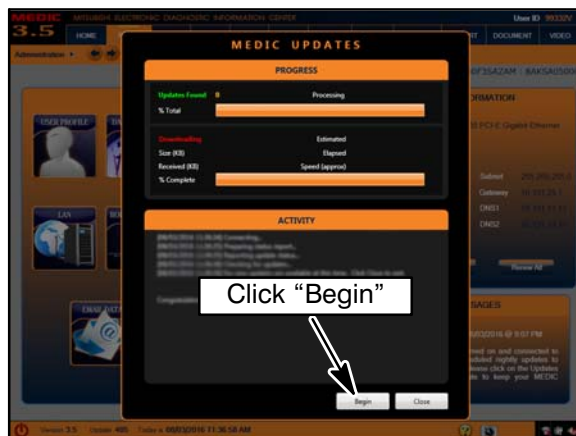
3. Select the MEDIC 3.5/4 Admin tab and click on “Updates.”

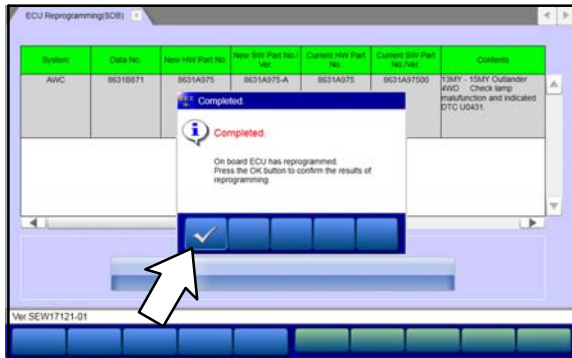
g. Once the reprogramming is initiated, the screen shown will indicate the reprogramming progress.

NOTE: Do NOT disturb the cables or turn off the ignition during reprogramming.
