# Technical Service Bulletin

SUBJECT:			No: <b>TSB-18-54-004</b>
<b>SOFTWARE UPDATE FOR SMARTPHONE LINK DISPLAY AUDIO</b>			DATE: <b>June, 2018</b>
			MODEL: <b>See below</b>
<b>CIRCULATE TO:</b>	<input type="checkbox"/> GENERAL MANAGER	<input checked="" type="checkbox"/> PARTS MANAGER	<input checked="" type="checkbox"/> TECHNICIAN
<input checked="" type="checkbox"/> SERVICE ADVISOR	<input checked="" type="checkbox"/> SERVICE MANAGER	<input checked="" type="checkbox"/> WARRANTY PROCESSOR	<input type="checkbox"/> SALES MANAGER

A software update is now available for the Smartphone Link Display Audio built by JVC Kenwood. This update resolves several issues that may occur in various models, as listed below.

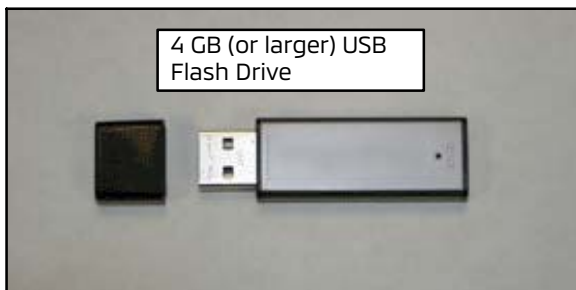
A USB version 2.0 standard flash drive (thumb drive) with a **minimum capacity of 4.0 GB**, formatted to FAT32 is required for this procedure. Formatting to FAT32 will erase all data from the flash drive. The flash drive must have no other files or folders saved to it.

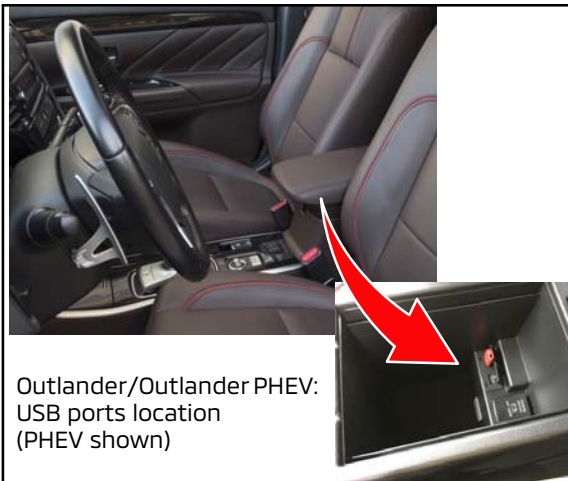
2. Plug in the USB flash drive containing the software update file into the vehicle's USB port (either port may be used for the update).  
For Outlander and Outlander PHEV, two USB ports are located inside the center console.

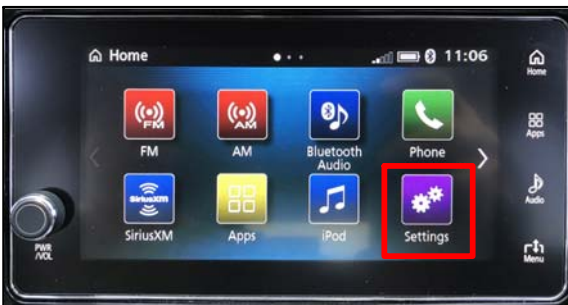
3. Before starting the update process, confirm the current software version.
  - a. Touch the "Settings" icon on the Home screen.

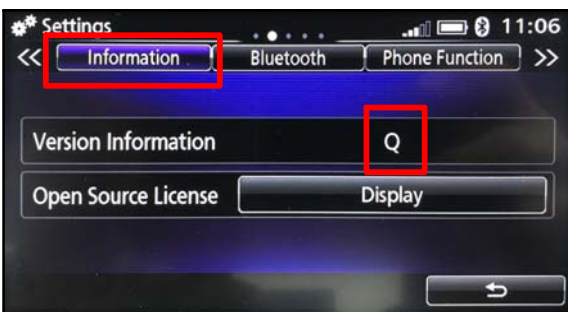
- b. On the Settings screen, touch the "Information" tab and check the Version Information.

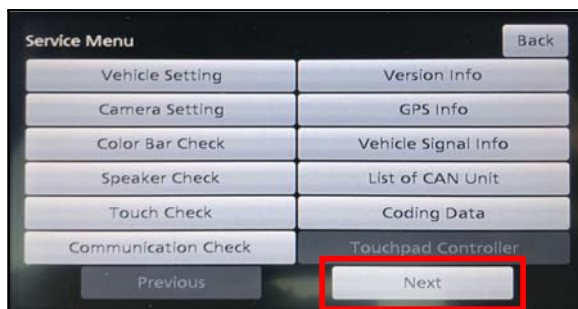
- e. Touch the "SW Update" button on the Service Menu.

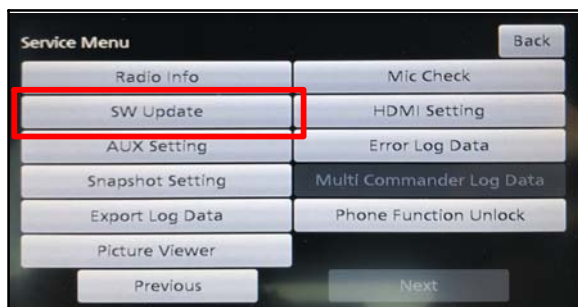
- f. On the SW Update screen, touch the "Update" button.

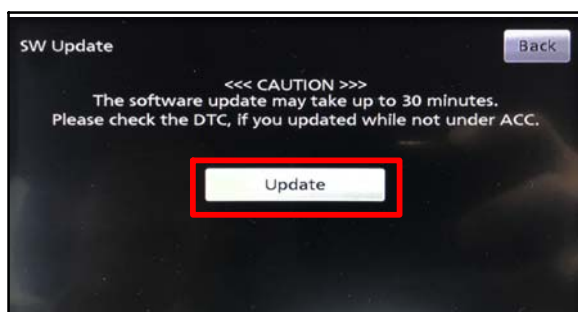
- g. Touch "Yes" to start the software update.  
**NOTE: Do NOT turn the power OFF or remove the flash drive during the update.**

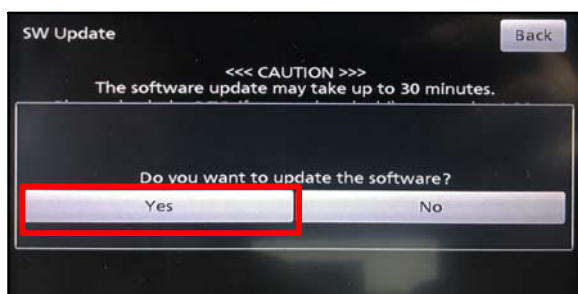
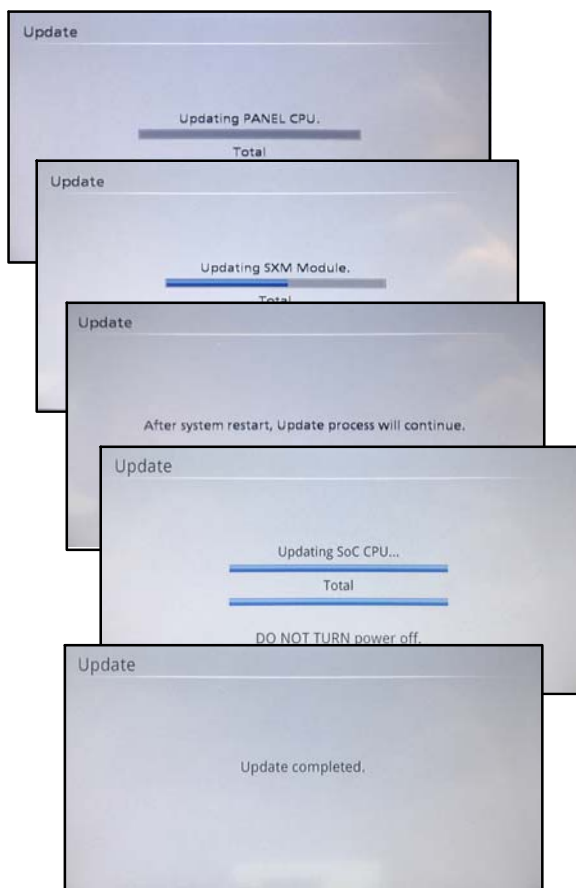
The system will automatically reboot twice during the update, ending with an "Update completed" screen.

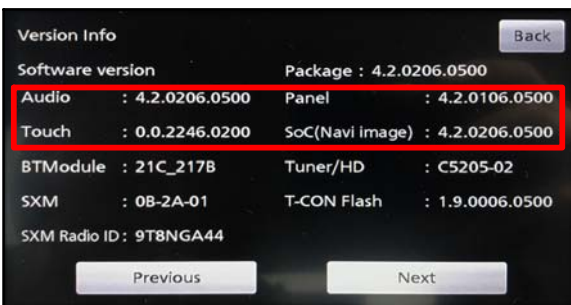
- e. Touch the "Next" button.
- f. Confirm the software version has been updated and matches the New version shown for the applicable model in the "**Display Audio Software Version Chart**," on page 2 of this TSB.

(Version info for 2018 Outlander PHEV shown at left.)

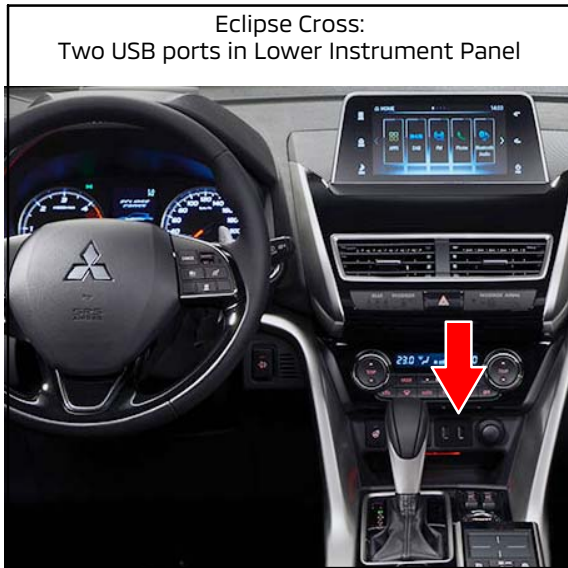
2. Plug in the USB flash drive containing the software update file into the vehicle's USB port (either port may be used for the update).  
Two USB ports are located in the lower part of the center instrument panel.

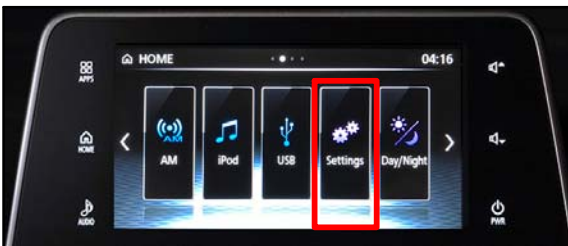
3. Before starting the update process, confirm the current software version.
  - a. On the Home screen, touch the right arrow to get to the Settings icon.

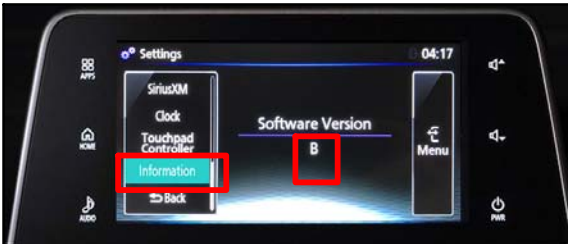
- b. Touch the "Settings" icon.

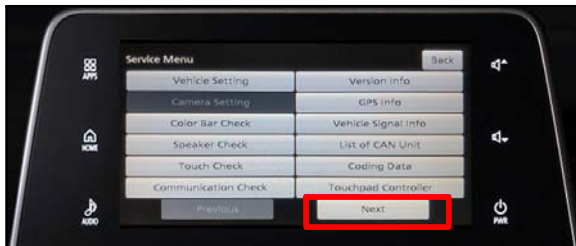
- e. Touch the "SW Update" button on the Service Menu.

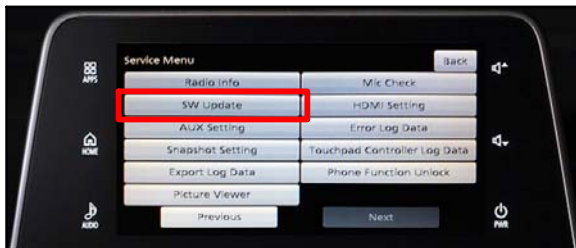
- f. On the SW Update screen, touch the "Update" button.

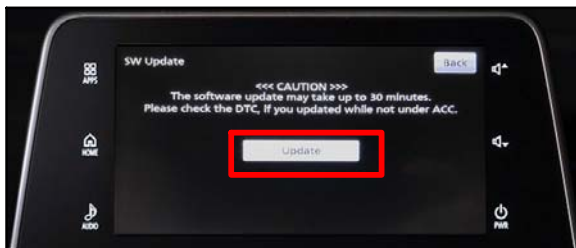
- g. Touch "Yes" to start the software update.

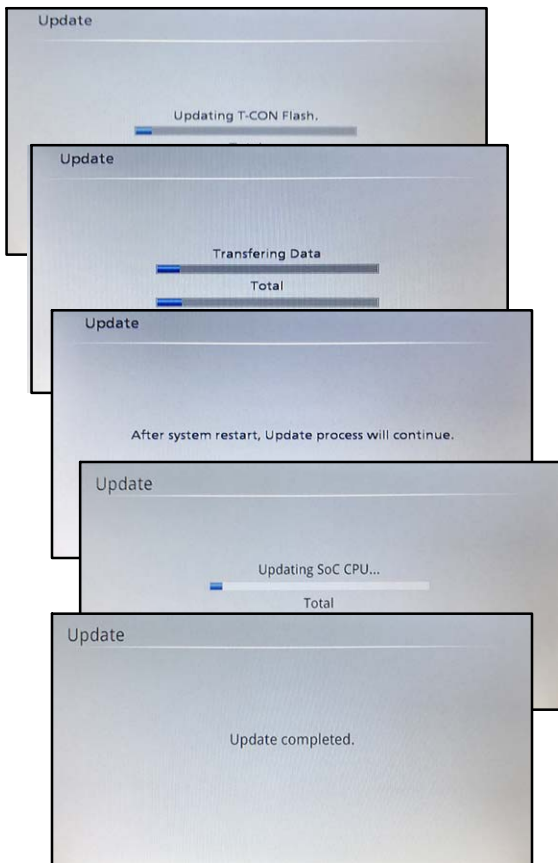
The system will automatically reboot twice during the update, ending with an "Update completed" screen.

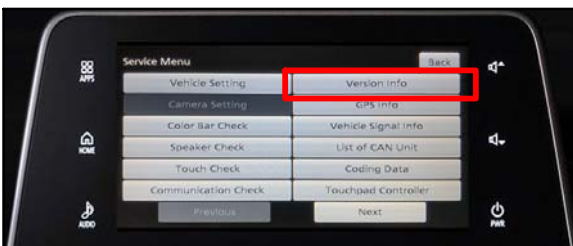
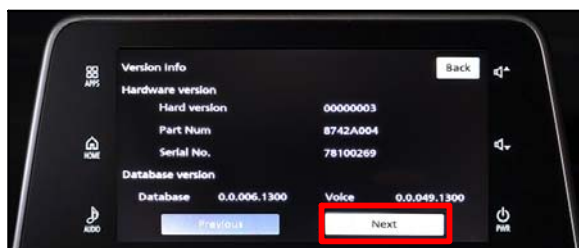
d. On the Service Menu screen, touch the "Version Info" button.

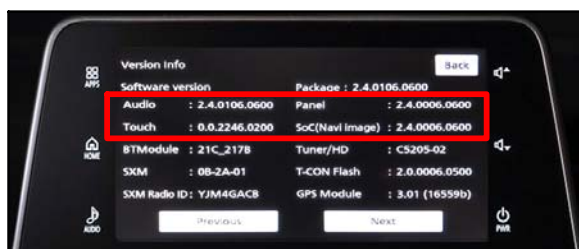
f. Confirm the software version has been updated and matches the New version shown in the "Display Audio Software Version Chart," on page 2 of this TSB.

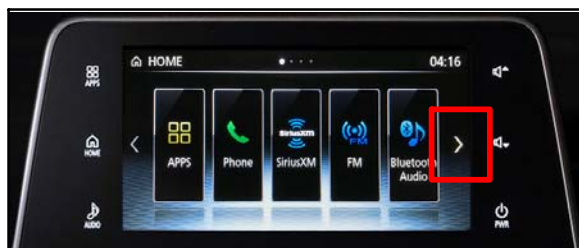
a. On the Home screen, touch the right arrow to get to the Settings icon.

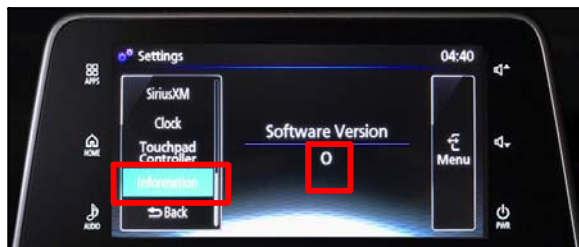
c. On the Settings screen, touch the "Information" tab and check the Version Information.

**NOTE: If necessary, scroll to the right or left to see the Information tab.**
