LTB01191NAS1

TECHNICAL BULLETIN

303-14: Electronic Engine Controls

Engine MIL Illuminated With DTC P0030-29 and/or P2251-13 Stored

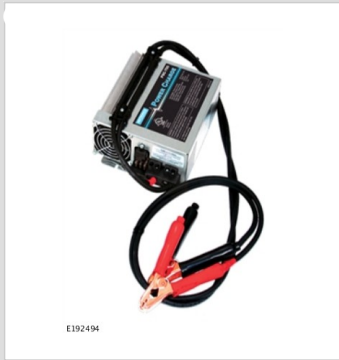
E192494

Jaguar Land Rover-approved Midtronics battery power supply

- A Jaguar Land Rover-approved Midtronics battery power supply must be connected to the vehicle startup battery during diagnosis / module programming.
- All ignition ON/OFF requests must be carried out. Failure to perform these steps may cause damage to control modules in the vehicle.

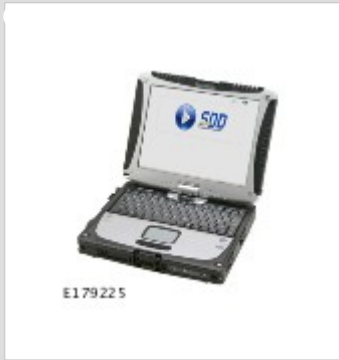
E179225

Jaguar Land Rover-approved diagnostic tool with latest SDD Software Management Pack

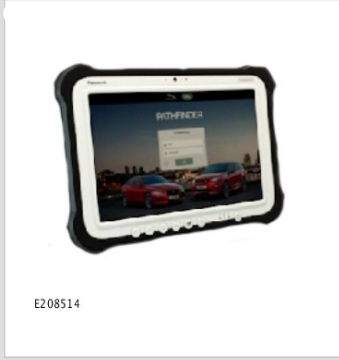
E208514

Jaguar Land Rover-approved diagnostic tool with latest PATHFINDER software
