**Volvo Models****Volvo Model** VNX , VNL , VNM , VHD , VAH**Engine family**

**Title** Volvo Chassis - Particulate Matter ( PM ) Sensor Diagnostic Trouble Codes ( DTC ) Illuminating The Malfunction Indicator Lamp ( MIL ); Tech Tip TT-014-2016 - **OBD16 And Newer Emissions (Commonly Model Year 2017, Includes Common Rail Fuel System Chassis) - To Be Used For EVERY Visit**

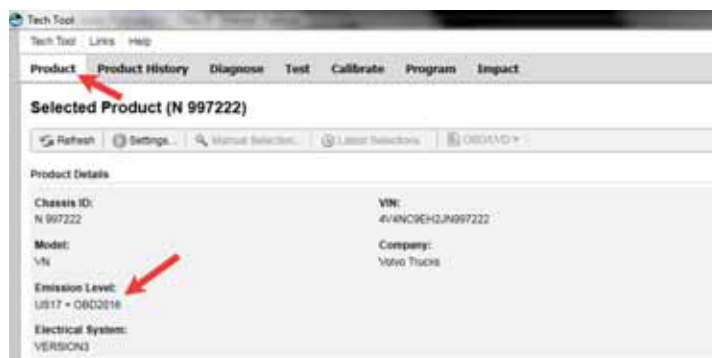
**Verify the chassis emissions level**

- Details can be found in the Product Details box on the Product tab in PTT as

seen below:
