Entune Audio Head Unit Software Update (Pioneer)

YEAR(S)	MODEL(S)	ADDITIONAL INFORMATION
2018	Camry, Camry HV

Introduction

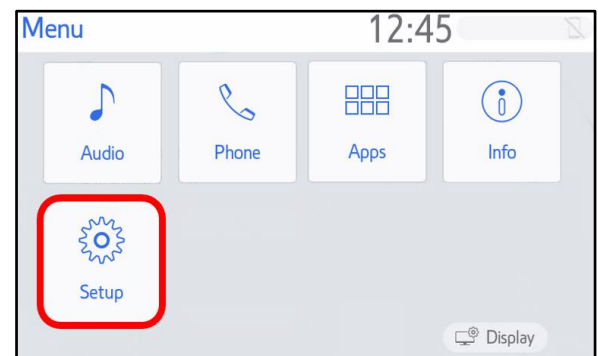
Figure 1.

1. Start the engine.
2. Press the Menu button on the radio faceplate, then select Setup.

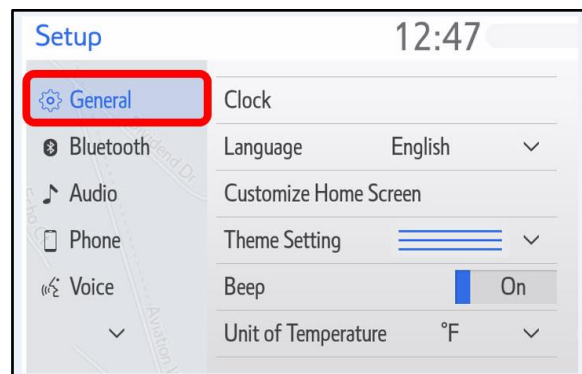
Figure 2.

3. Select General on the Setup screen.

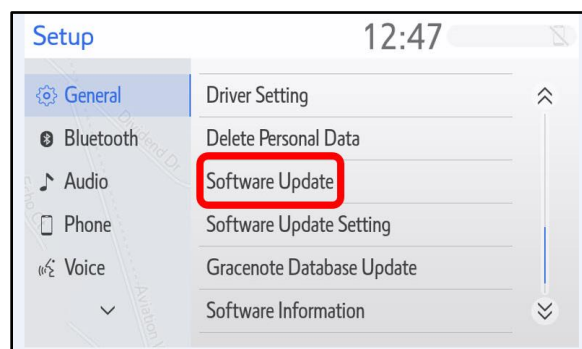
Figure 3.

4. Scroll down and select Software Update.

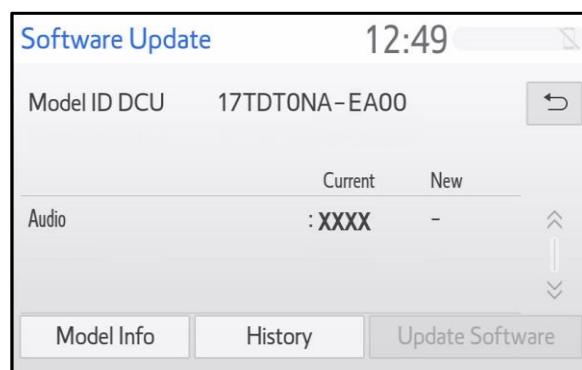
Figure 4.

5. Verify that the software version is the same or earlier than indicated in the Introduction.

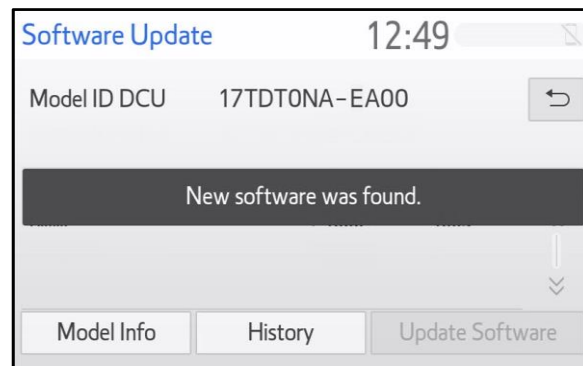
Figure 5.

7. Insert the prepared USB flash drive into the vehicle's USB port.

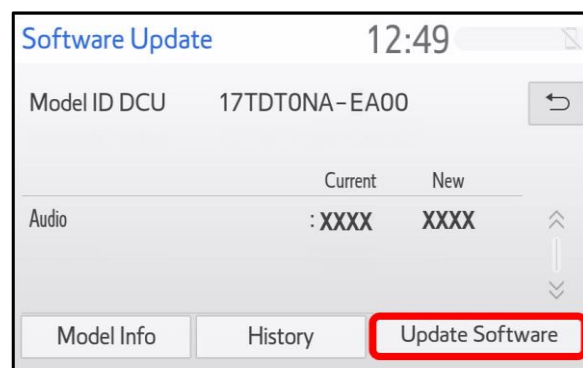
Figure 6.

9. Select the Update Software button in the lower right-hand corner.

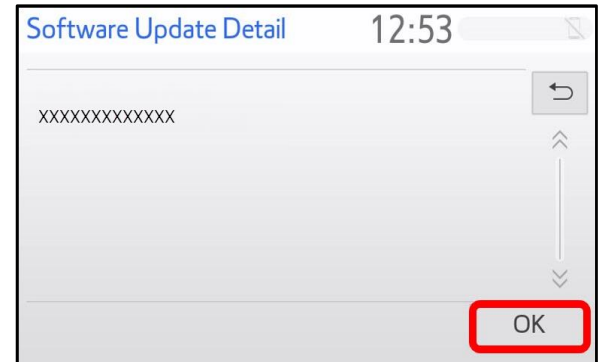
Figure 7.

10. Select Ok on the Software Update Detail screen.

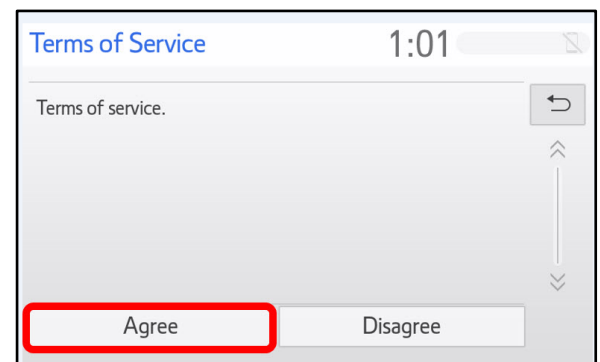
Figure 8.

11. Select Agree on the Terms of Service screen.

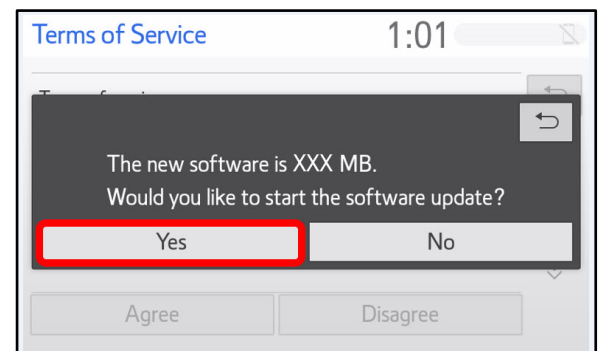
Figure 9.

12. Select Yes on the "Would you like to start the software update?" pop-up.

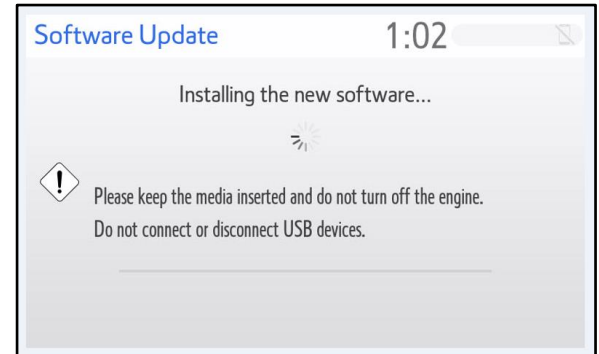
Figure 10.

13. Once the head unit begins installation, the update will take approximately 10 minutes.

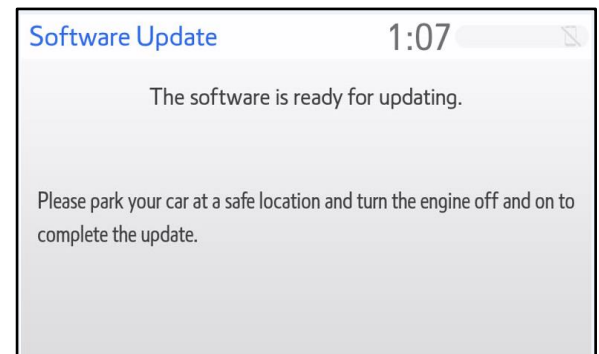
Figure 11.

15. Turn the ignition ON to complete the software update.
16. Once the software update is completed, remove the USB flash drive.

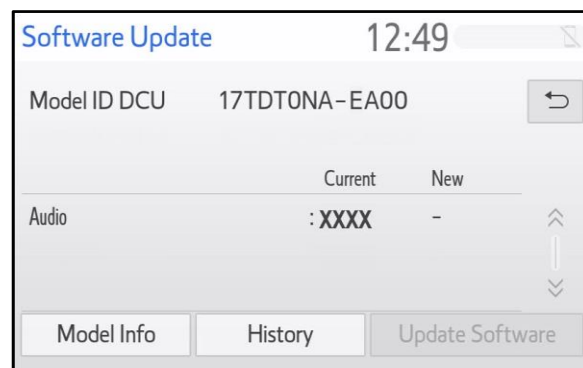
Figure 12.

17. Perform steps 1 – 4 to verify the software version matches the current software version information table below.
