SI B65 13 16  
Audio, Navigation, Monitors, Alarms, SRS

## NBT-EVO (NEXT GENERATION NAVIGATION PROFESSIONAL) HEAD UNIT CANNOT BE SWAPPED BETWEEN VEHICLES FOR TESTING. 'COMPONENT PROTECTION ACTIVE'

This Service Information bulletin supersedes SI B65 13 16 dated **October 2017**.

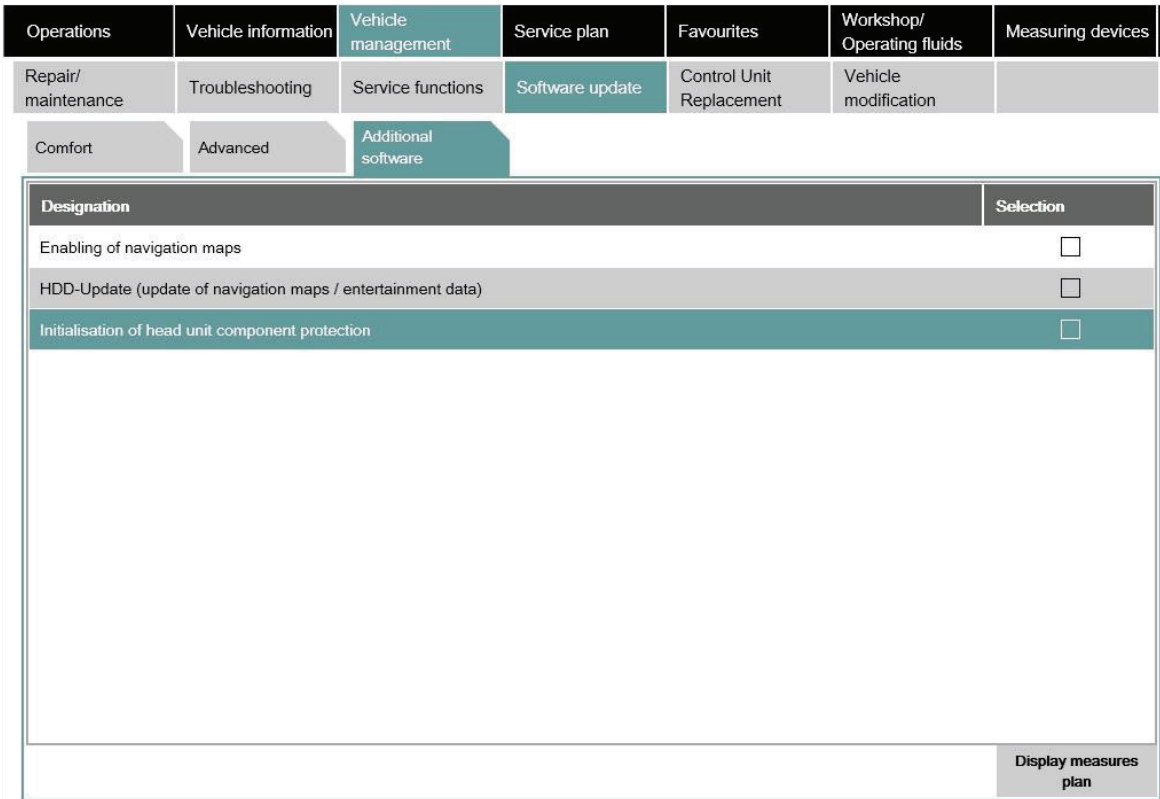
4. Connect the vehicle and select the initialisation of component protection function in the Additional software tab.
