GROUP Product Improvement	MODEL 2015MY Sorento (XMa)
	NUMBER 1802	DATE July 2018
PRODUCT IMPROVEMENT CAMPAIGN		
SUBJECT: KNOCK SENSOR DETECTION SYSTEM - ECU LOGIC IMPROVEMENT (PI1802)

This bulletin provides information related to a software update to the Engine Control Unit (ECU) to install the Knock Sensor Detection System (KSDS) in order to protect the engine from excessive connecting rod bearing damage. This update is for all 2015MY Sorento (XMa) vehicles equipped with 2.4L GDI engines, manufactured from January 3, 2014 through December 11, 2014. The KSDS detects vibrations indicating the onset of excessive connecting rod bearing wear. It is designed to alert the driver at an early stage of bearing wear before the occurrence of severe engine damage, including engine failure. If vibrations caused by bearing wear start to occur, the Malfunction Indicator Lamp (MIL) will blink continuously, and the vehicle will be placed in Limp Home Mode. This will reduce further damage to the engine and ensure that the vehicle occupants are not exposed to the risk of a more severe engine failure. At that time, Diagnostic Trouble Code (“DTC”) P1326, specific to the KSDS, will be recorded in the E

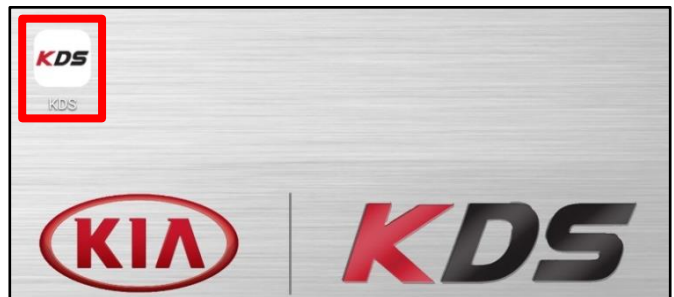
2. With the ignition ON, turn ON the KDS tablet. Select **KDS** from the home screen.

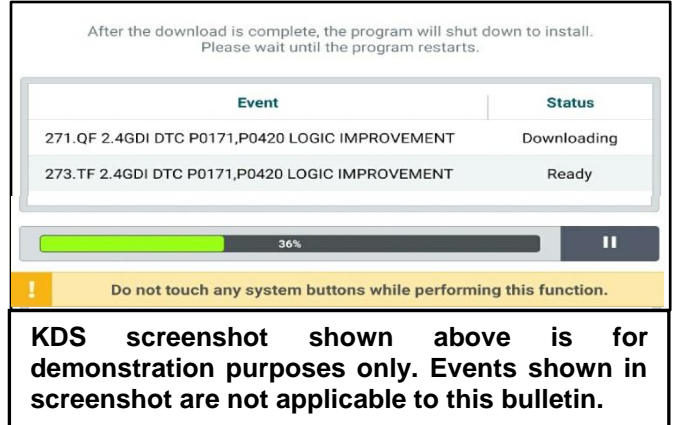
- The KDS will check the server for recently uploaded Events and then automatically download **Upgrade Event #374**.

The vehicle must be identified in Vehicle Selection to download an Event for that vehicle.

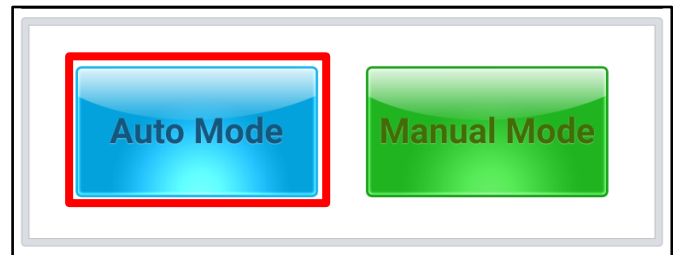
- Select **Auto Mode**.

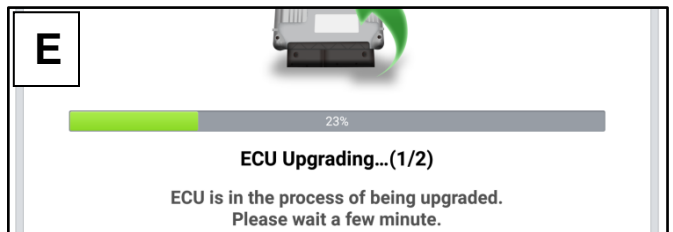
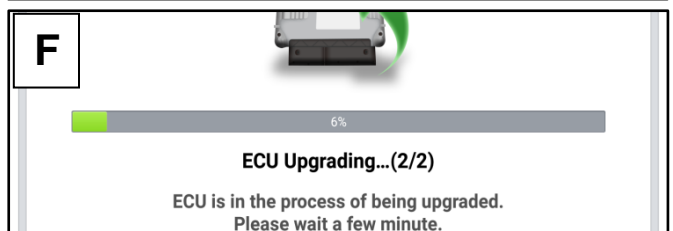
- The ECU upgrade will begin and the progress of the upgrade will appear on the bar graph. Upgrade part (1/2) (E) will download the upgrade event to the VCI-II. Upgrade part (2/2) (F) will upgrade the ECU.

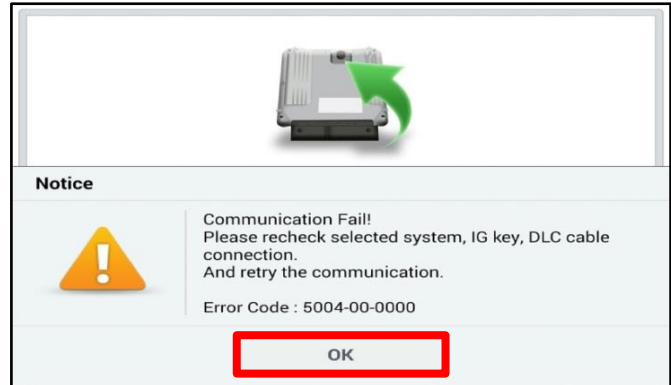
9. If a “Communication Fail” screen appears, verify that the VCI-II and KDS are communicating properly. Touch **OK** and restart the procedure from step 4.

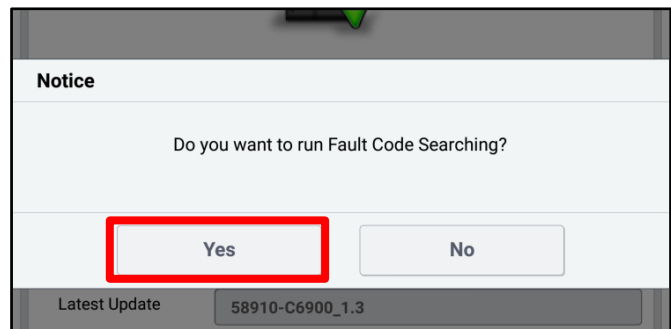
12. When prompted, select **YES** to check for Diagnostic Trouble Codes (DTC) and erase any DTCs stored such as EPS, ESC, and TPMS that may have been set during the upgrade.
