SERVICE BULLETIN

EL18-018

2011-2015 LEAF; 12 VOLT BATTERY LOSES CHARGE AND/OR TELEMATICS SERVICES DO NOT WORK

APPLIED SYSTEM: Vehicles equipped with a 3G Telematics control unit

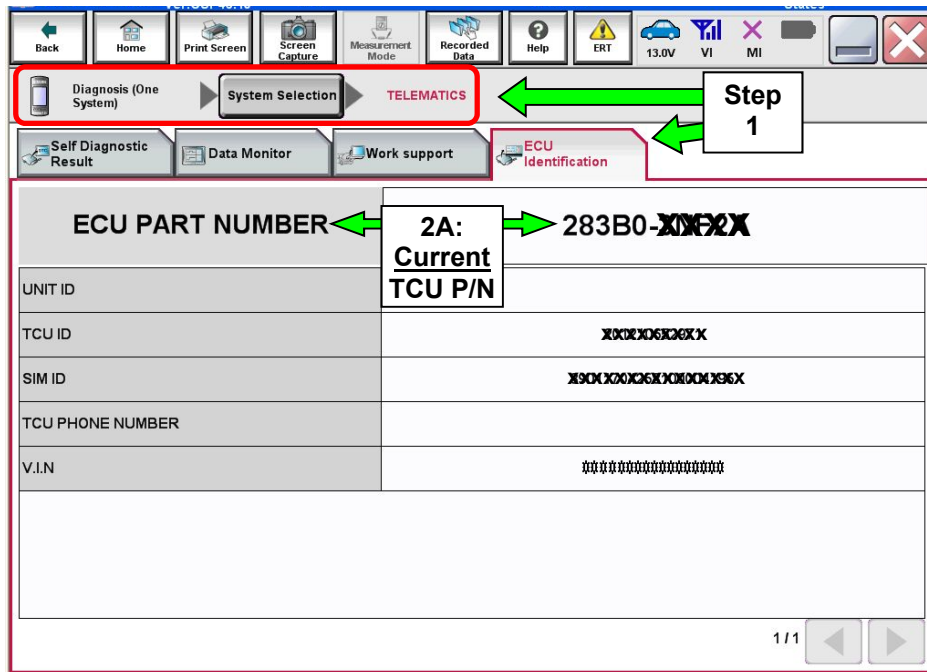
Figure 1

1. With CONSULT-III plus (C-III plus), go to **Diagnosis (One System) > System Selection > TELEMATICS > ECU identification**.
2. When you get to the screen shown in Figure 1, confirm this bulletin applies as follows.
 - A. Find the **TCU Part Number** and write it on the repair order.

NOTE: This is the current TCU Part Number (P/N).

- B. Compare the P/N you wrote down to the numbers in the **Current TCU Part Number** column in **Table A** below.
 - If there is a match, this bulletin applies. Go to **TCU Reprogramming (includes turning OFF the TCU)** on the next page.
 - If there is not a match, this bulletin does not apply. Refer to ASIST for further diagnostic and repair information.
