SERVICE BULLETIN

EL18-005

2018 ROGUE, ROGUE HYBRID AND ROGUE SPORT; UNEXPECTED OPERATION OF AEB, FEB OR FCW

APPLIED VEHICLES: 2018 Rogue (T32)
2018 Rogue Sport (J11)
2018 Rogue Hybrid (T32)

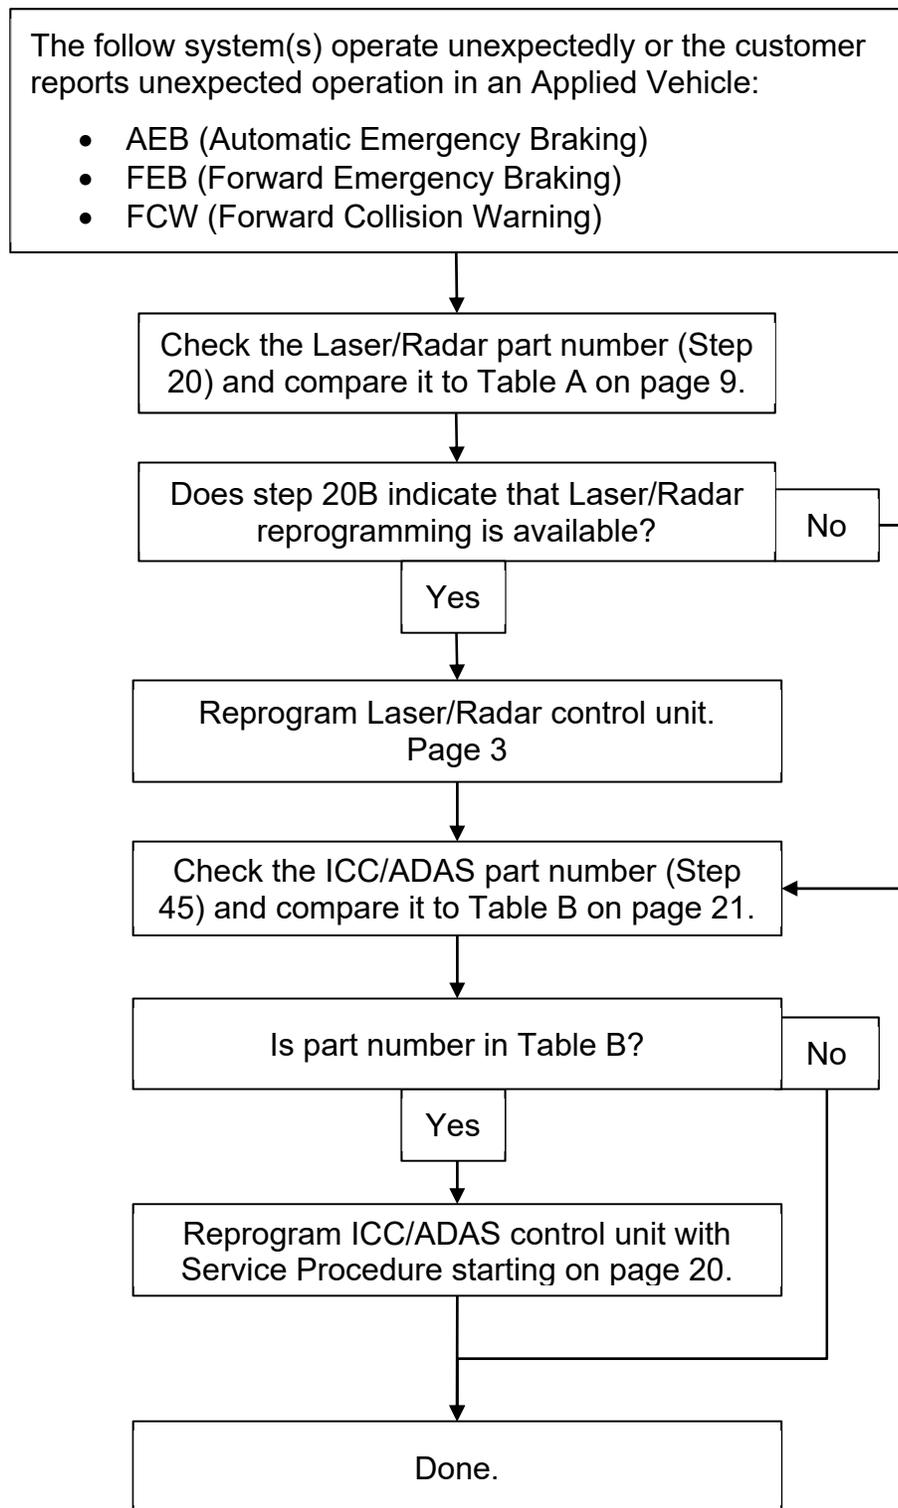
NOTE: If reprogramming is not available, refer to the Electronic Service Manual (ESM) for further diagnostic information.

Refer to the Repair Overview on page 2.

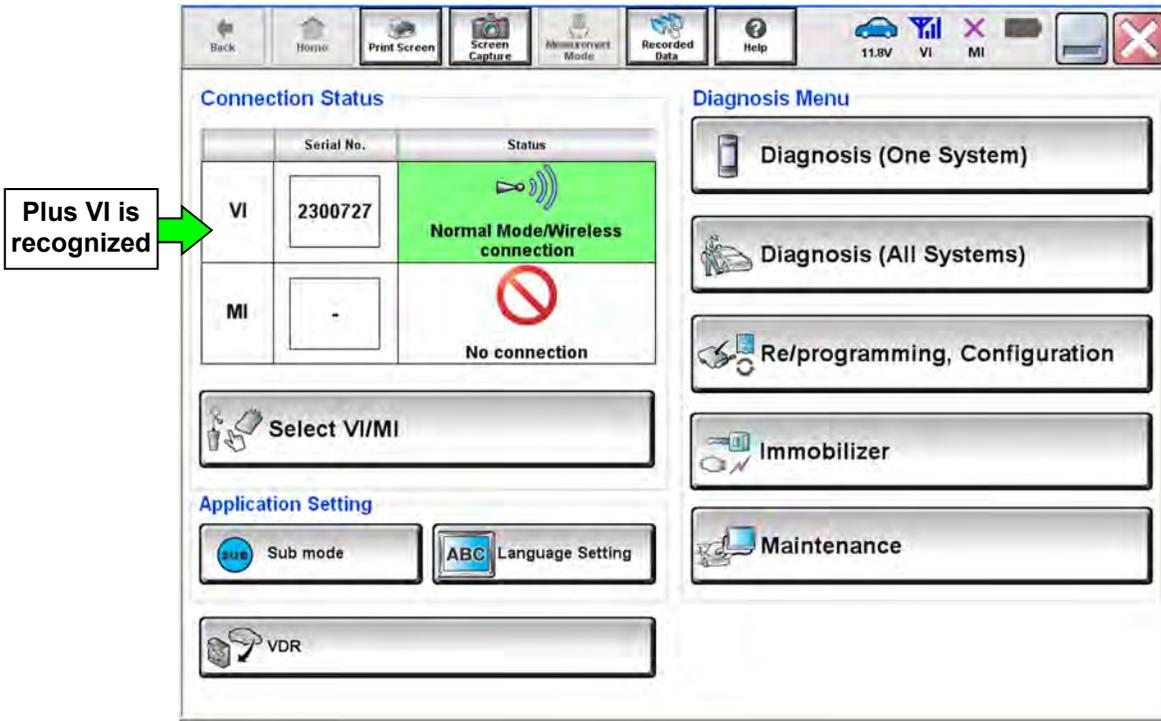
Figure 1

9. Wait for the plus VI to be recognized.
- Serial number will display when the plus VI is recognized.

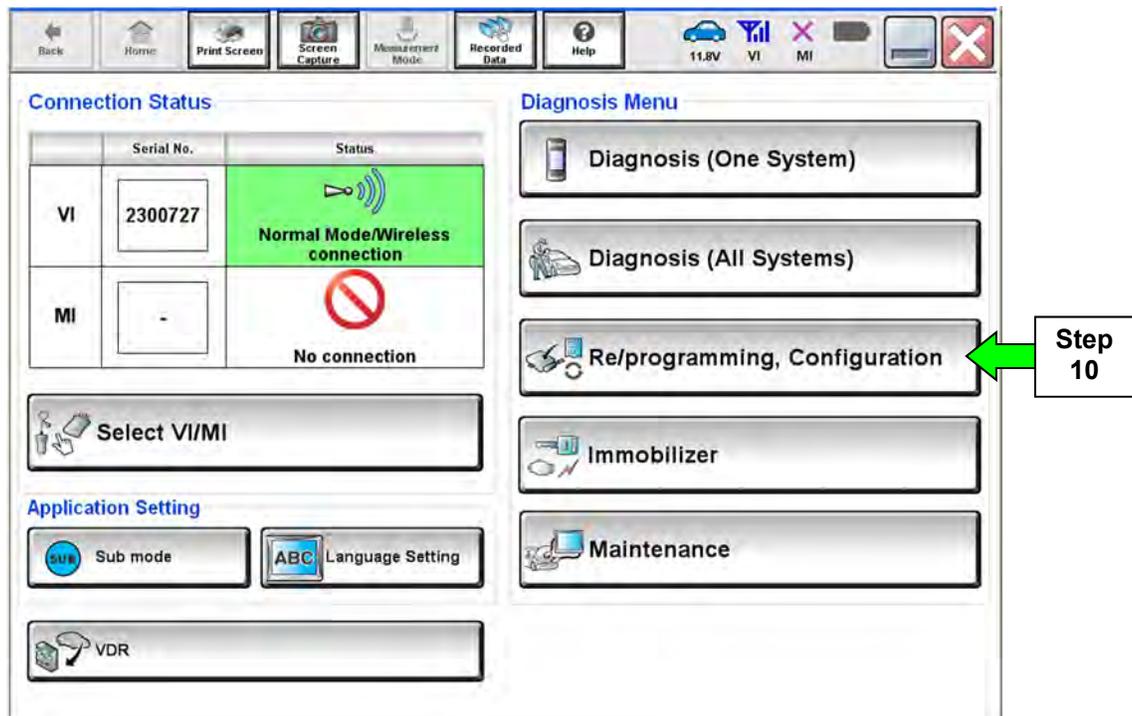
Figure 2

10. Select **Re/programming, Configuration**.

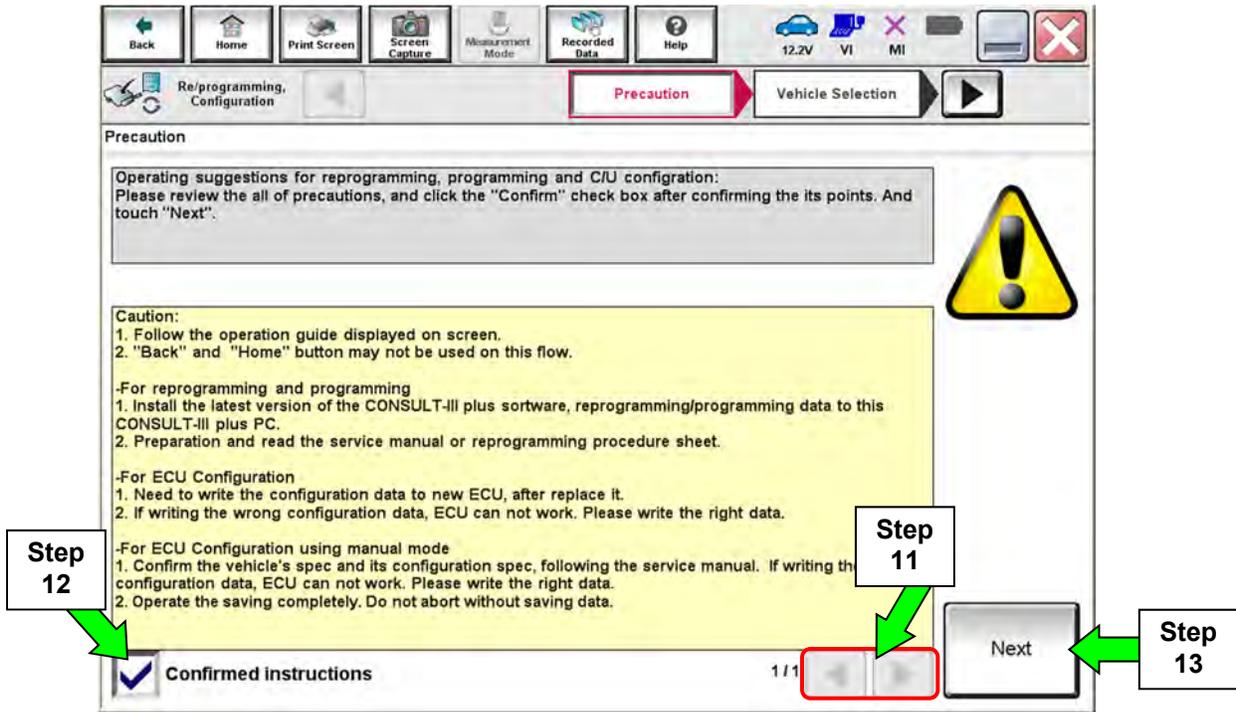
Figure 3

11. Use arrows (if needed) to view and read all precautions.
12. Check the box confirming the precautions have been read.
13. Select **Next**.

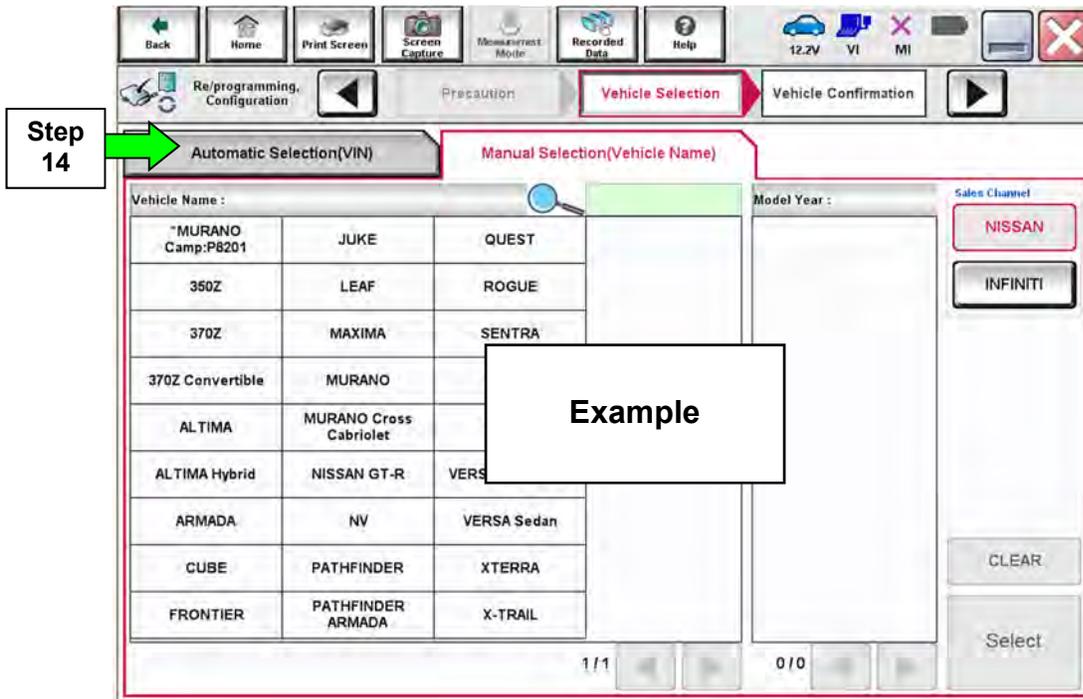
14. Select **Automatic Selection(VIN)**.

- If the screen in Figure 4 does not display, skip to step 15.

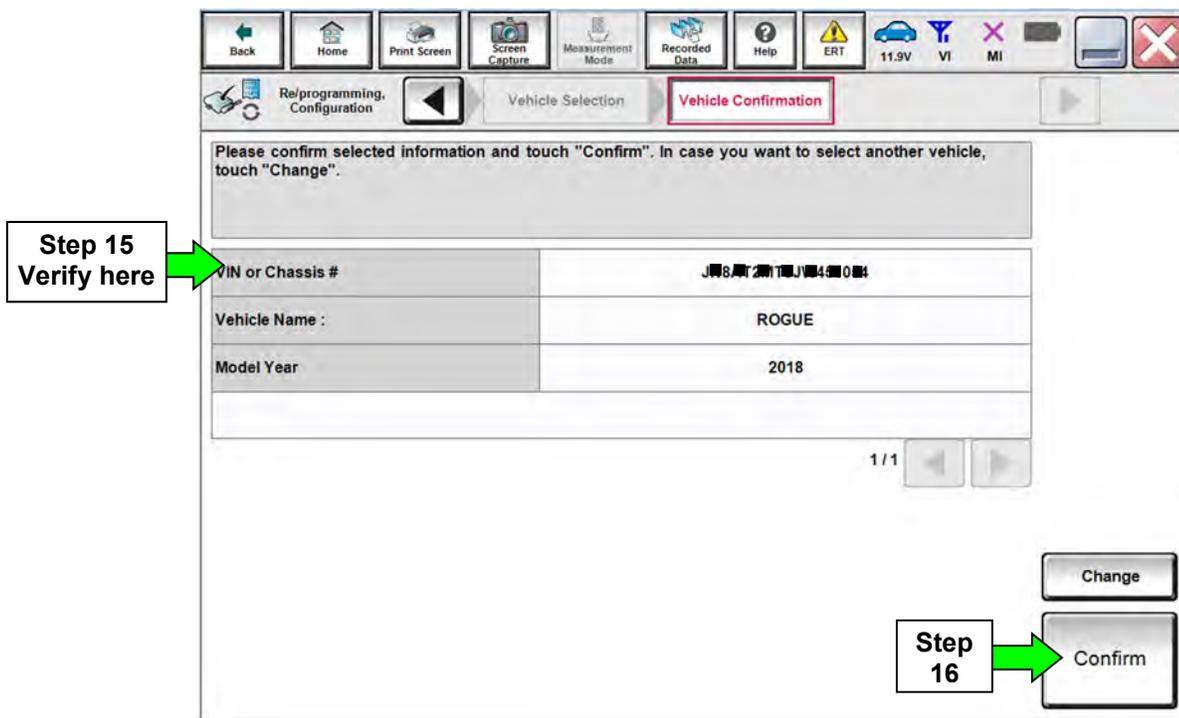
Figure 5

15. Make sure **VIN or Chassis #** matches the vehicle's VIN.

16. If the correct VIN is displayed, select **Confirm**.

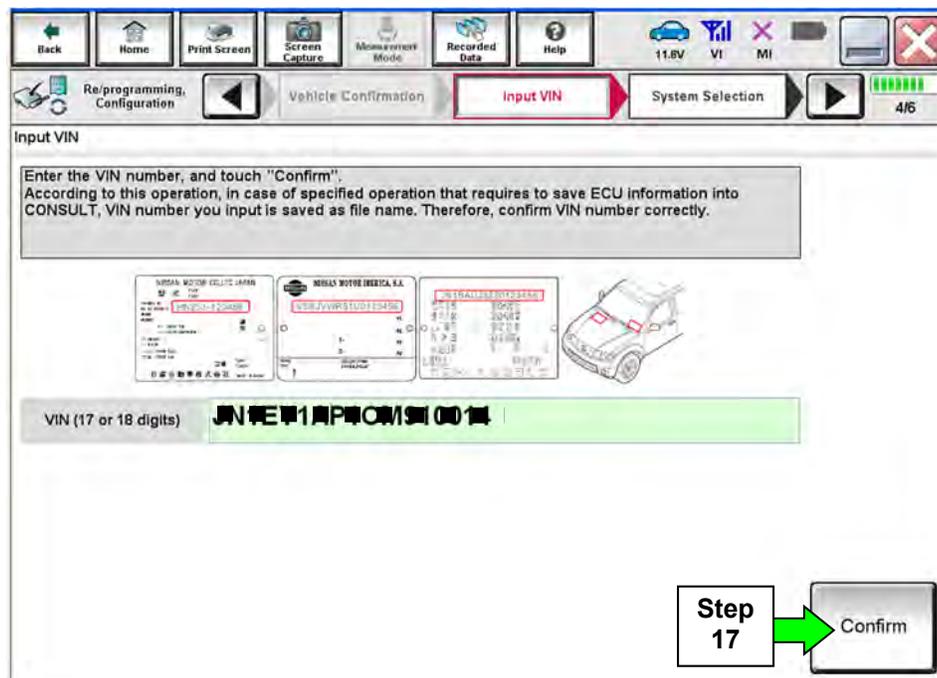
Figure 6

17. Select **Confirm**.

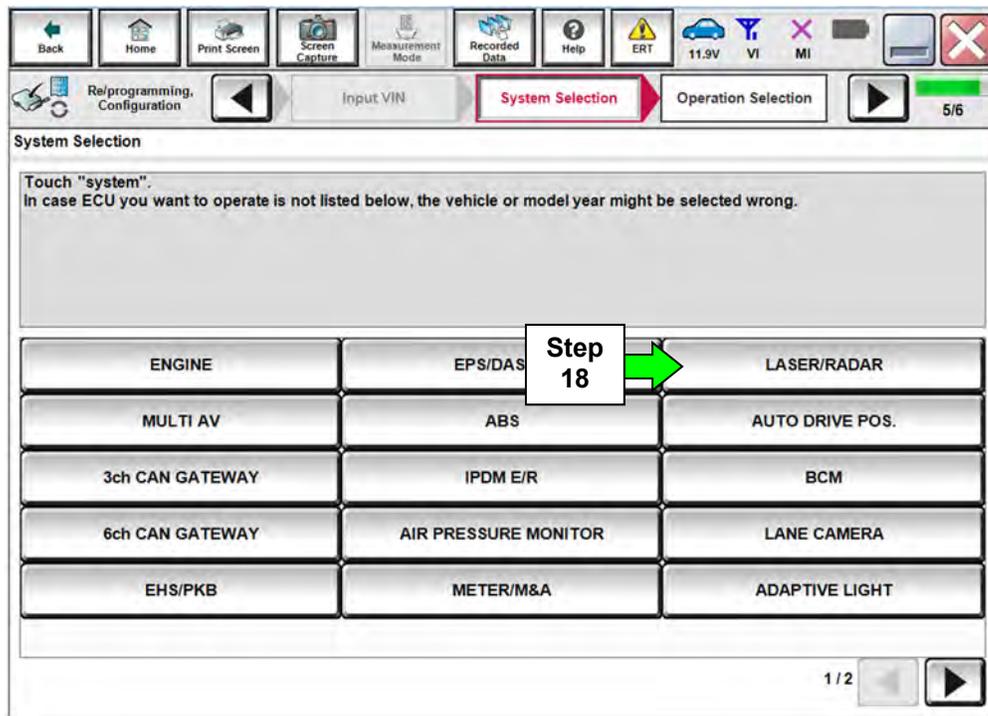
Figure 7

18. Select **LASER/RADAR**.

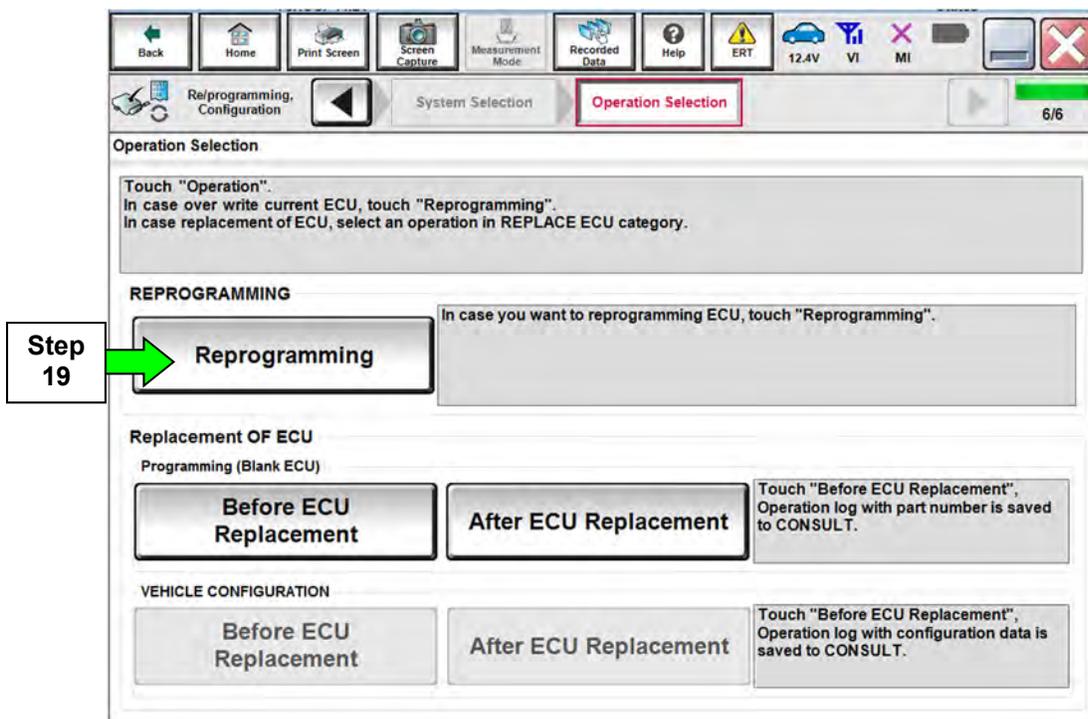
Figure 8

19. Select **Reprogramming**.

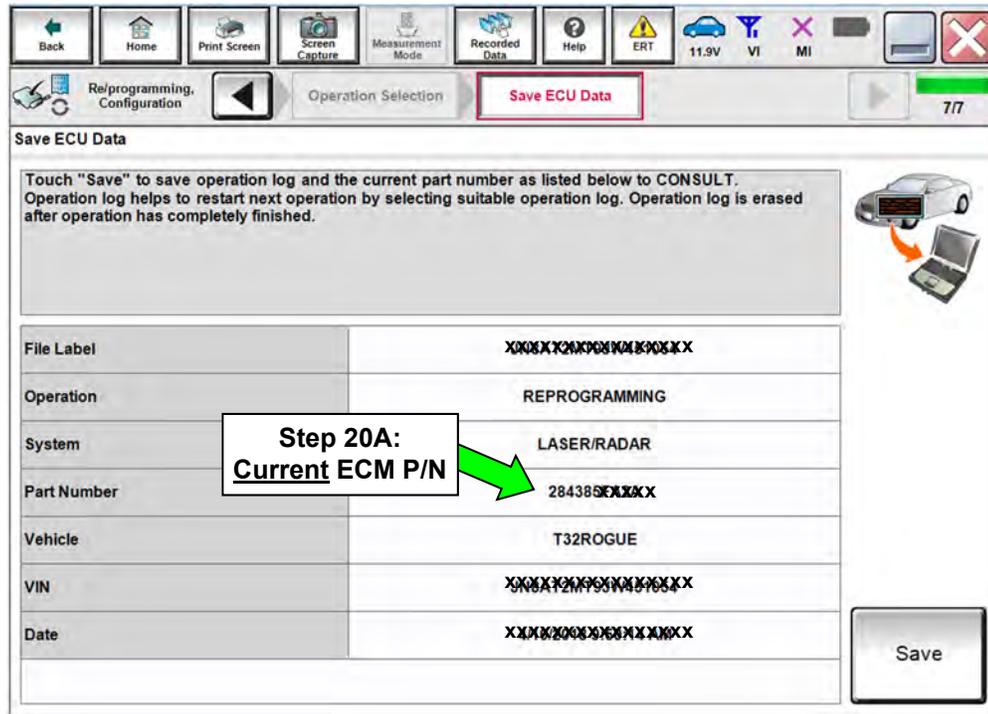
Figure 9

20. When you get to the screen shown in Figure 9, confirm that a reprogram is available as follows.

A. Find the LASER/RADAR **Part Number** and write it on the repair order.

NOTE: This is the current LASER/RADAR Part Number (P/N).

B. Compare the P/N you wrote down to the numbers in the **Current LASER/RADAR Part Number** column in **Table A**.

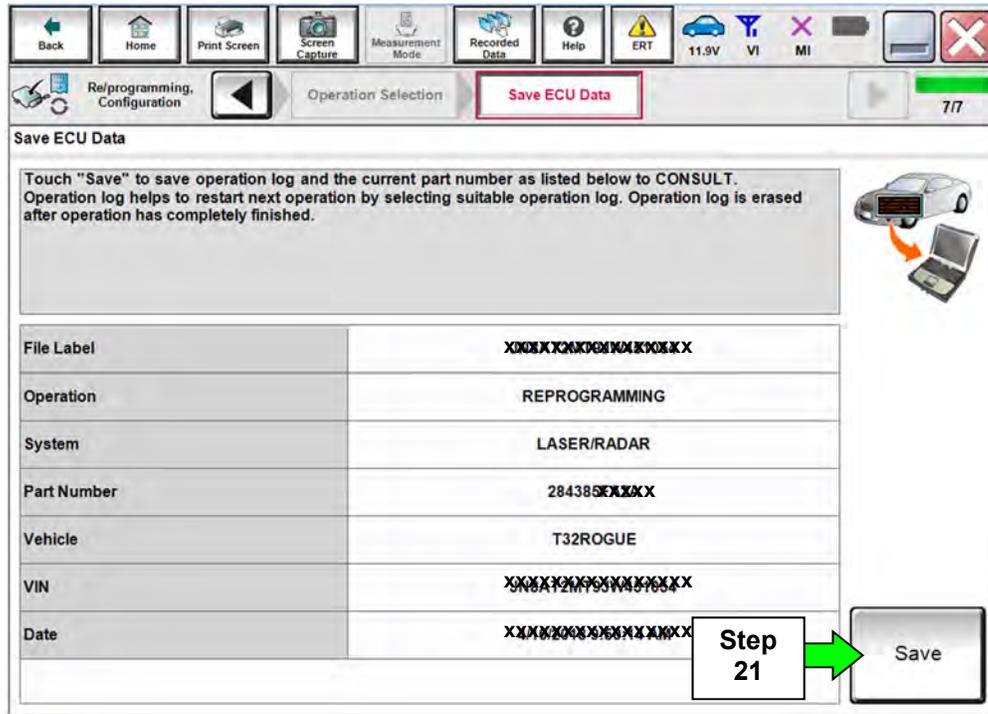
Figure 10

21. Select **Save**.

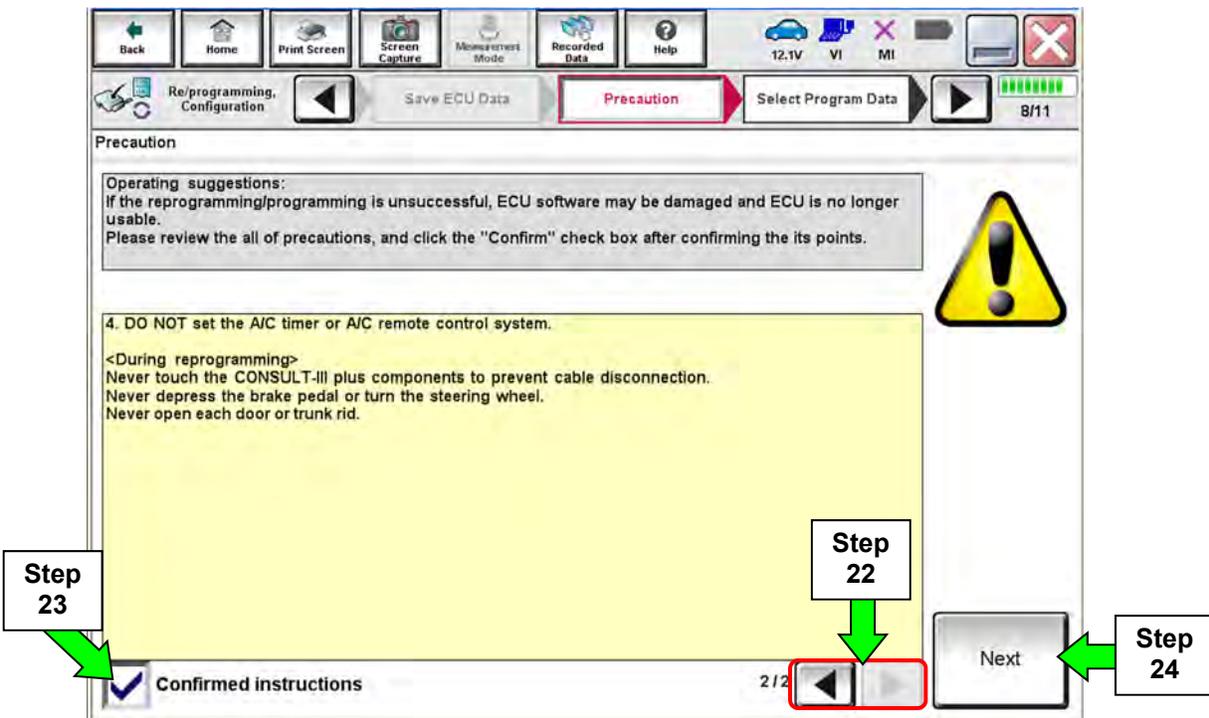
Figure 11

22. Use arrows (if needed) to view and read all precautions.

23. Check the box confirming the precautions have been read.

24. Select **Next**.

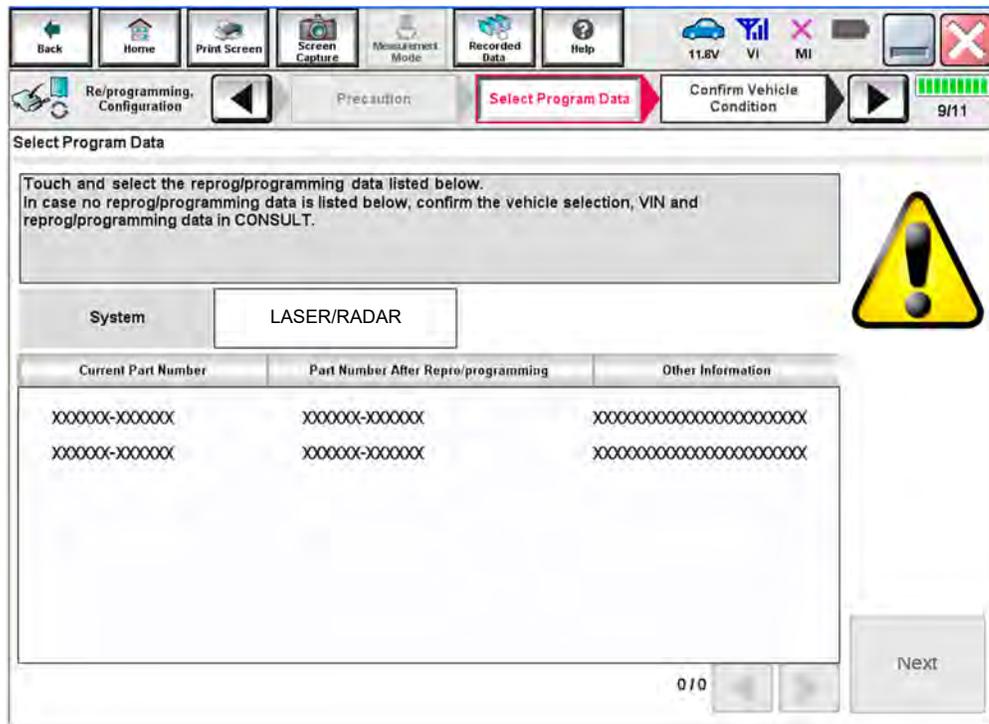
- In some cases, more than one new P/N for reprogramming is available.
 - If more than one new P/N is available, the screen in Figure 13 displays.
 - Select and use the reprogramming option that does **not** have the message “Caution! Use ONLY with NTBXX-XXX”.
- If you get this screen and it is blank (no reprogramming listed), it means there is no reprogramming available for the Laser/Radar control unit in this vehicle. Proceed to **ICC/ADAS Reprogramming**.

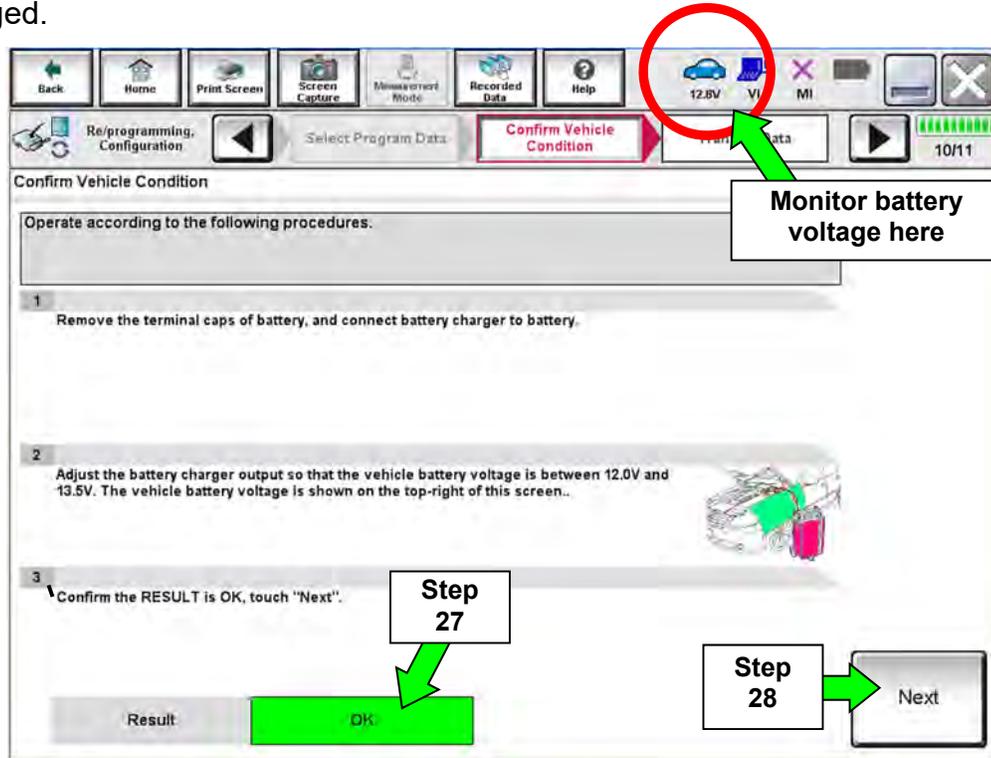
Figure 14

27. Make sure **OK** is highlighted **green** (battery voltage must be between **12.0 and 15.5 Volts**).

28. Select **Next**.

IMPORTANT: Battery voltage must stay between **12.0 and 15.5 Volts** during reprogramming or ECM reprogramming may be interrupted and ECM/TCM may be damaged.

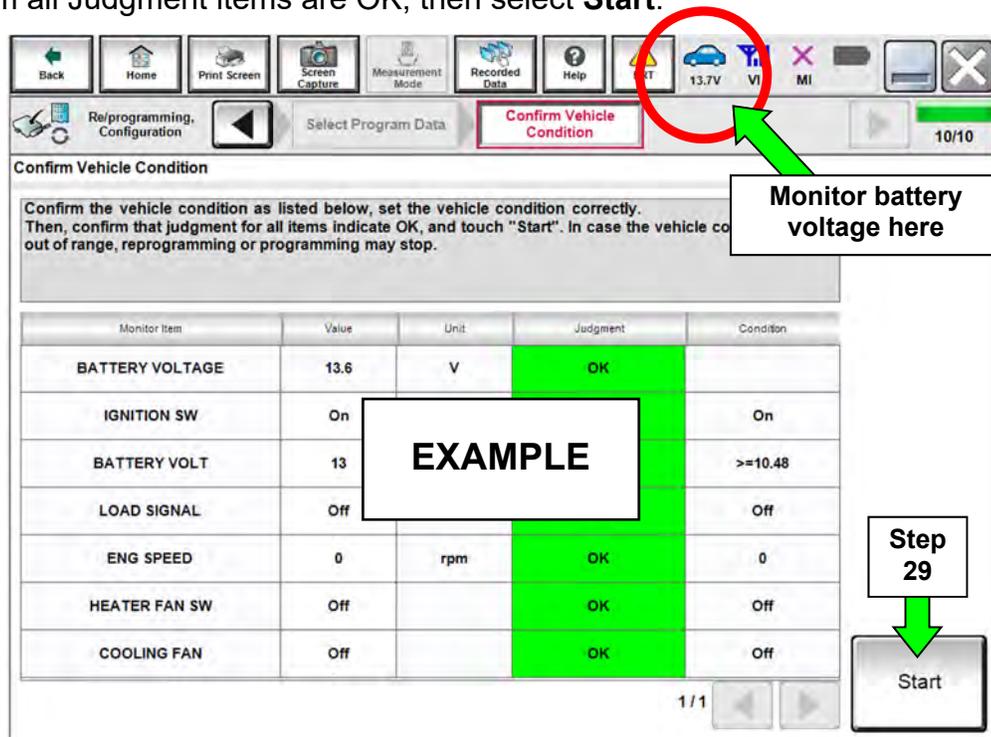
Figure 15

29. Confirm all Judgment items are OK, then select **Start**.

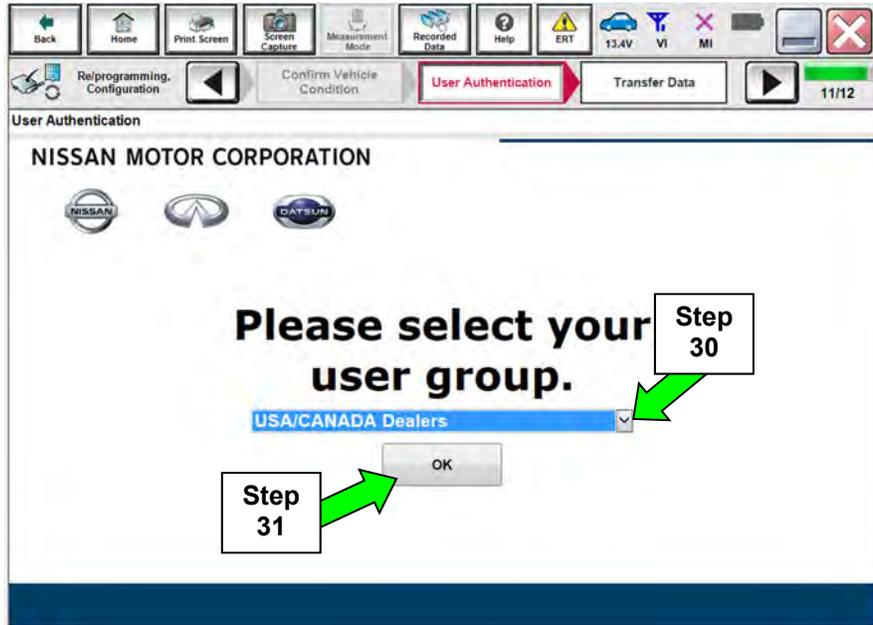
Figure 16

30. Select **USA/CANADA Dealers**.

31. Select **OK**.

- The above screen may not display if the CONSULT PC has remained ON since the last reprogramming.
- If the CONSULT PC is not connected to the Internet, the screen in Figure 17 will display.

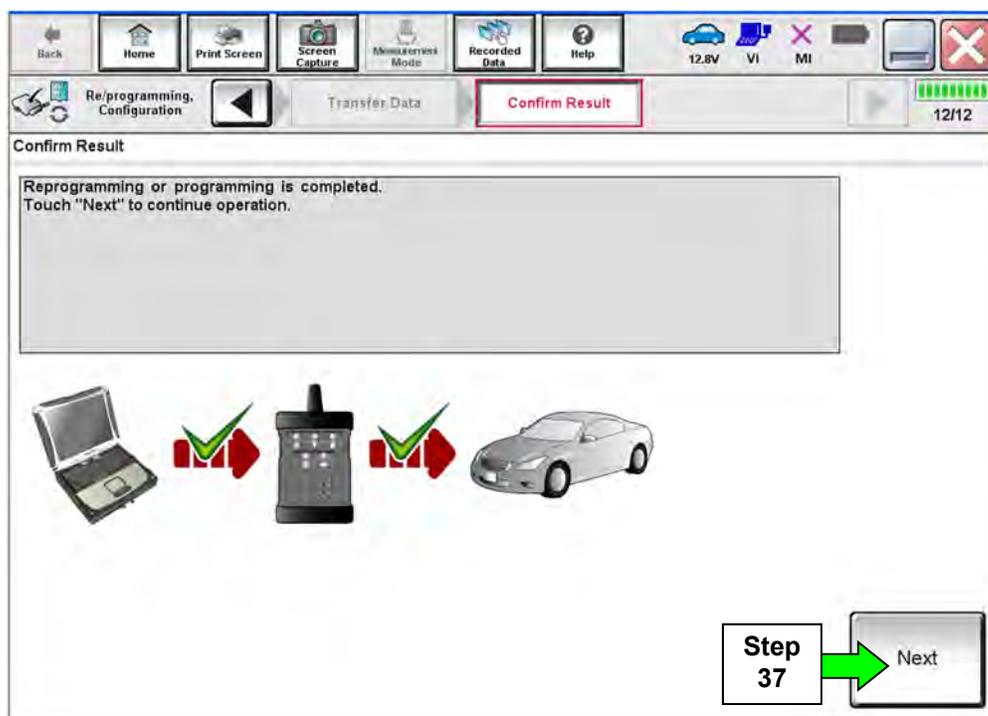
35. When the screen in Figure 20 displays, the reprogramming is complete.

NOTE: If the screen in Figure 20 does not display (indicating that reprogramming did not complete), refer to the information on the next page.

37. Select **Next**.

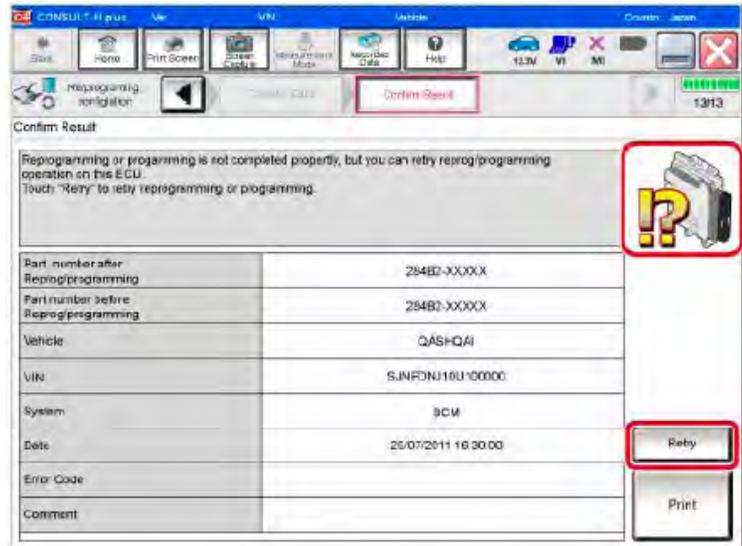
Figure 21

If reprogramming does not complete and the “!?” icon displays as shown in Figure 21:

- Check battery voltage (12.0 - 15.5 V).
- Ignition is ON, engine OFF.
- External Bluetooth® devices are OFF.
- All electrical loads are OFF.
- **Select retry and follow the on screen instructions.**
- **“Retry” may not go through on first attempt and can be selected more than once.**

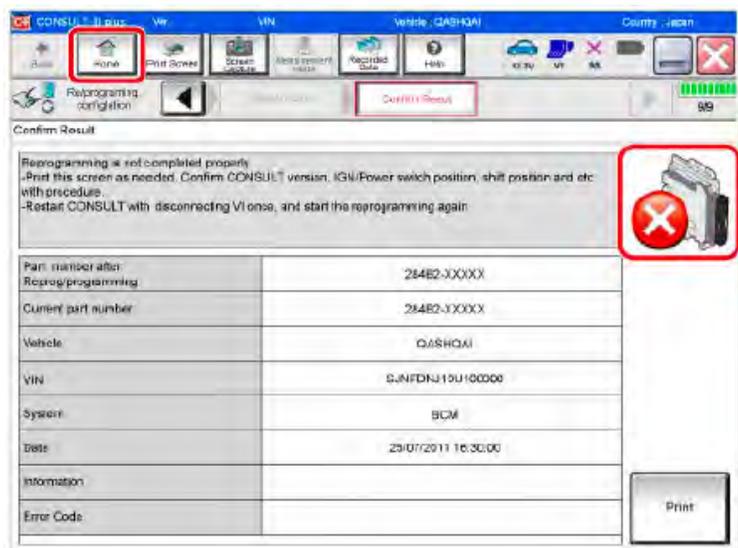
Figure 22

If reprogramming does not complete and the “X” icon displays as shown in Figure 22:

- Check battery voltage (12.0 - 15.5 V).
- CONSULT A/C adapter is plugged in.
- Ignition is ON, engine OFF.
- Transmission is in Park.
- All C-III plus / VI cables are securely connected.
- All C-III plus updates are installed.
- **Select Home, and restart the reprogram procedure from the beginning.**

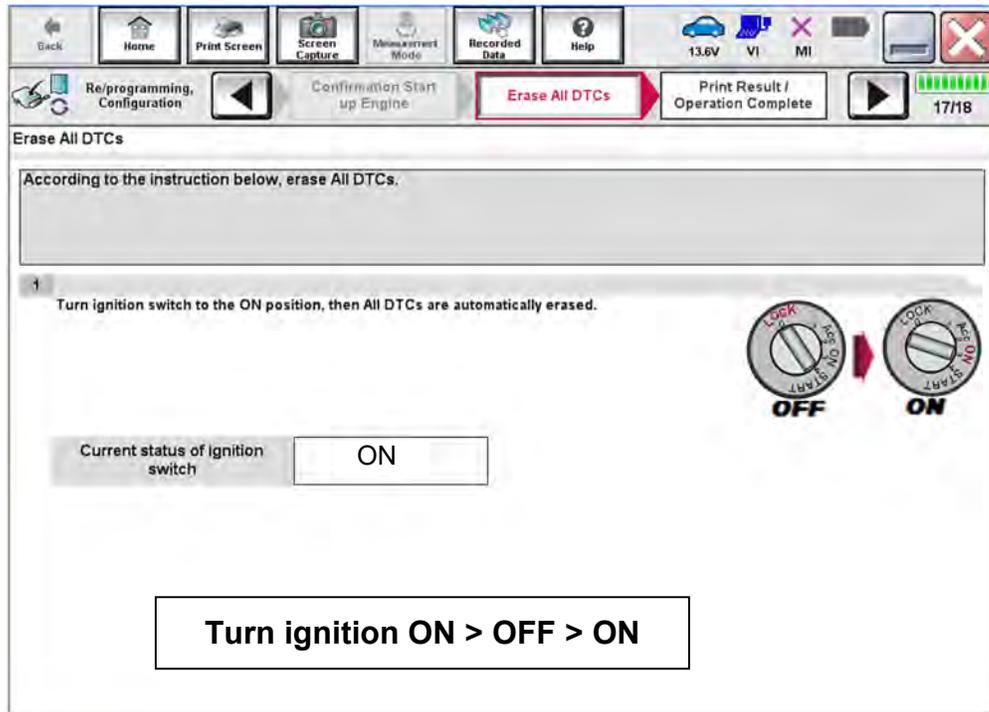
Figure 23

38. **Erase all DTCs** as follows:

- a. Turn the ignition OFF.
- b. Turn the Ignition ON.
- c. Wait for DTC erase to complete.

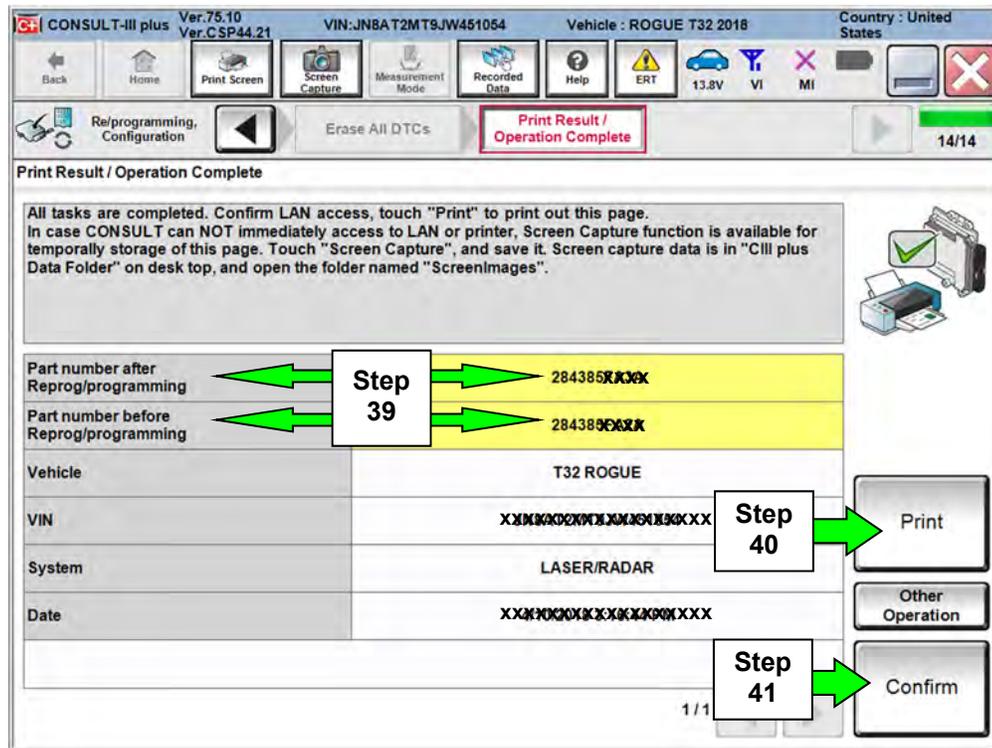
Figure 24

39. Verify the before and after part numbers are different.

40. Print a copy of this screen (Figure 24) and attach it to the repair order.

41. Select **Confirm**.

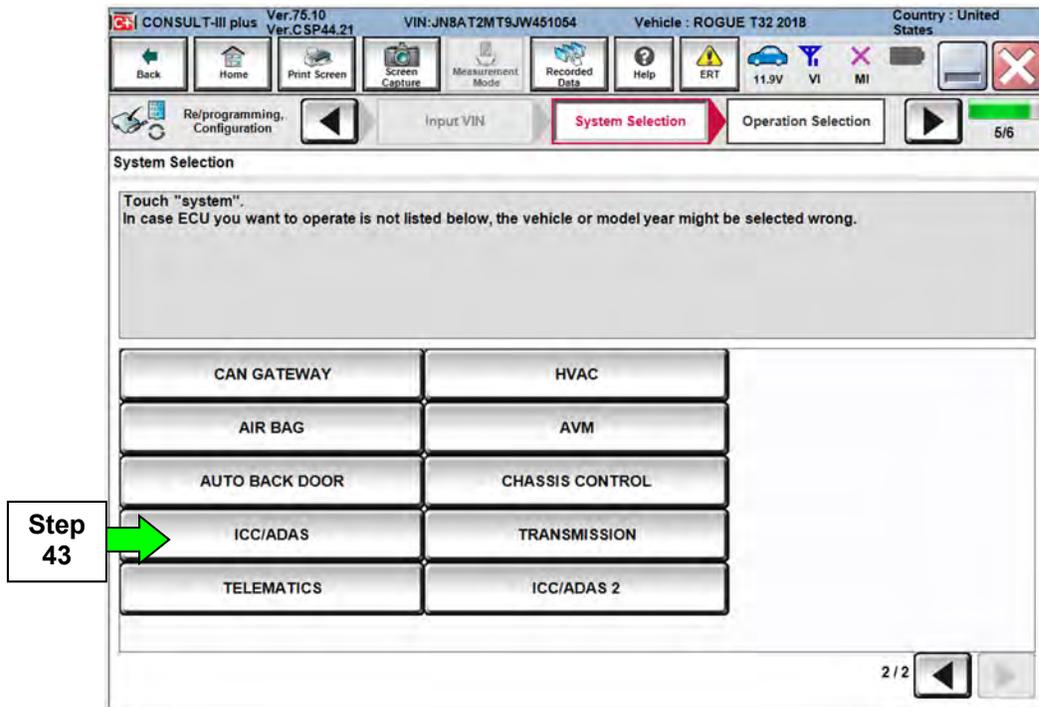
Figure 25

43. Select **ICC/ADAS**.

42. Refer to steps 1-17 starting on page 3 to navigate to Figure 25.

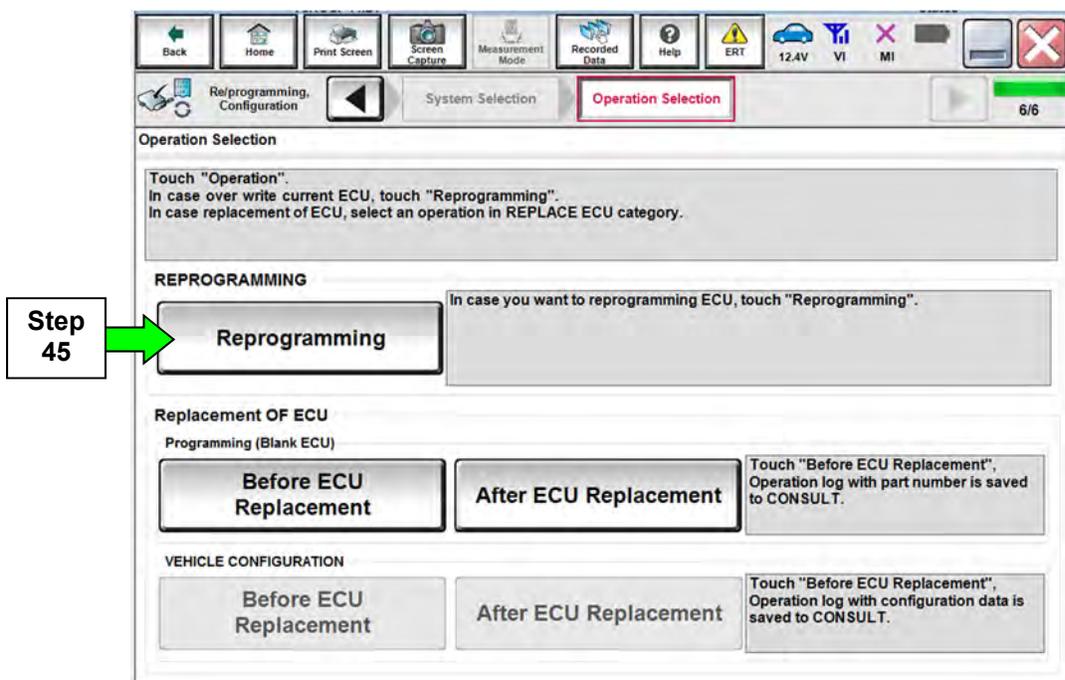
Figure 26

44. Select **Reprogramming**.

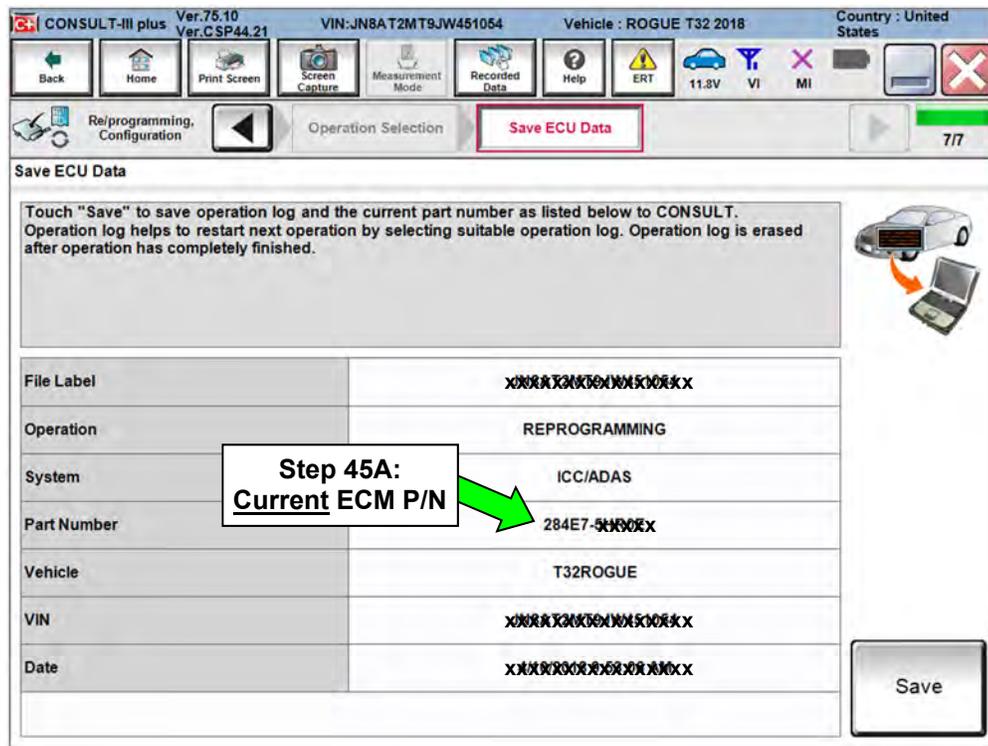
Figure 27

45. When you get to the screen shown in Figure 27, confirm that a reprogram is available as follows.

A. Find the ICC/ADAS **Part Number** and write it on the repair order.

NOTE: This is the current ICC/ADAS Part Number (P/N).

B. Compare the P/N you wrote down to the numbers in the **Current ICC/ADAS Part Number** column in **Table B**.

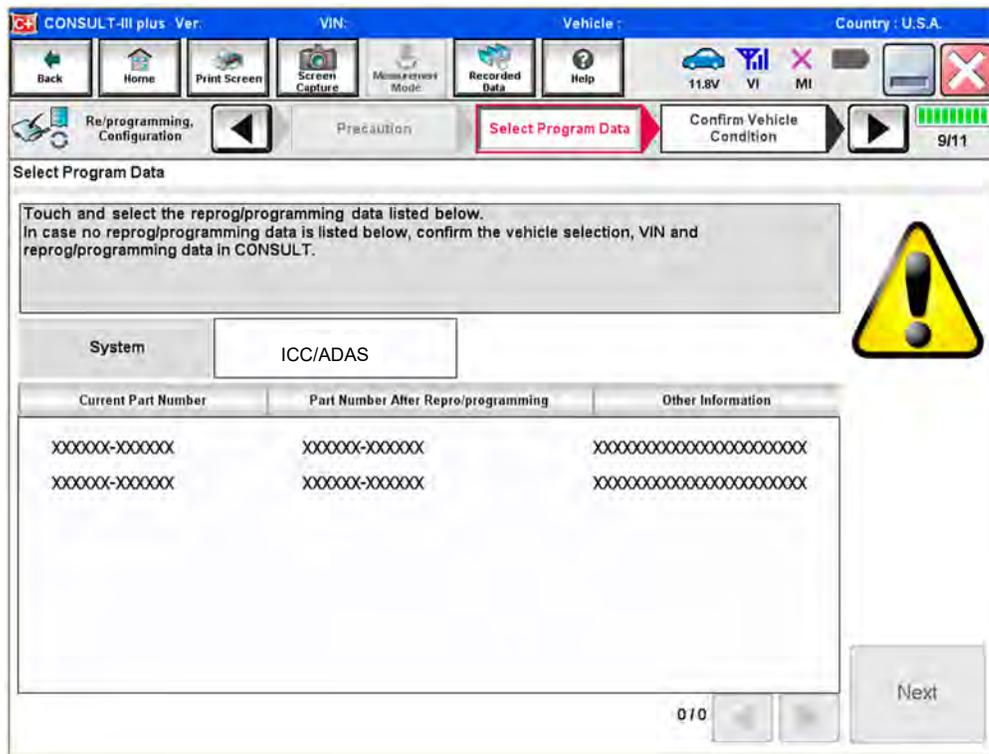
- In some cases, more than one new P/N for reprogramming is available.
 - If more than one new P/N is available, the screen in Figure 28 displays.
 - Select and use the reprogramming option that does **not** have the message “Caution! Use ONLY with NTBXX-XXX”.
- If you get this screen and it is blank (no reprogramming listed), it means there is no reprogramming available for this vehicle. Close C-III plus and refer back to ASIST for further diagnosis.

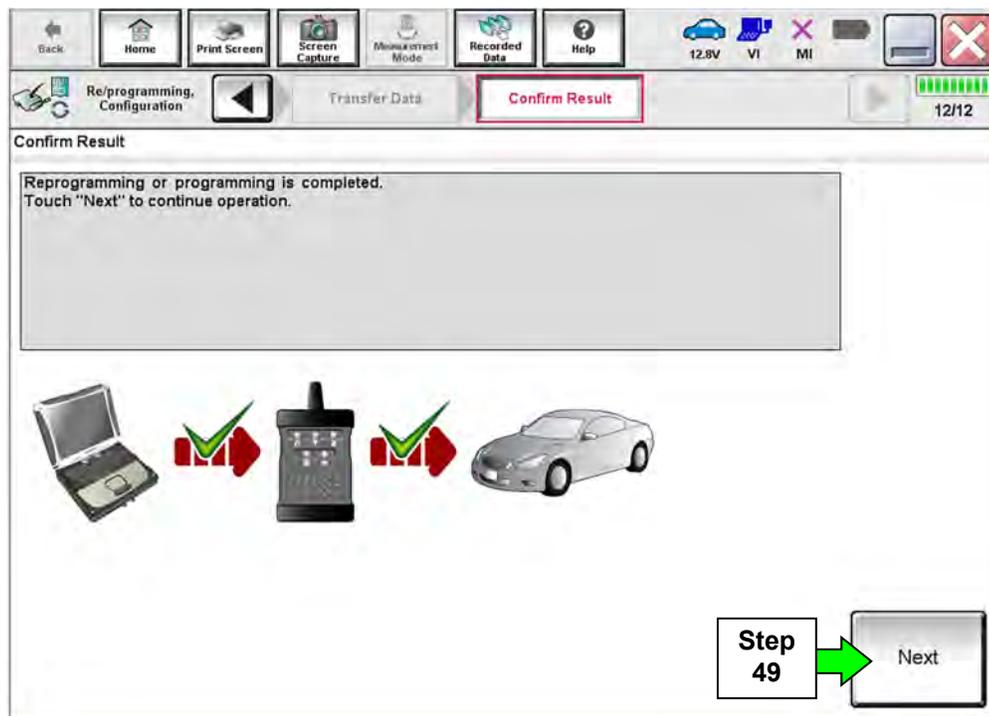
47. When the screen in Figure 29 displays, reprogramming is complete.

NOTE: If the screen in Figure 29 does not display (indicating that reprogramming did not complete), refer to ICC/ADAS recovery on the next page.

49. Select **Next**.

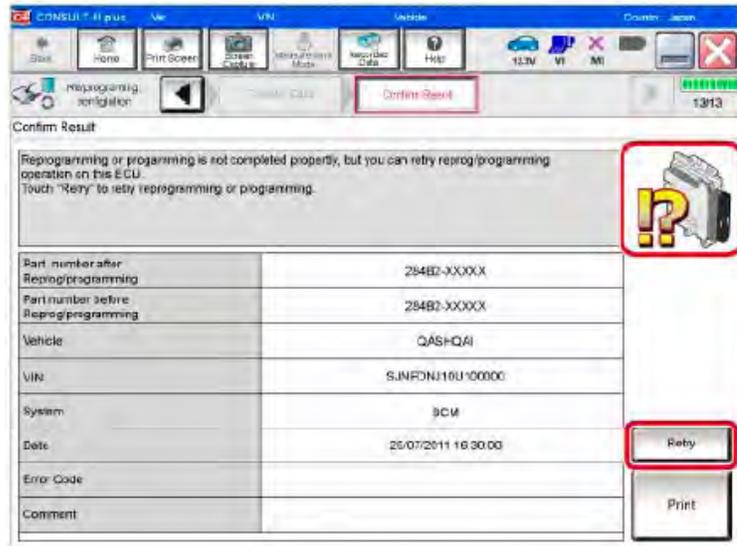
Figure 30

If reprogramming does not complete and the “!?” icon displays as shown in Figure 30:

- Check battery voltage (12.0 - 15.5 V).
- Ignition is ON, engine OFF.
- External Bluetooth® devices are OFF.
- All electrical loads are OFF.
- **Select retry and follow the on screen instructions.**
- “Retry” may not go through on first attempt and can be selected more than once.

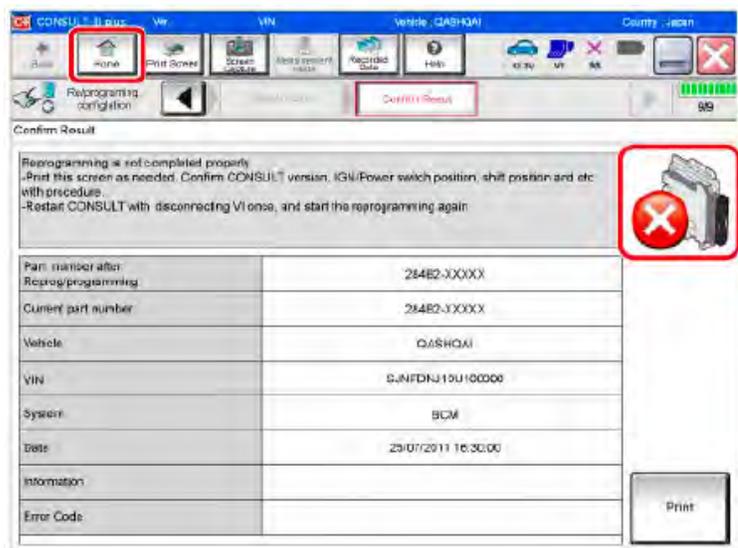
Figure 31

If reprogramming does not complete and the “X” icon displays as shown in Figure 31:

- Check battery voltage (12.0 - 15.5 V).
- CONSULT A/C adapter is plugged in.
- Ignition is ON, engine OFF.
- Transmission is in Park.
- All C-III plus / VI cables are securely connected.
- All C-III plus updates are installed.
- **Select Home, and restart the reprogram procedure from the beginning.**

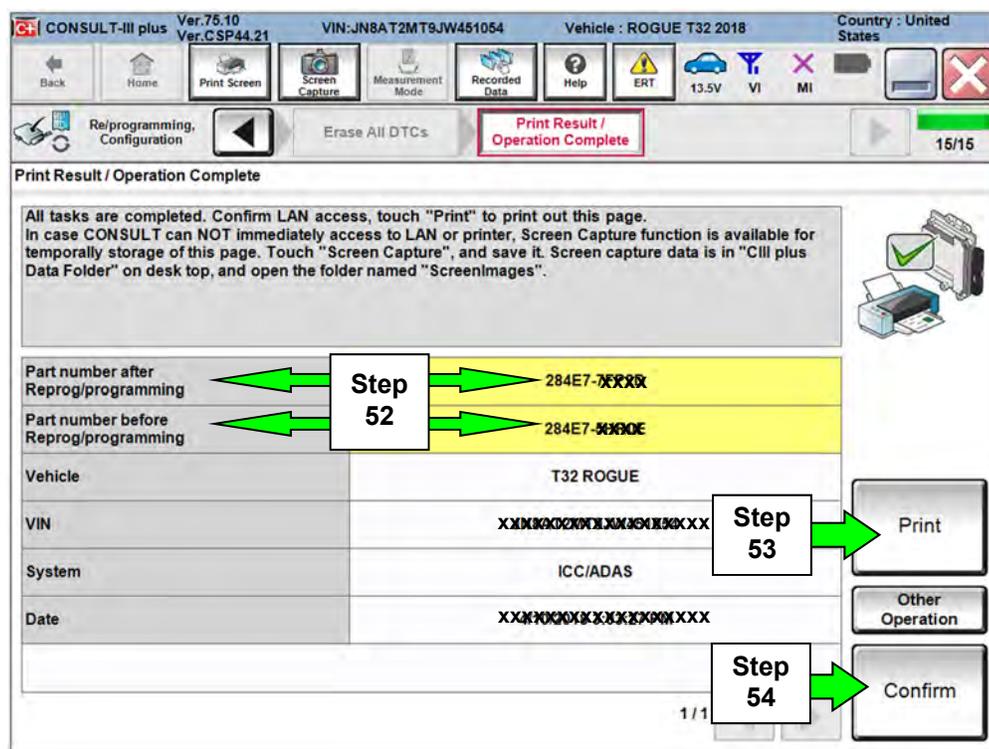
50. Follow the on on-screen instructions to erase DTCs.
 - If needed, refer to step 38 on page 18 for further details.
51. When the entire reprogramming process is complete, the screen in Figure 32 will display.
52. Verify the before and after part numbers are different.
53. Print a copy of this screen (Figure 32) and attach it to the repair order for warranty documentation.
54. Select **Confirm**.
