SERVICE BULLETIN

EC18-017

2016-2018 TITAN XD DIESEL; AIR CONDITIONING BLOWS HOT AIR AFTER EXTENDED IDLING OVER 100°F

APPLIED VEHICLES: 2016-2018 Titan XD (A61)

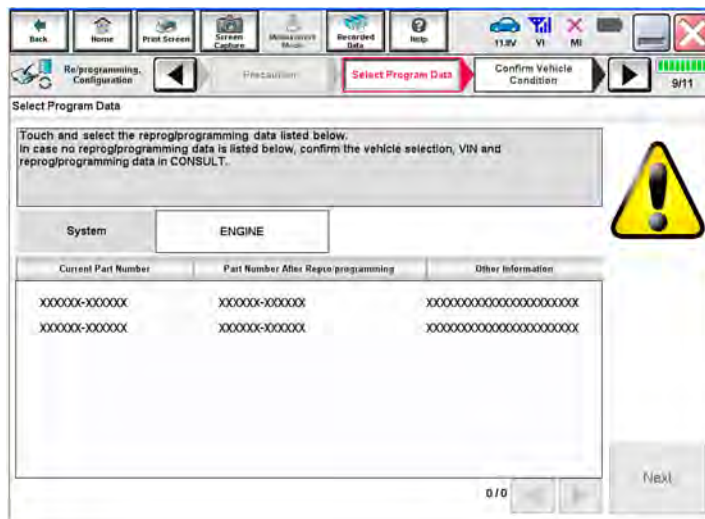
- In some cases, more than one new P/N for reprogramming is available.
 - If more than one new P/N is available, the screen in Figure 7 displays.
 - Select and use the reprogramming option that does **not** have the message “Caution! Use ONLY with NTBXX-XXX”.
- If you get this screen and it is blank (no reprogramming listed), it means there is no reprogramming available for this vehicle. Close C-III plus and refer back to ASIST for further diagnosis.

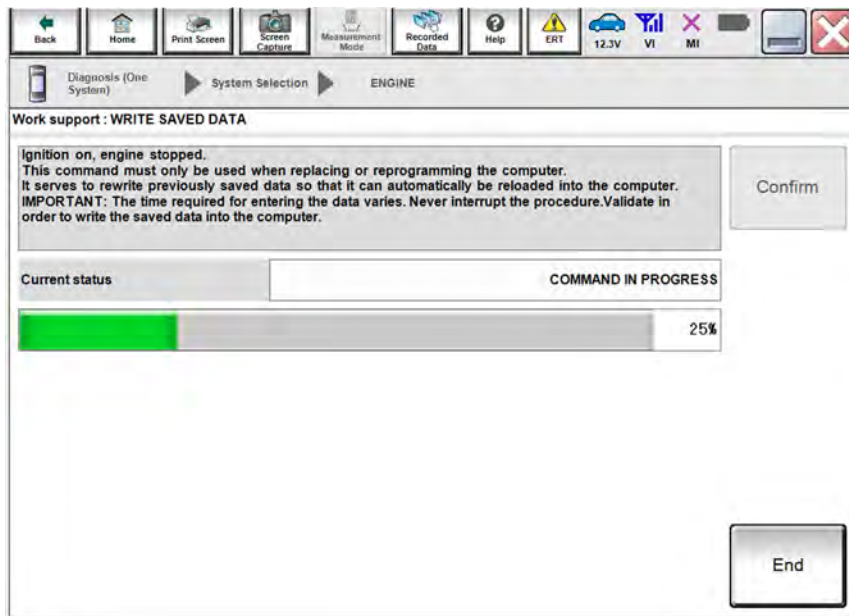
Figure 15

10. Wait for the procedure to complete.
