SERVICE BULLETIN

Classification: HA18-002a	Reference: NTB18-046a	Date: July 17, 2018
------------------------------	--------------------------	------------------------

2016-2018 TITAN XD DIESEL; AIR CONDITIONING BLOWS HOT AIR AFTER EXTENDED IDLING OVER 100°F

APPLIED VEHICLES: 2016-2018 Titan XD (A61)

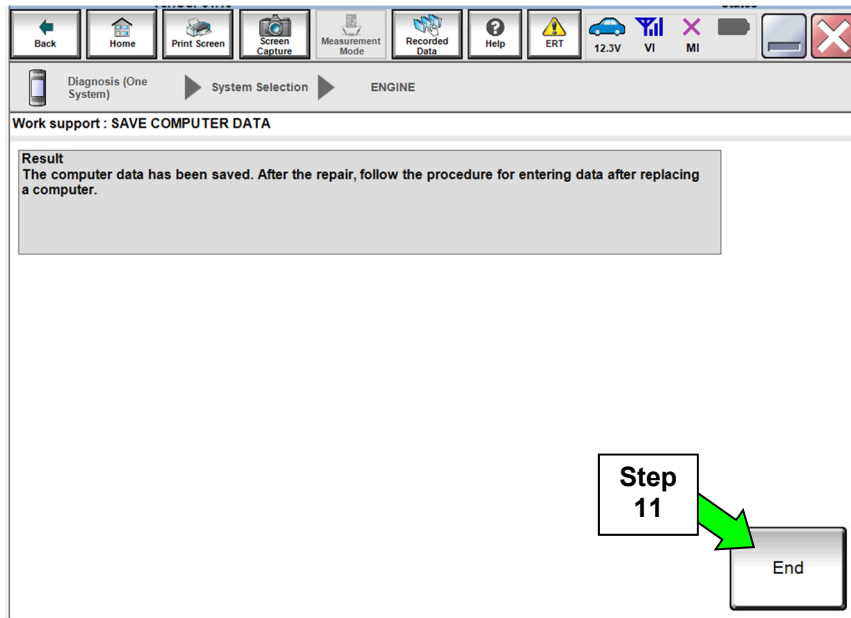
Figure 4

11. Select **End**.

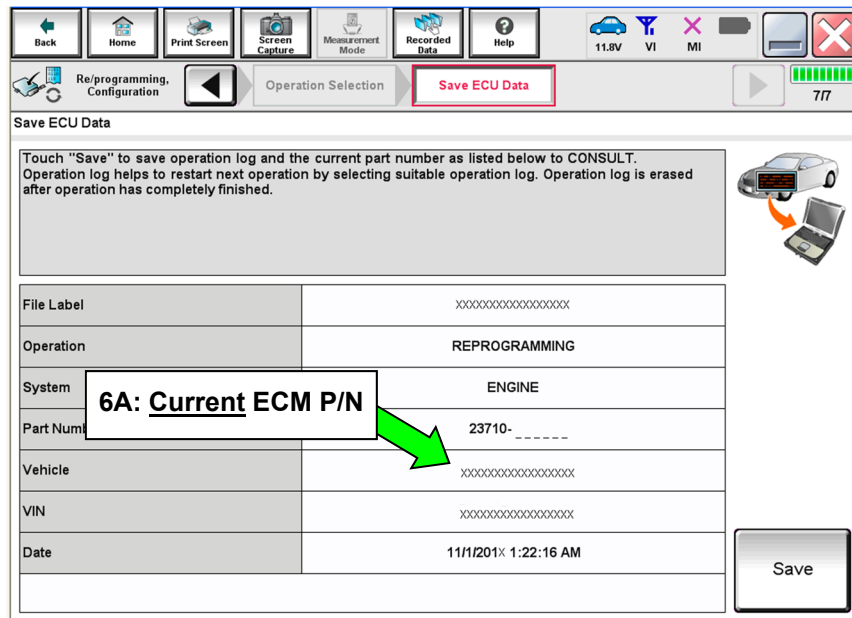
6. When you get to the screen shown in Figure 6, confirm this bulletin applies as follows.

A. Find the ECM **Part Number** and write it on the repair order.

NOTE: This is the current ECM Part Number (P/N).

5. Follow the on-screen instructions and navigate C-III plus to the screen shown in Figure 6 on the next page.
