**TECHNICAL INSTRUCTIONS  
FOR  
LIMITED SERVICE CAMPAIGN FOR  
ENGINE SOFTWARE UPDATE FOR VARIABLE LIFT CONTROL  
CERTAIN 2014 COROLLA ECO VEHICLES**

**THIS LSC EXPIRES ON JUNE 30, 2018**

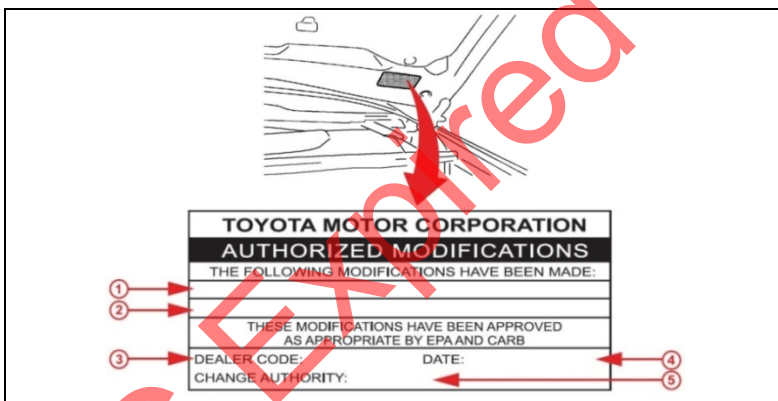
- a) Fill out the label.
- b) Affix the label to the under-side of the hood.

1	Replacement ECM P/N
2	New Calibration ID
3	Dealer Code
4	Date Completed
5	Campaign Code (FOA)
