# Entune Audio Head Unit Software Update (Fujitsu Ten)

**Service Category** Audio/Visual/Telematics

**Section** Navigation/Multi Info Display

## Entune Audio Head Unit Software Update (Fujitsu Ten)

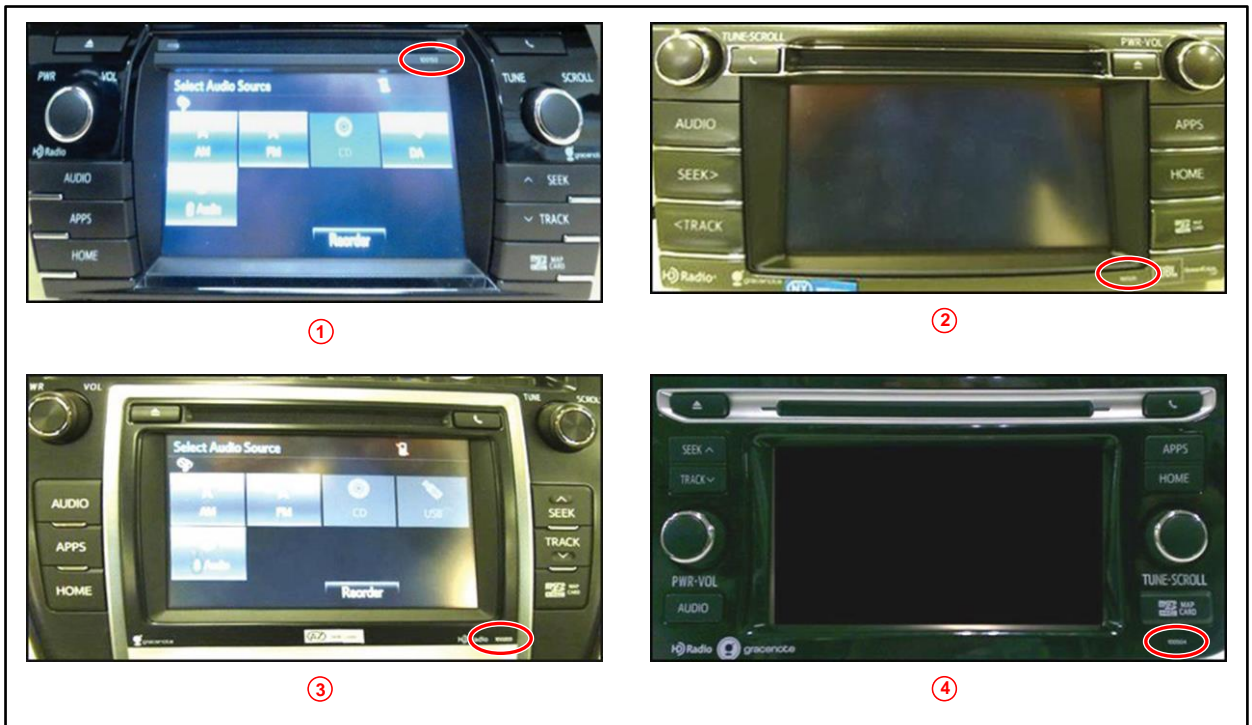
**Figure 1.**

1. Confirm the audio system type by checking the panel ID printed above the top-right or bottom-right of the display.

<b>1</b>	<b>Corolla</b>
<b>2</b>	<b>RAV4, RAV4 HV</b>

<b>3</b>	<b>Camry, Camry HV</b>
<b>4</b>	<b>Prius C</b>

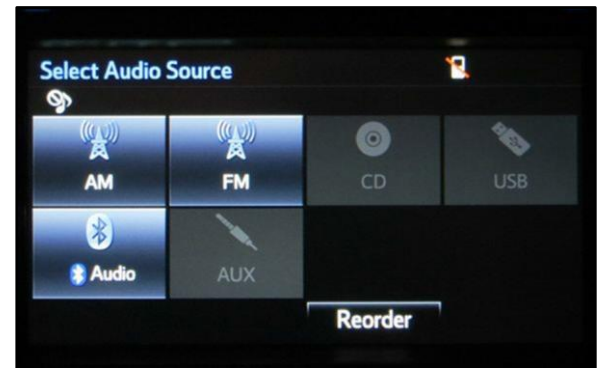
Figure 2.

2. Perform steps 7 – 11 and verify the latest software needs to be installed.  
Is the software up to date?
  - **YES** — This bulletin does NOT apply. Continue diagnosis using the applicable Repair Manual.
  - **NO** — Continue to step 3.
3. Insert the USB flash drive into the vehicle USB port.
4. Start the engine.
5. When the Select Audio Source screen displays, continue to the next step.

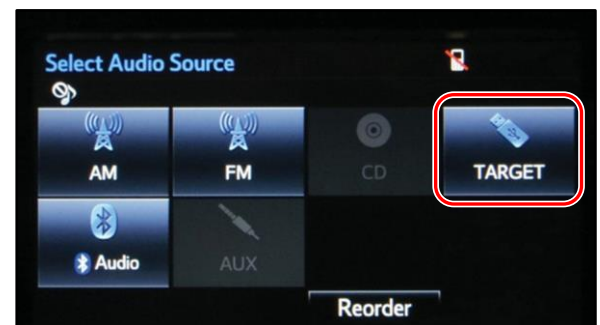
Figure 3.

6. When the USB source icon highlights and displays the USB name with the icon, continue to the next step.

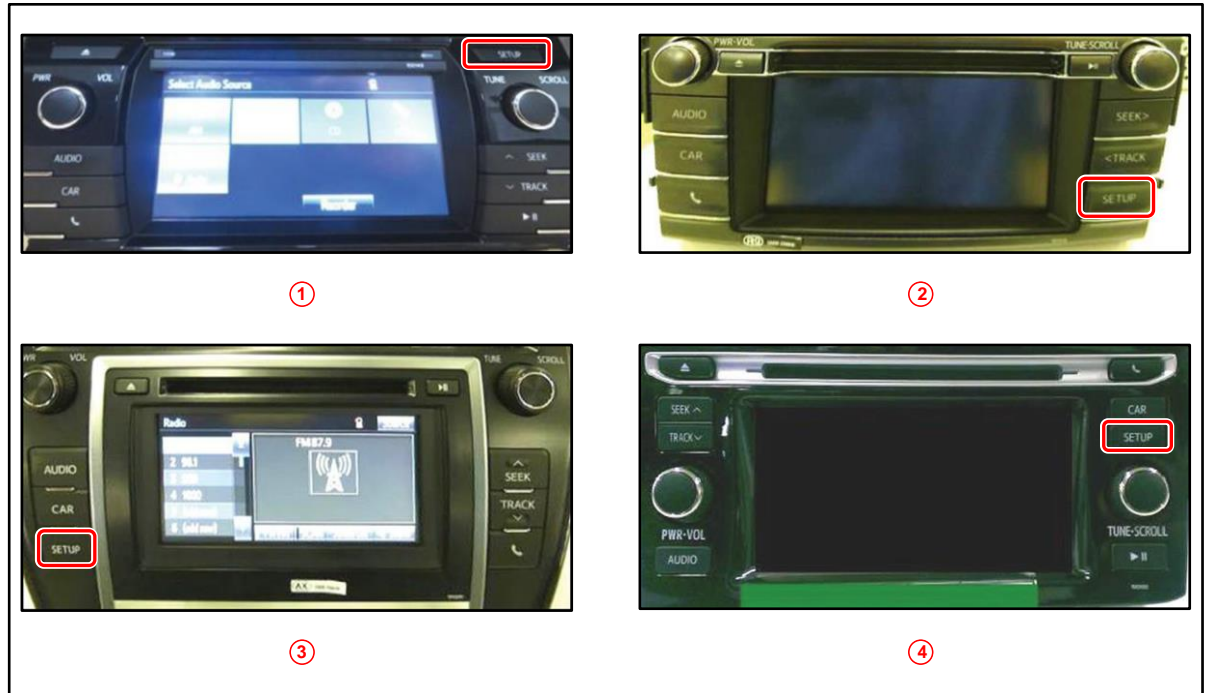
**Figure 4.**

7. Go to the Setup screen.
  - A. For Entune™ Audio:  
Press the Setup button on the panel.

<b>1</b>	<b>Corolla</b>
<b>2</b>	<b>RAV4, RAV4 HV</b>

<b>3</b>	<b>Camry, Camry HV</b>
<b>4</b>	<b>Prius C</b>

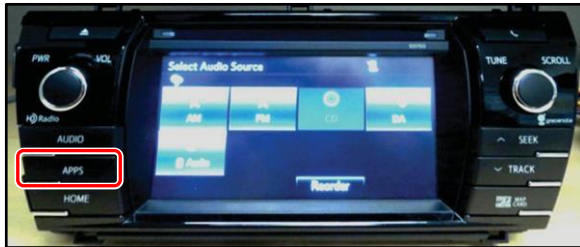
**Figure 5. Camry, Camry HV, Corolla, RAV4, RAV4 HV**

(1) Press the Apps button on the left or right of the panel.

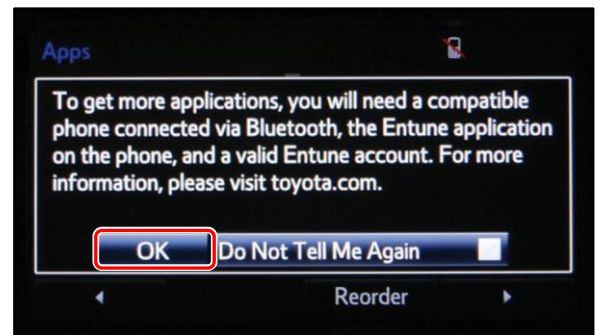
**Figure 7.**

**NOTE**  
If the Entune™ pop-up displays, select Ok.

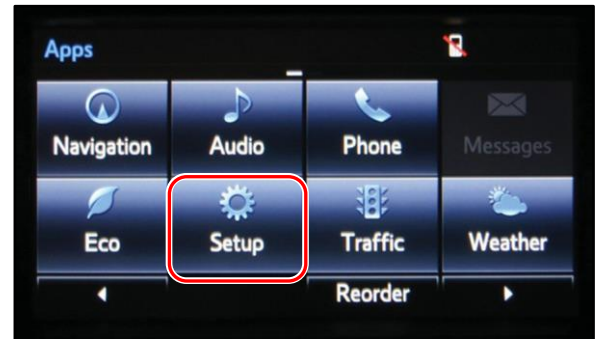
**Figure 8.**

(2) Select Setup on the Apps screen.

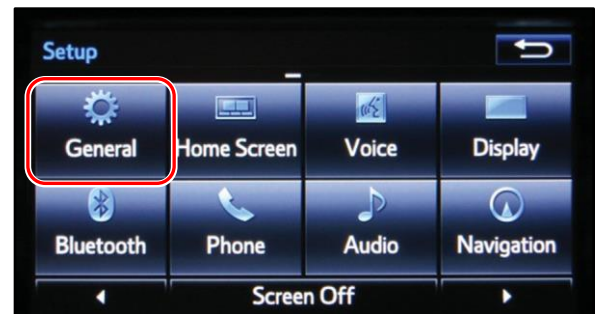
**Figure 9.**

8. Select General on the Setup screen

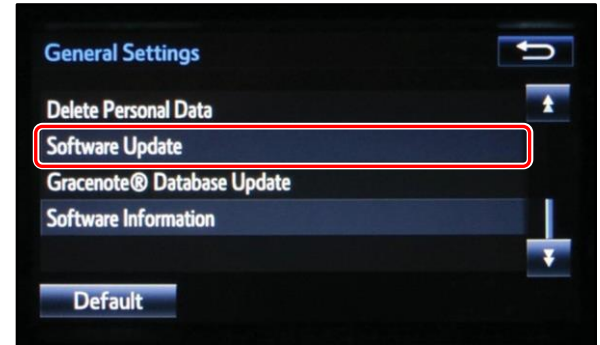
Figure 10.

9. Select Software Update from the list on the General Settings screen.

Scroll down the list until Software Update displays.

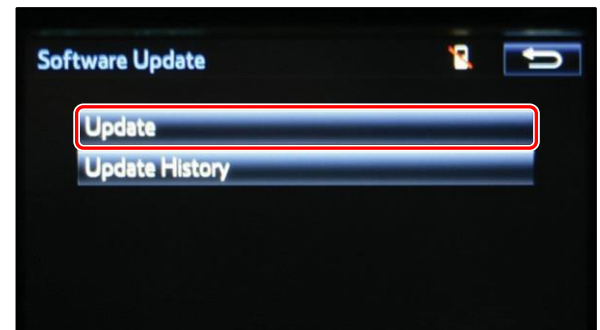
Figure 11.

10. Select Update on the Software Update screen.

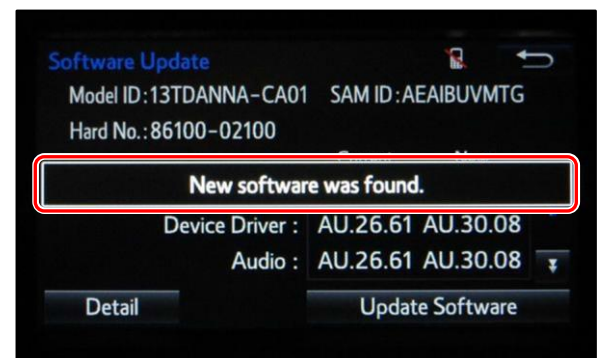
Figure 12.

If software is detected properly, a "New Software was found." pop-up will display.

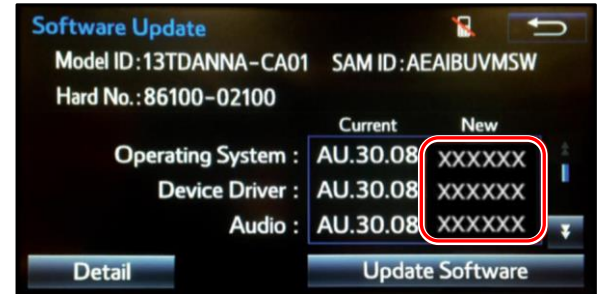
Figure 13.

- Verify that the NEW software is up to date on the Software Update screen.

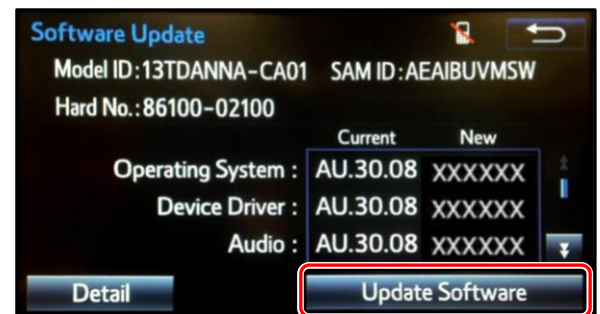
Figure 14.

- Select Update Software on the Software Update screen.

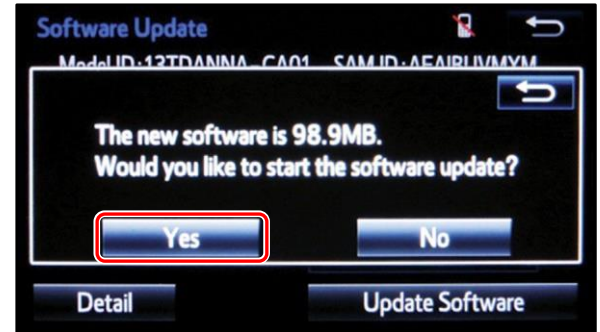
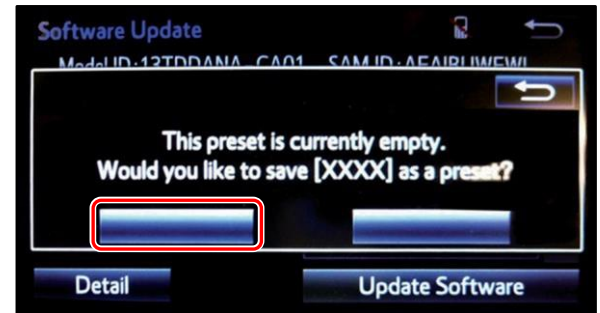
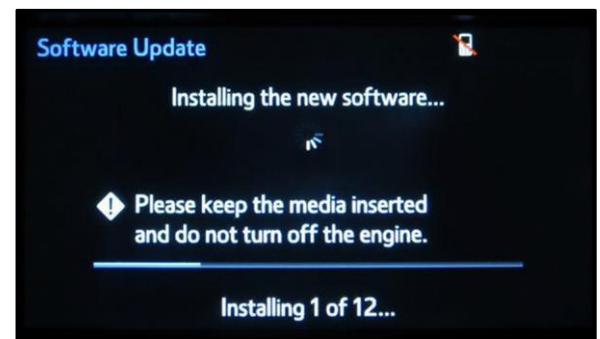
13. Select Yes on the “Would you like to start the software update?” pop-up.

Entune™ Audio Plus ONLY: Select the left box on the “This preset is currently empty. Would you like to save [XXXX] as a preset?” pop-up.

14. This unit will begin installation.

Do NOT turn off ACC before the software is ready for updating.

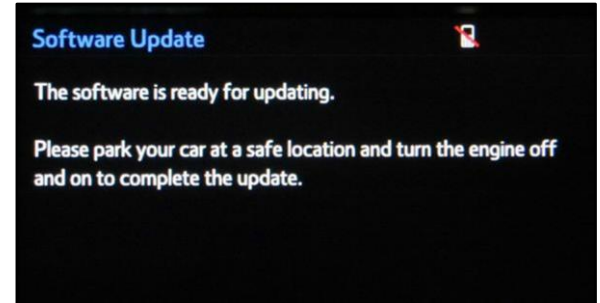
**Figure 18.**

15. When “The software is ready for updating” displays, cycle the ignition OFF, wait 30 seconds, then cycle the ignition ON again.

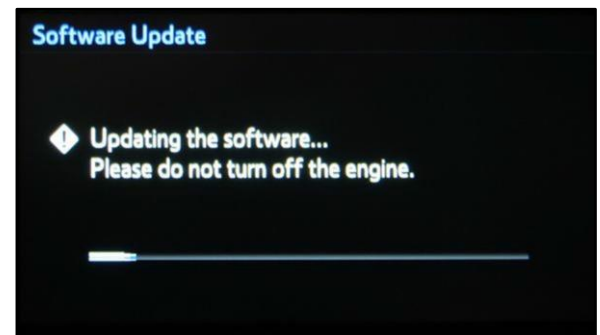
**Figure 19.**

16. Wait for the audio system to complete the software update.

Do NOT turn off ACC before the next Toyota logo screen displays.

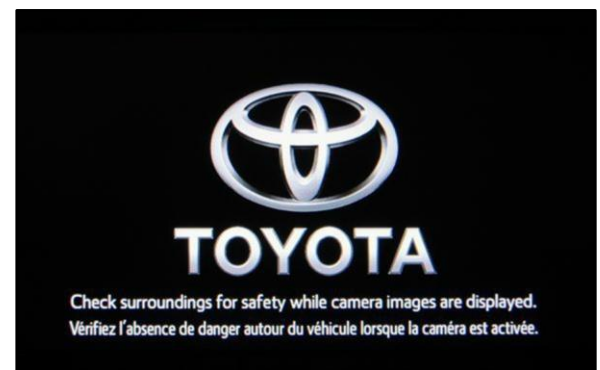
**Figure 20.**

When the Toyota logo screen displays, the update is complete.

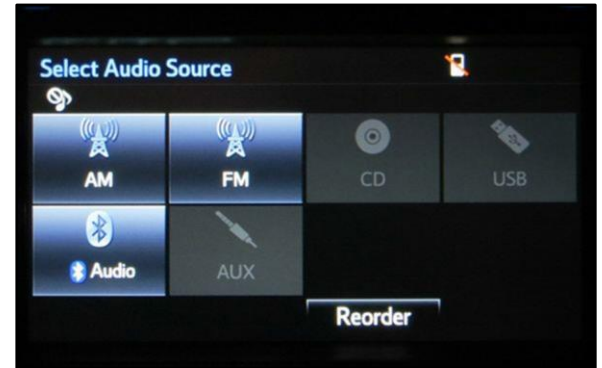
Figure 21.

- When the the Select Audio Source screen displays, continue to the next step.
