## ROADSTER 2018-4 Large Panoramic 78 Wide LCD Display - Software Update Registered Units\_000135063\_WCN61Y018S00\_en

Bulletin no: **2018-4** (rbg2018-005 en AP)

Subject: **Large Panoramic 7.8" Wide LCD Display - Software Update  
Registered Units**

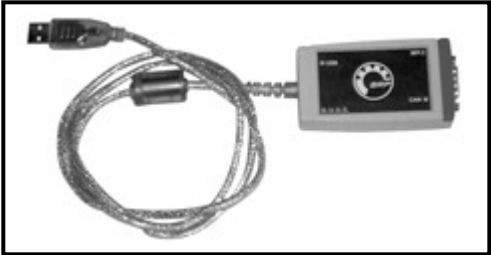
| MPI-2 INTERFACE CARD<br>(P/N 529 036 018) | |

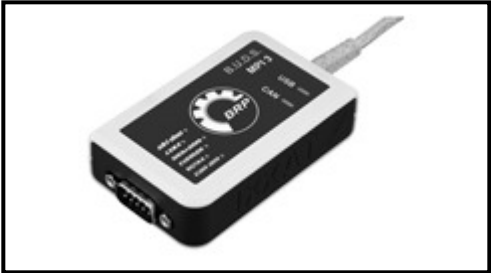
| MPI-3 INTERFACE CARD (P/N 529 036 353) | |

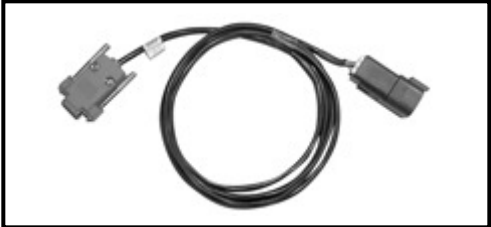
| DIAGNOSTIC CABLE<br>(P/N 710 000 851) | |

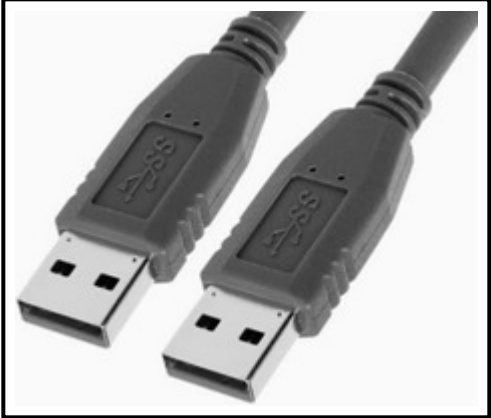
| USB 2.0 or higher Cable (Type A Male to Type A Male)<br>BRP (P/N 715900623) or equivalent available at electronic retail outlets.<br>DO NOT EXCEED 2 m (7 ft) | |

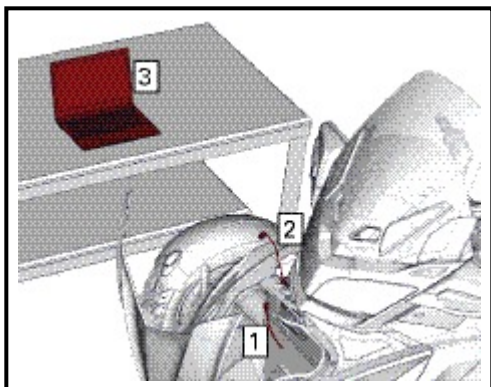
SHOWING RT MODELS

1. Vehicle USB cable
2. BRP diagnostic software cable
3. Computer

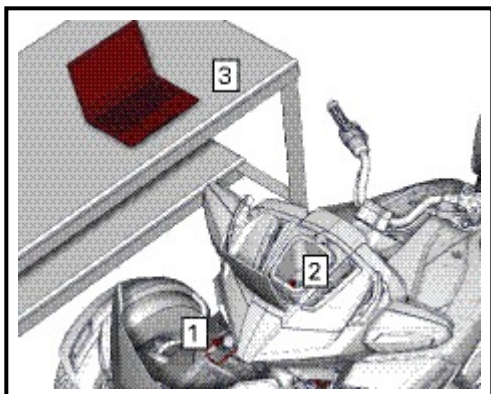
SHOWING F3 MODELS

1. BRP diagnostic software cable
2. Vehicle USB cable
3. Computer

**NOTE:** BOTH DIAGNOSTIC CABLE AND USB CABLE ARE REQUIRED TO DO THE UPDATE.

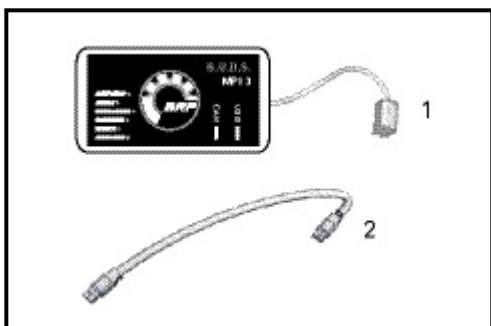
1. MPI Diagnostic Cable
2. USB Cable

1. Access the vehicle USB connector.
2. Connect the USB cable between the computer and the vehicle.
3. Connect the vehicle to the BRP diagnostic software (BUDS2) using the *MPI DIAGNOSTIC CABLE*.
4. Logon as administrator by doing a right click on the BUDS2 icon and select the *RUN AS ADMINISTRATOR* option.

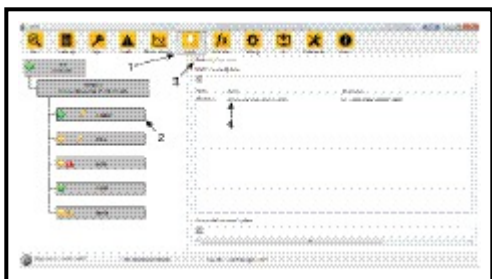
**TYPICAL**

8. Select and run the multifunction gauge software update file in the *VALID FIRMWARE UPDATES* window.

1. FLASH page
2. CLUSTER button
3. FLASH tab
4. Update files

6. In BUDS2, select:
  - FLASH page
  - CLUSTER button
  - FLASH tab.
