MODEL
2018MY
Stinger (CK)

NUMBER
077 (Rev 1, 08/16/2018)

TECHNICAL SERVICE BULLETIN

SUBJECT: SERVICE ACTION: FAST STATIC GEAR SHIFT
LOGIC IMPROVEMENT (SA341)

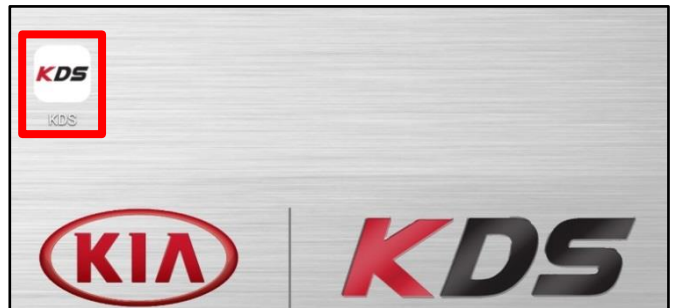
2. With the ignition ON, turn ON the KDS tablet. Select **KDS** from the home screen.
