GROUP TRA	MODEL 2013-2015MY Optima Hybrid (TF HEV)
	NUMBER 079	DATE August 2018

TECHNICAL SERVICE BULLETIN

**SUBJECT: SERVICE ACTION: HCU/TCU LOGIC IMPROVEMENT
FOR DTC P1744 (400 MESH EQUIPPED TRANS) (SA351)**

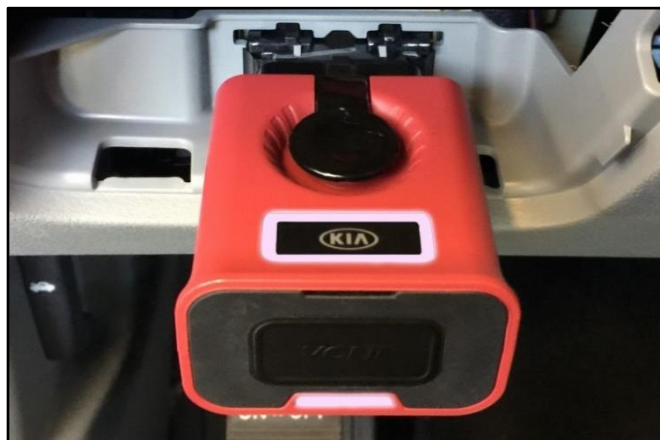
- With the ignition ON, turn ON the KDS tablet. Select **KDS** from the home screen.

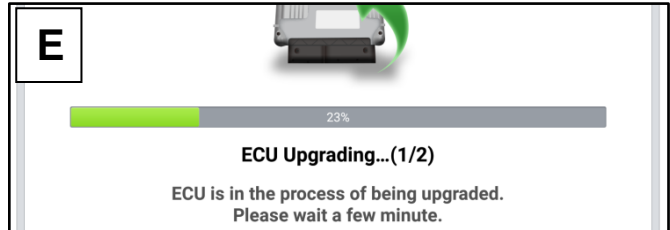
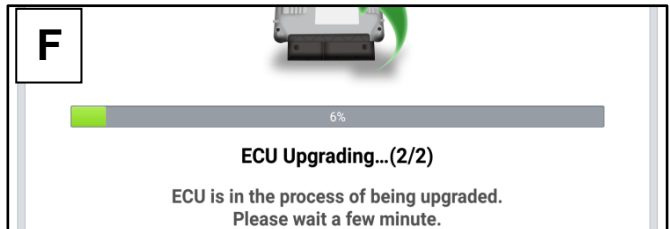
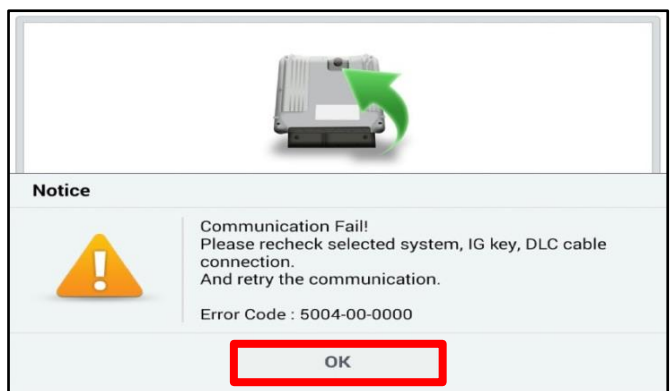
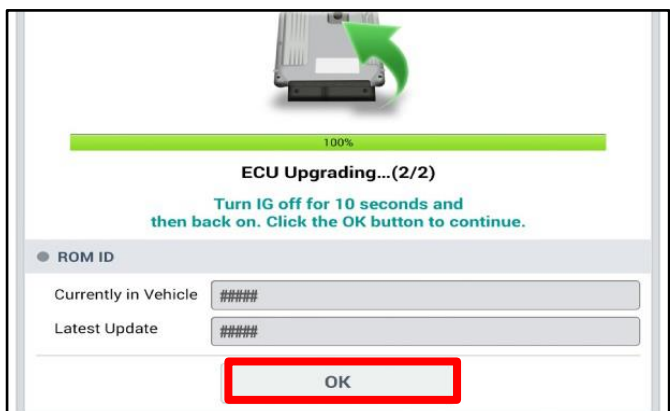
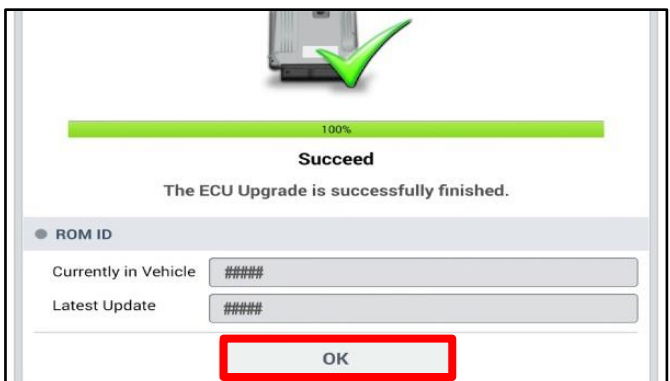
10. If a "Communication Fail" screen appears, verify that the VCI-II and KDS are communicating properly. Touch **OK** and restart the procedure from step 4.

11. When instructed on the KDS, turn the ignition **OFF** for ten (10) seconds then back on. Touch **OK** to continue.

12. Once the upgrade is complete, touch **OK** to finalize the procedure.

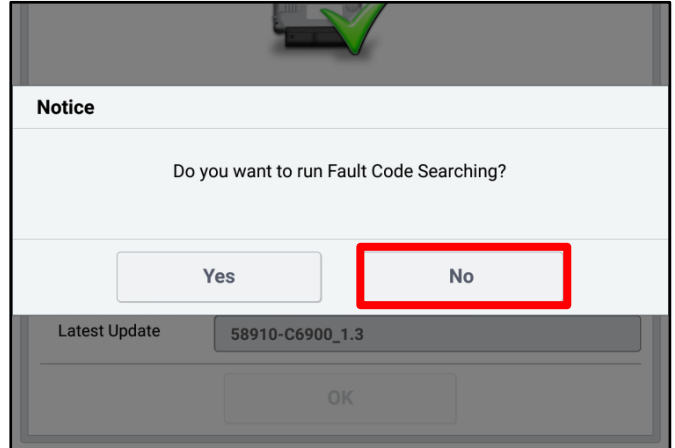
- When prompted, select **No** for the Diagnostic Trouble Codes (DTC) check, then return to the KDS Home Page and proceed to the next step.

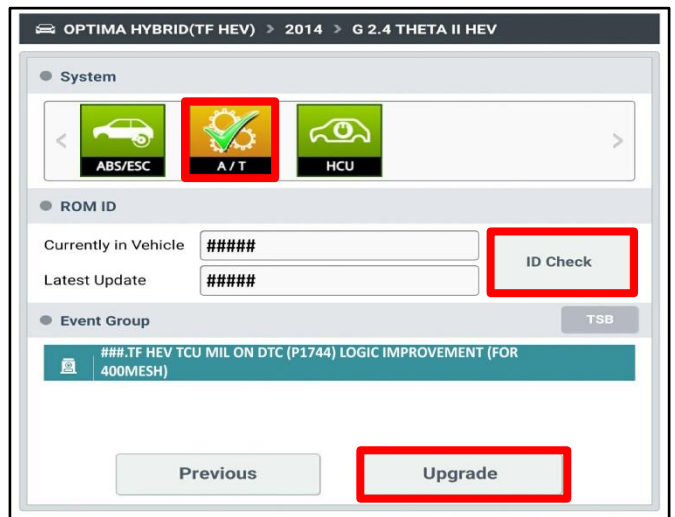
- Repeat steps 4-12 and perform **Upgrade Event #336** with the **A/T** system selected under the System selection menu.

When prompted, select **YES** to check for Diagnostic Trouble Codes (DTC) and erase any DTCs stored such as EPS, ESC, and TPMS that may have been set during the upgrade.

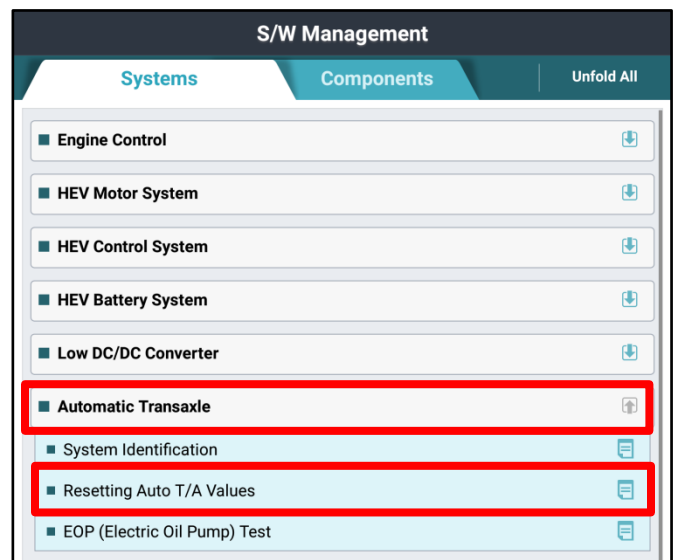
- After completion of the upgrade(s), reset the TCU adaptive values in S/W Management → Automatic Transaxle → Resetting Auto T/A Values.

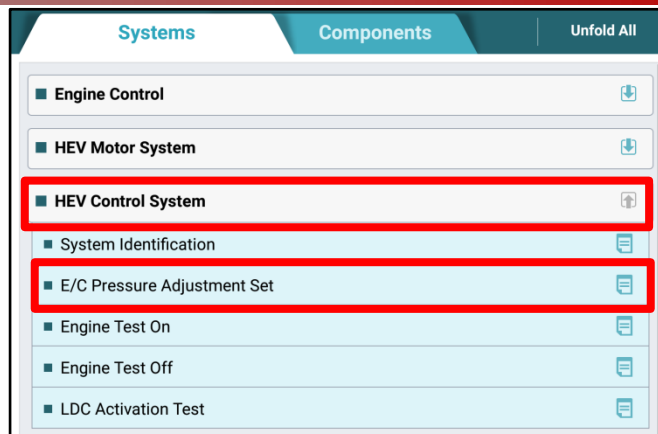
16. Perform an Electronic Clutch Fluid Pressure Calibration by returning to the KDS home screen then selecting S/W Management → HEV Control System → E/C Pressure Adjustment.
